Project	Telford & Wrekin Level 2 SFRA	Date	4 th March 2008
Note	Site Visit 21/02/2008	Ref	WBTWCS
Author	M Grogan

1.1 On the 21st February 2008 Halcrow visited the Hurley Brook/Ketley Brook and the Crow Brook to facilitate the hydraulic modelling exercises that will follow for the Level 2 SFRA. This Technical Note is a brief summary of the site visit and findings.

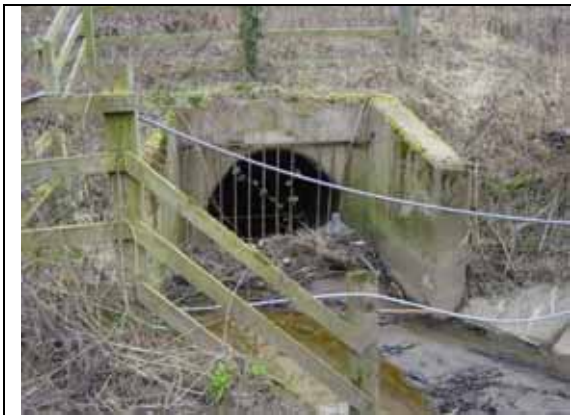
001 Ketley Brook Culvert US Under M54

2.2 The first structure on Ketley Brook is the culvert under the M54. This is a 1m diameter circular culvert (picture 001 Appendix A). Downstream of this culvert there is a flow baffle (pictures 003-005 Appendix A) (SJ 67305 10252). The base of this appears to be just above the low flow conditions for the brook. Immediately downstream of this is a balancing pond (pictures 006, 007 Appendix A). Water from the pond flows out over a spill at the eastern side (picture 008) (SJ 67195 10276). The spill incorporates a drop of approximately 1.75m, downstream of which the channel becomes an artificial concrete channel (picture 009). At the downstream end of the artificial channel there is an inflow from the drains on the Ketley Dingle Interchange (M54 junction 6) (SJ 67112 10404). The watercourse then reverts to natural channel and flows towards the Sinclair Ironworks.

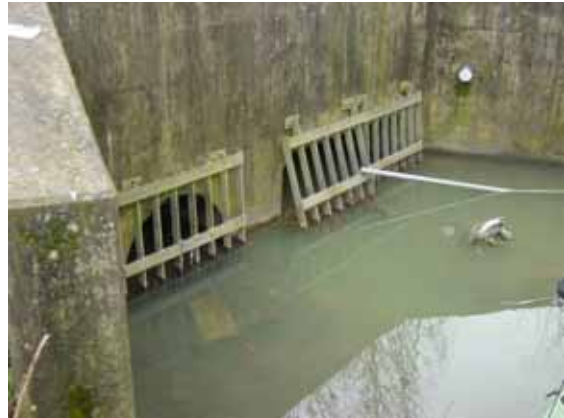
010 Ketley Brook DS Culvert DS A518
Holyhead Road

2.3 Information from the EA (based on the submitted consent for modification of the culvert) has indicated that Sinclair Ironworks has diverted a culvert (which originally flowed under the site) and replaced it as it was in poor condition. The culvert is now a 1950mm diameter pipe with an invert of 102.180m and is located at SJ 67100 10500. It was not possible to examine the inlet as it lies within the Sinclair Ironworks site and permission to enter the site had not been obtained. The culvert emerges north of Holyhead Road (A518) (pictures 10-12 Appendix A) (SJ 66950 11063). The watercourse emerges from two

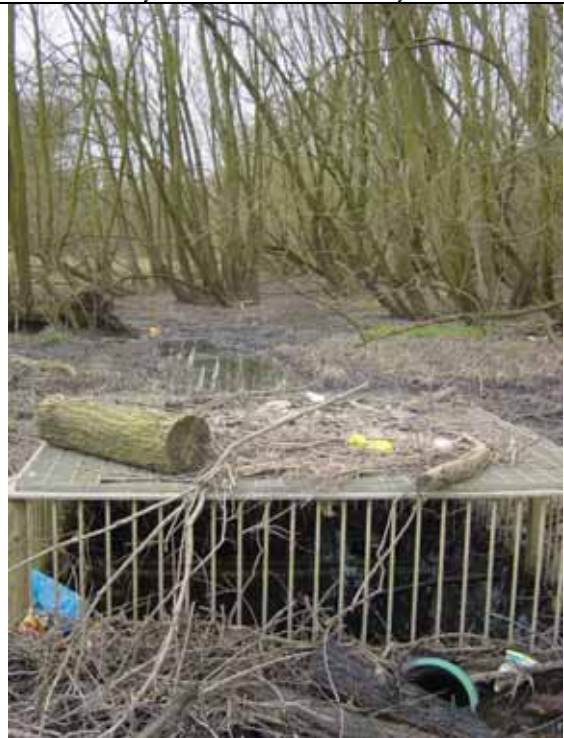
014 Ketley Brook Sink nr Wedgewood Crescent

culverts, a circular culvert 1m in diameter and a box culvert 1m by 2m. The watercourse flows onward to a flood storage area where it sinks into a drop culvert (pictures 13-21 Appendix A) (SJ 66885 11361). The drop culvert appears to be 2.5m deep with a plan of 2m by 2m, with two 450mm diameter culverts exiting it. The brook eventually emerges at its confluence with the Hurley Brook (pictures 22-27 Appendix A) (SJ 66728 12671).

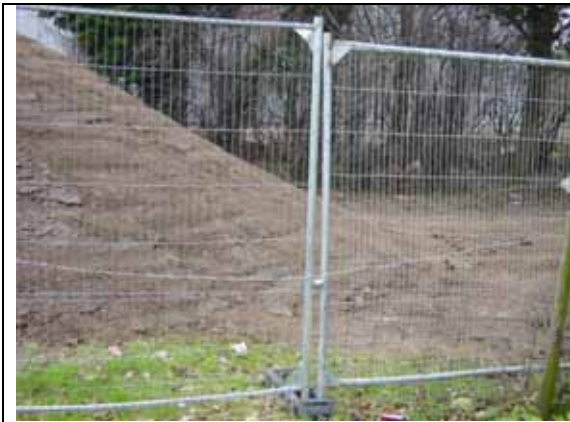
- 4.3 When following the assumed 'old path' and looking for possible places where the Crow Brook may emerge from the culvert, it was observed that site 61900 Land adjacent Oakland House, Hortonwood, was already being developed (picture 65 Appendix A) (SJ 68872 13641). This site also incorporates a reach of watercourse which drains east to west. The interaction of this with either the old or new Crow Brook is not known, and needs to be understood from any existing data on the diversion, to inform how it should be appropriately modelled.

065 Hortonwood Development Site Mound of Earth Over Location of Drain

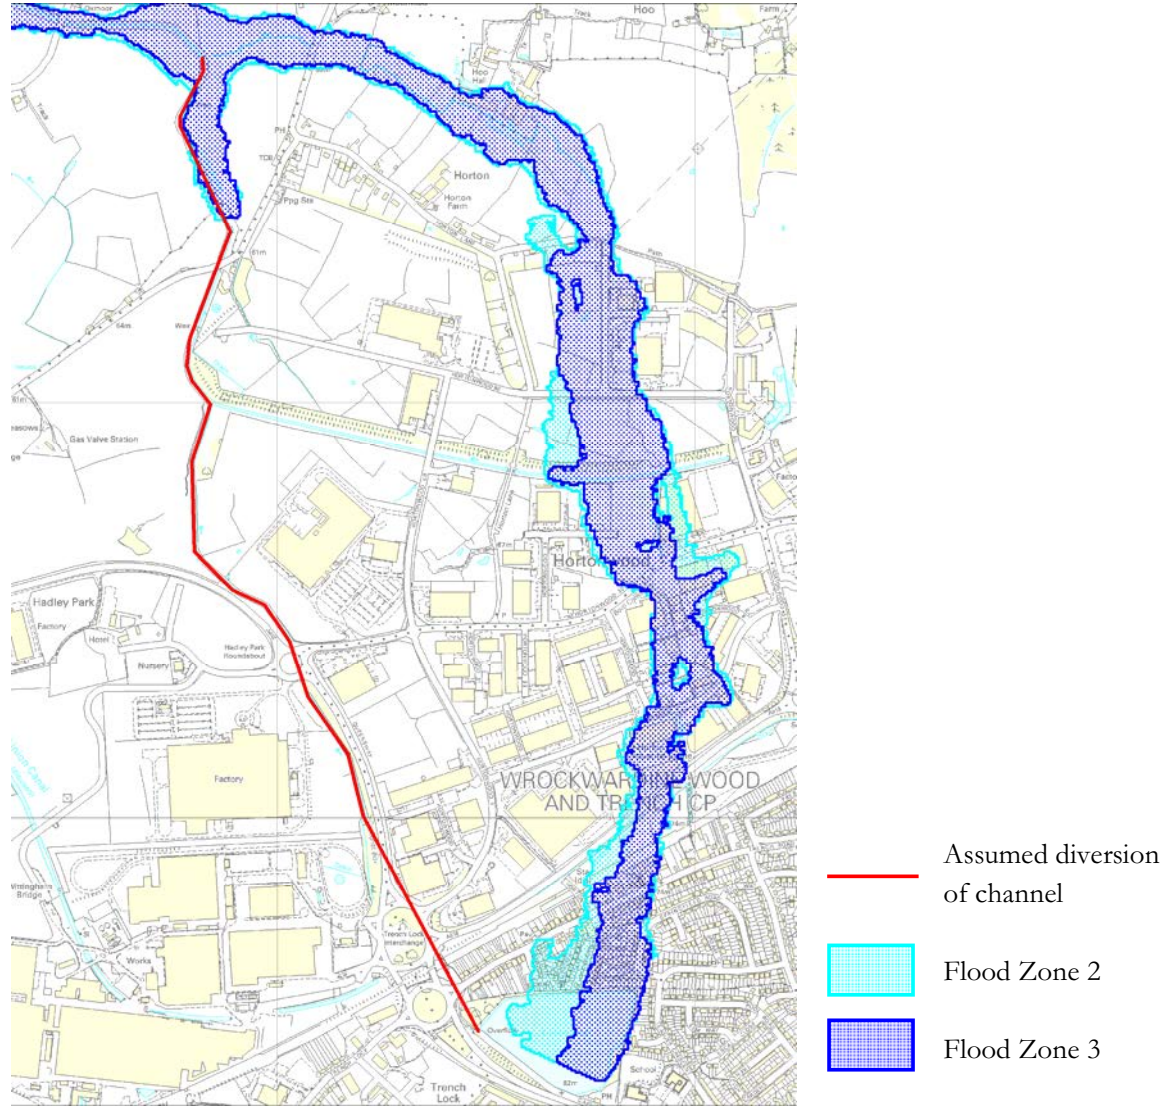
Figure B.1: Crow Brook flood zones and assumed channel diversion

- 4.2 At the upstream extent of the reach the Crow Brook emerges from a culvert into a natural channel (pictures 47-48 Appendix A) (SJ 68590 11510). The brook flows in a north eastern direction before entering two 400mm diameter culverts under Sommerfeld Road (pictures 54-55 Appendix A) (SJ 68723 11759). When the brook emerges the water is a red-orange colour (pictures 49-51, 53), denoting possible water quality issues, possibly due to contamination emerging from the ground, inside the culvert, or interaction with the wetland area to the east (picture 52 Appendix A) (SJ 68746 11951). The brook flows north for a short distance before entering a culvert (SJ 68772 12096). It was not possible to inspect this culvert as it was on a site and permission to enter had not been obtained. The culvert emerges again at Trench Pool (pictures 56-57, 60-63 Appendix A) (SJ 68774 12341), a large raised reservoir. Water from Trench Pool overflows at the eastern end (pictures 58-59, 64 Appendix A) (SJ 68491 12486), and it is at this point where it is assumed that the channel diverts from the old path where the Flood Zones currently exist (Figure B.1 in appendix B).

Zones for the old path are incorrect, while the new path of the channel does not have any Flood Zones. A model will be constructed to appropriately model the current drainage situation, which may result in the need to look at the Council's development sites again. From examining the OS maps of the area it does appear that the old channel has been severed from the new channel and does not connect to any other watercourses. Information on who created the channel diversion and drawings/information of the new channel will be required, as well as information on the interaction with the old channel. Ultimately agreement on how this watercourse is modelled will be required from the Environment Agency.
