Aga Rayburn

Coalbrookdale

Draft Phase 1a Site Condition Report and
Phase 2 Site Investigation (PPC)

28 August 2003

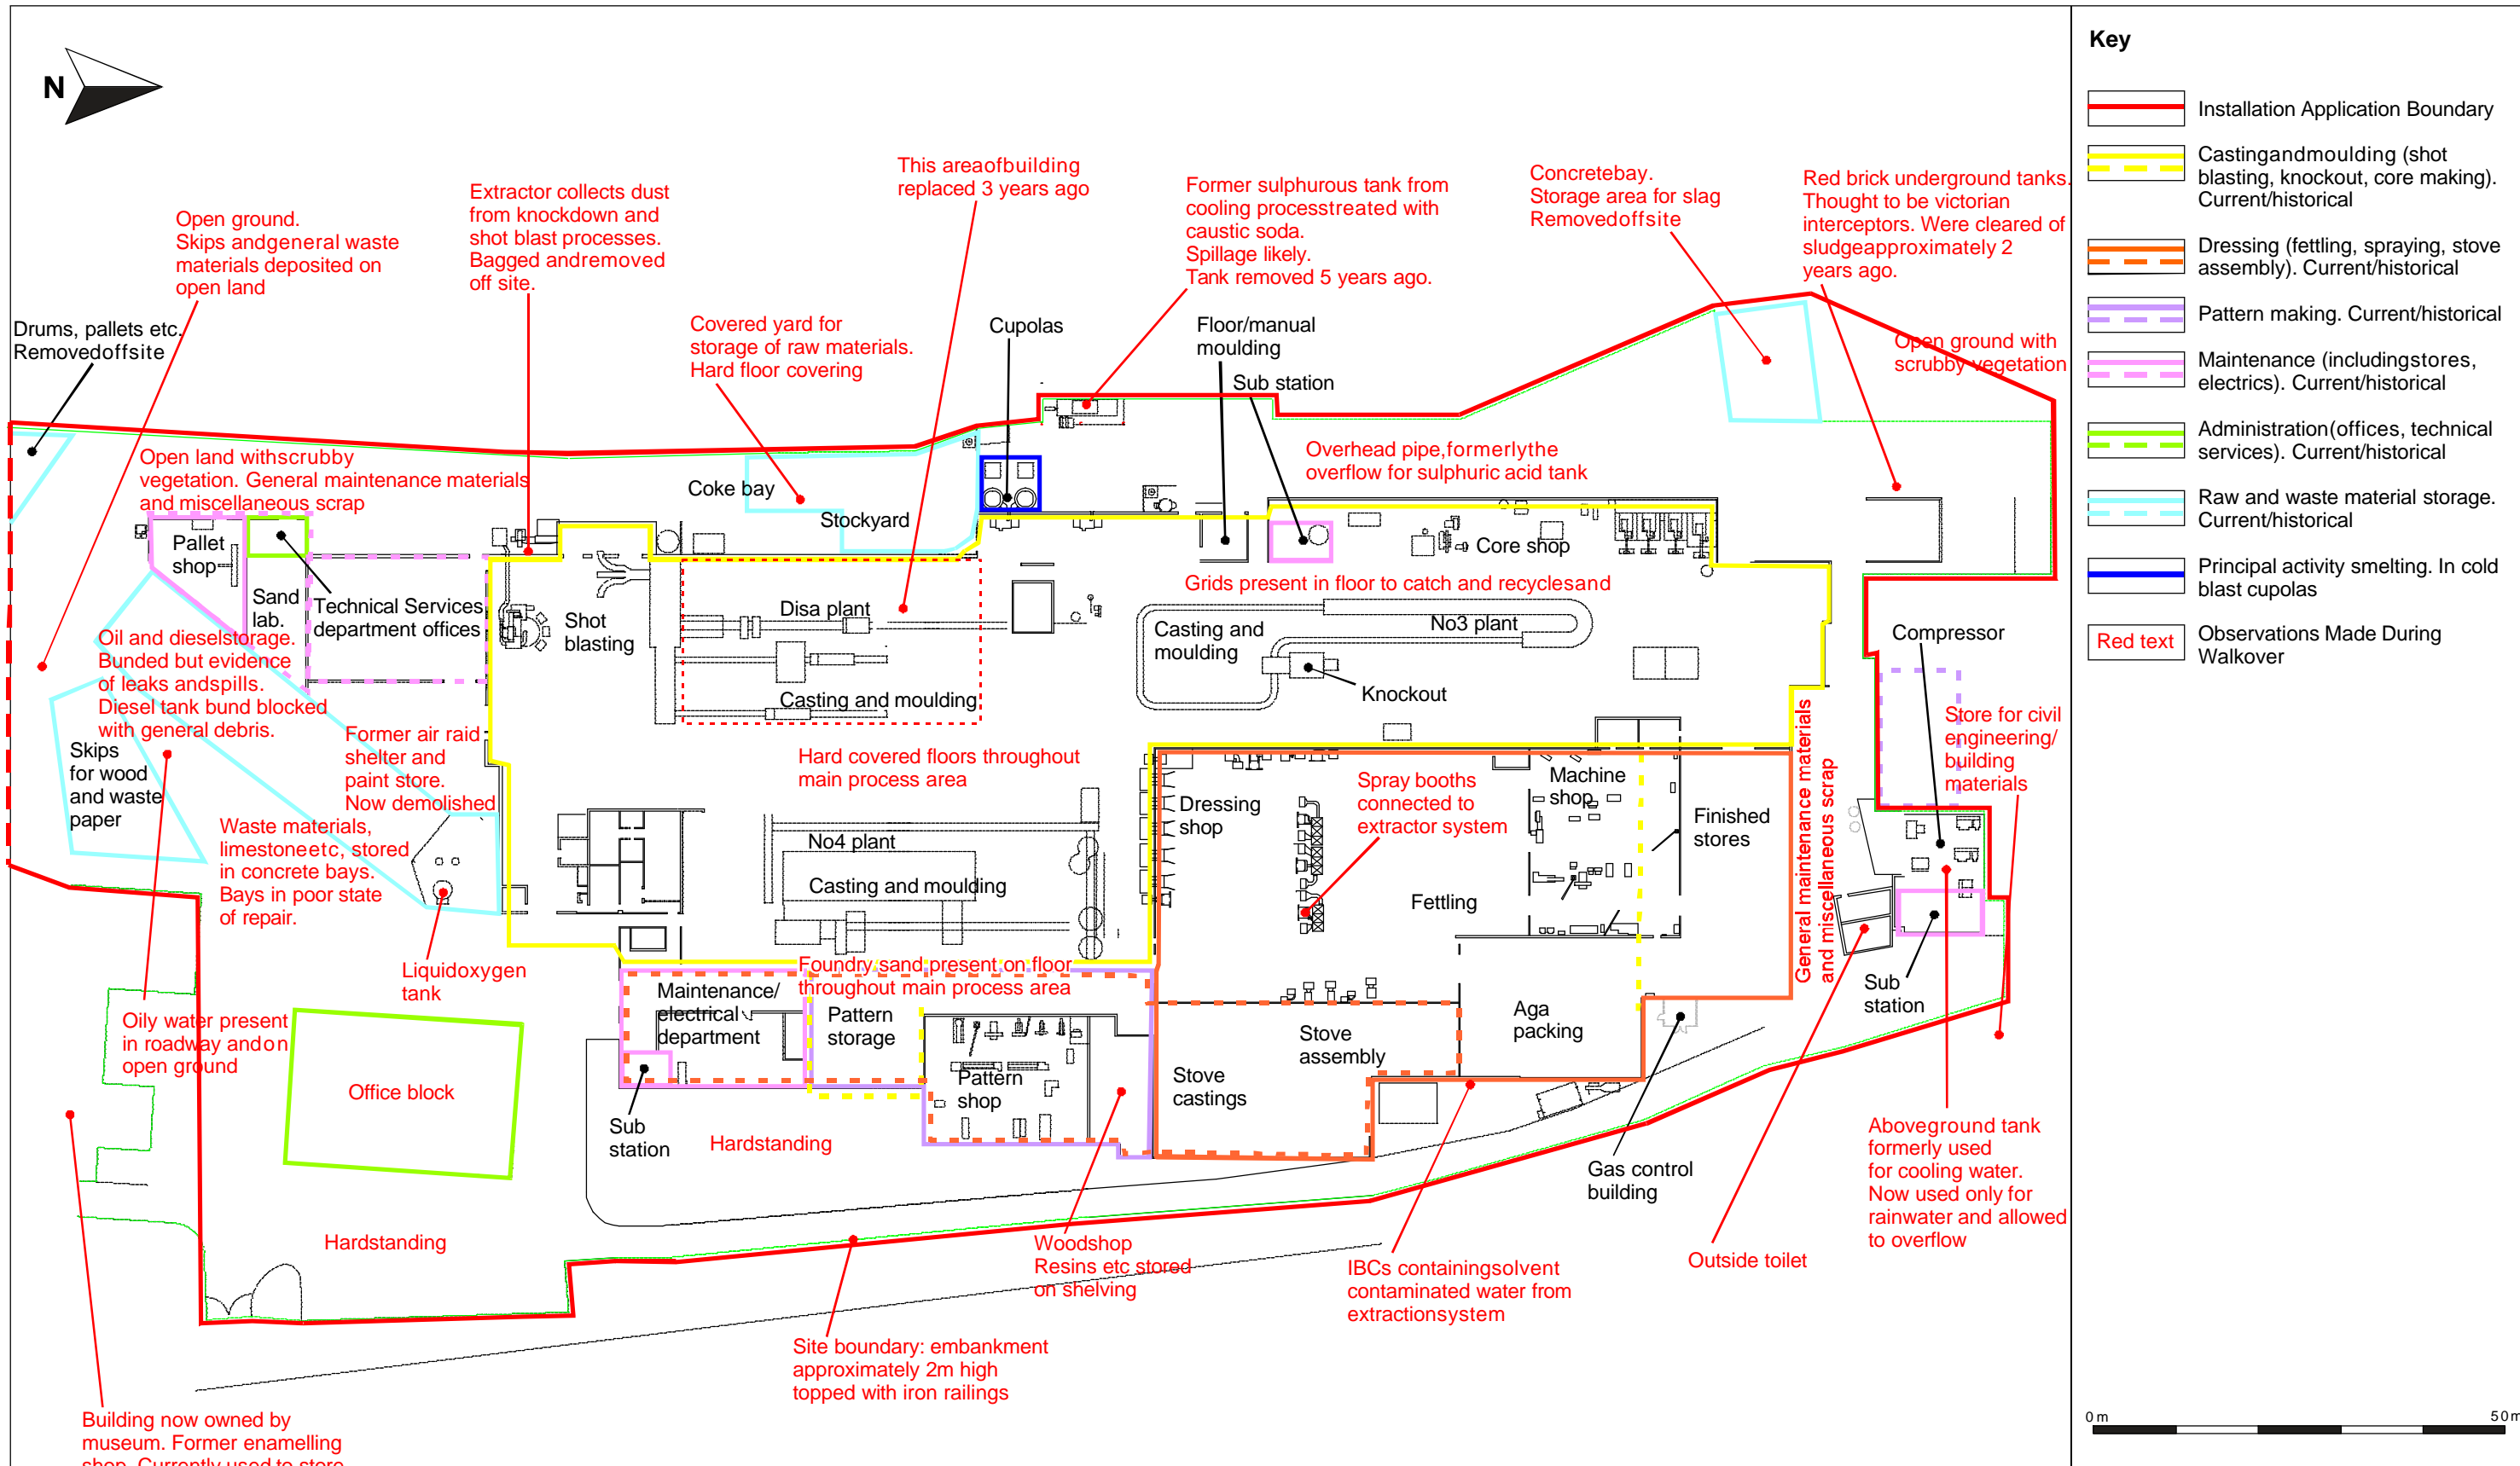
Figure 2.4
Observations Made During Walkover

Oil and diesel is stored within a bunded area in the south of the site. There is visual evidence that containment measures have been breached (hydrocarbon ponding and staining).

Visual evidence of contamination was noted only around the diesel and oil storage area in the south of the site. With the exception of the foundry sand which is reused. The process itself generates very little waste and although floors within the main process building appeared stained this is generally thought to be due to the coal dust within the foundry sand. The deterioration of the floor is to be expected given the age of the building.
