A518 Route Study Technical Note

**A518 Collision Investigation and Prevention Review
COMHA1T&W053 / TN-001**

25/07/2025

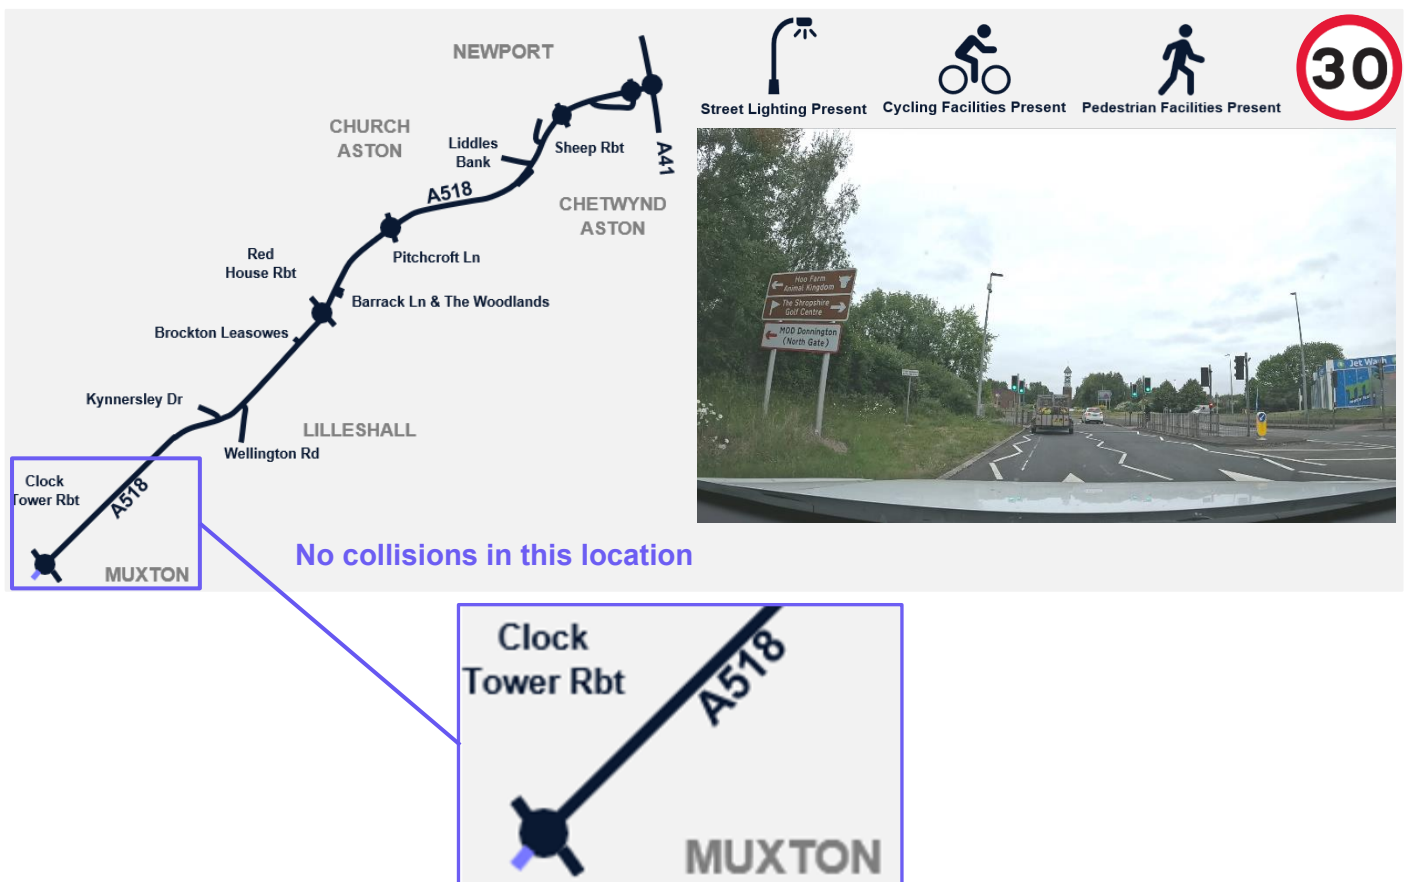
Figure 2: A518 Northbound Approach to Clock Tower Roundabout

- 3.1.3 Some visual deterioration of the carriageway was noted. However, the deterioration noted is not considered to present a safety concern. Traffic signs and road markings appeared to be in a serviceable condition. However, it was noted that double headed arrows are present on the approach to the roundabout in conjunction with worded lane destinations. These are not a prescribed marking within the Traffic Signs Regulations and General Directions 2016, instead single headed ahead arrows are advised for use with worded markings.

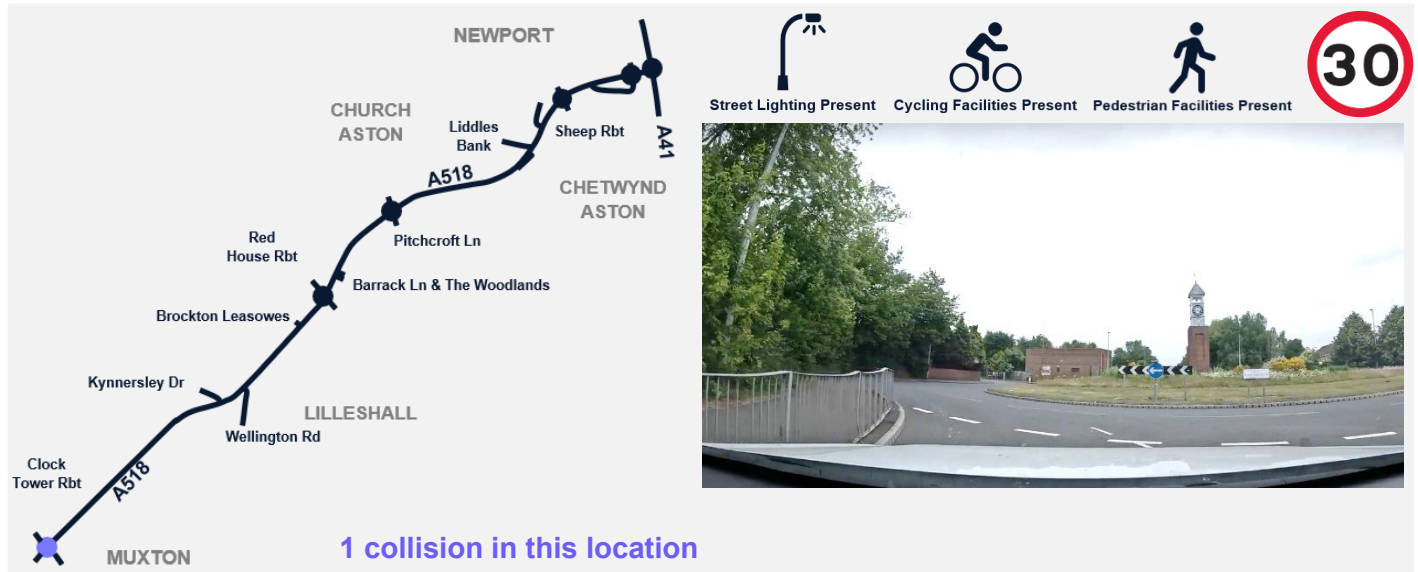
Figure 3: Clock Tower Roundabout

3.2.3 The exit kerb radius of the A518 northbound exit was found to be below the requirements of CD 116. A sharper exit could present issues for larger vehicles. However, there were no collisions related to this.

3.2.4 Some visual deterioration of the carriageway was noted. However, the deterioration noted is not considered to present a safety concern. Traffic signs and road markings appeared to be in a serviceable condition, although the road markings are becoming worn.

3.2.5 There was 30 metres (approximately 21%) of the roundabout section was at or below the IL, indicating skid deficiencies. There were no skid related collisions recorded in the data provided that relate to this location. Considering this and the level of SCRIM deficiency, continued monitoring would be recommended at this location to determine if further action or mitigation is needed.

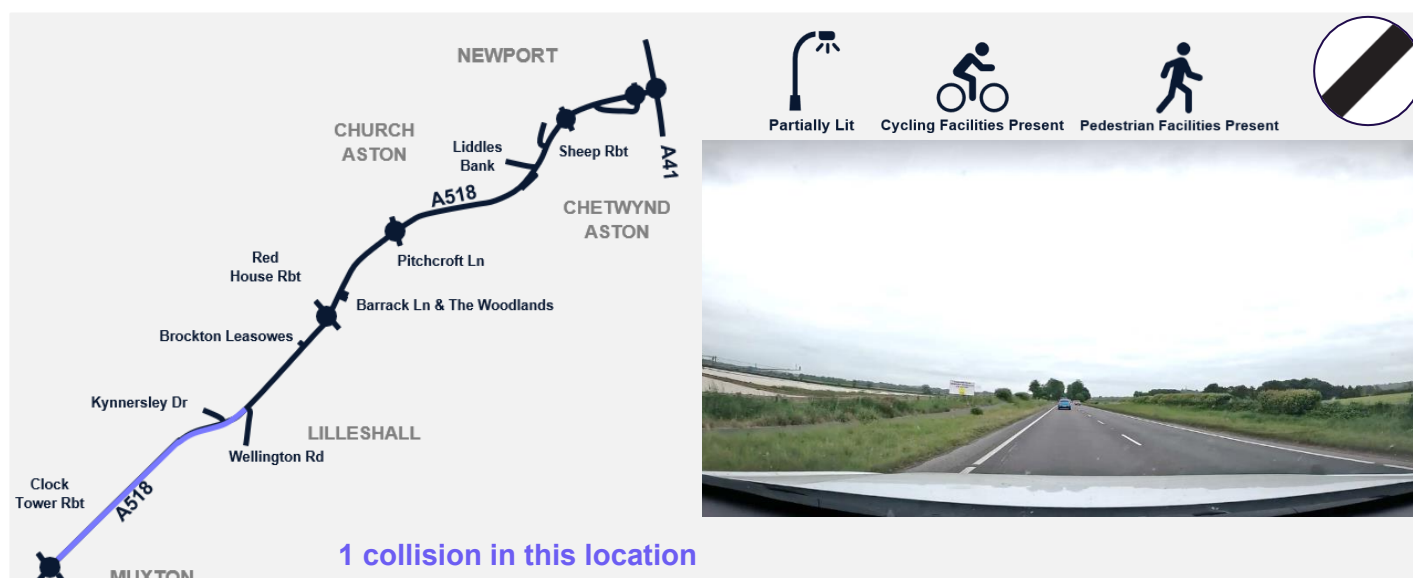
Figure 4: Clock Tower Roundabout to Kynnersley Drive / Wellington Road Link

- 3.3.4 The carriageway appeared to be in a serviceable condition. Traffic signs and road markings also appeared to be in a serviceable condition except for:

- Flag type direction signs opposite Wellington Road junction are no longer present.
- Speed limit repeater sign face (270m northeast of Clock Tower Rbt) quite worn.

- Direction & Bifurcation arrows at Kynnersley Drive/Wellington Road Junctions heavily worn.

- 3.3.5 There was 31 metres (approximately 1.44%) of the northbound direction at or below the IL, and 117 metres (approximately 5.44%) of the southbound direction at or below the IL indicating skid deficiencies.
- 3.3.6 There was one collision in this location which involved skidding, however this did not occur where there were any skid deficiencies in the surfacing. There are permanent Slippery Road warning signs present which cover this location. Continued monitoring would be recommended at this location to determine if further action or mitigation is needed.

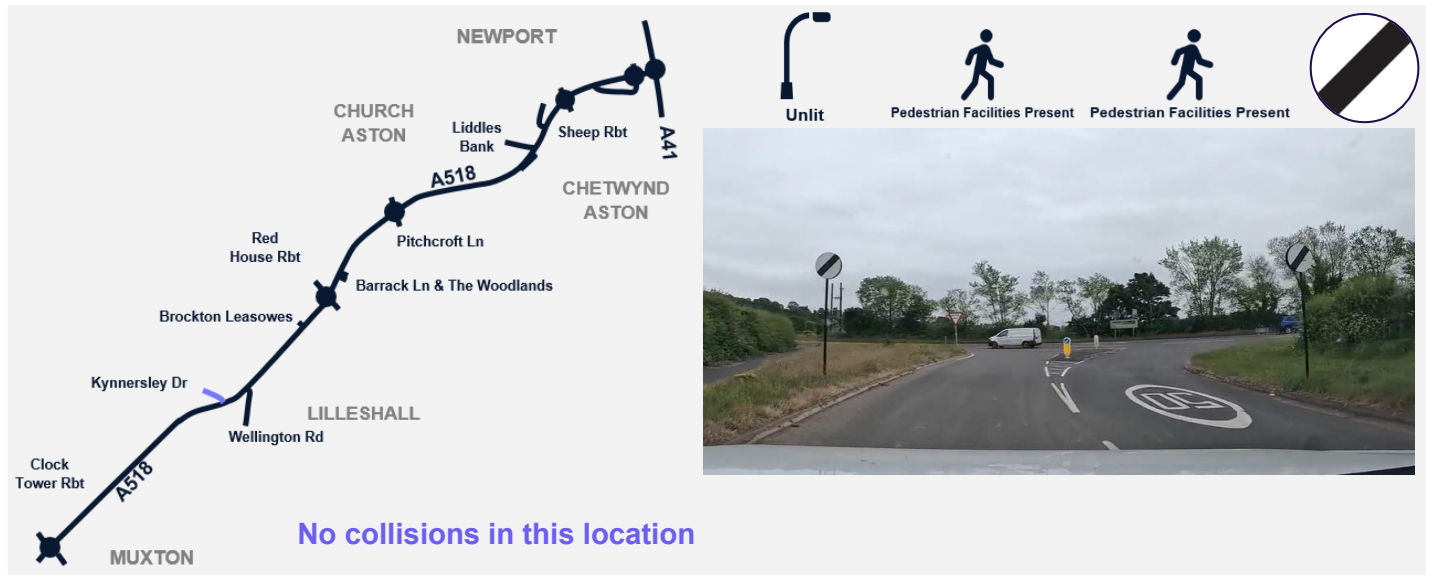
Figure 5: Kynnersley Drive Junction

- 3.4.4 The carriageway appeared to be in a serviceable condition. Traffic signs and road markings also appeared to be in a serviceable condition, although the road markings are becoming worn at the give way.

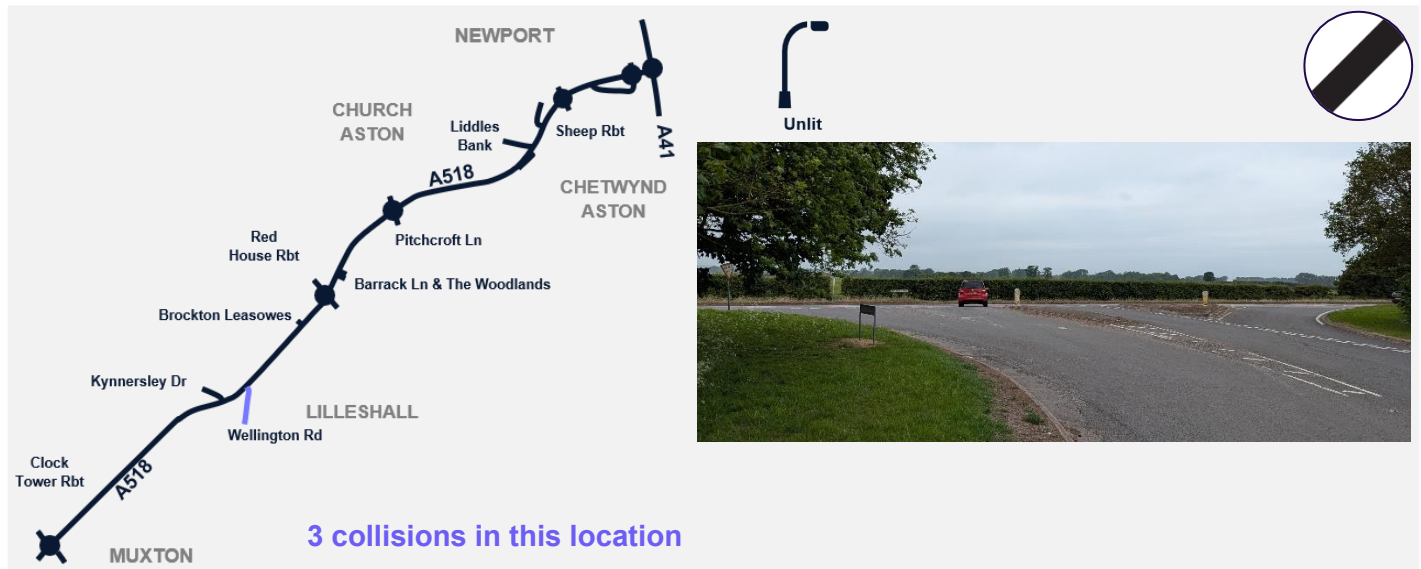
Figure 6: Wellington Road Junction

- 3.5.4 The carriageway appeared to be in a serviceable condition, although it is becoming worn. Traffic signs and road marking could be improved to address:

- Flag type direction signs opposite junction are no longer present.
- Keep Left bollard missing on approach to A518.
- Give way sign plate appears to have been knocked previously (damage to sign face visible).

- Heavily worn.

1. Given the occurrence of multiple collisions in the vicinity of the Wellington Road junction, it is considered that improvements could be made to the conspicuity of the A518 approaching and through the Kynnersley Drive and Wellington Road Junctions, and at the Wellington Road junction itself. It is considered that improving conspicuity could aid in calming traffic through this section of A518 and enhance the warning to users of the potential for vehicles slowing and turning. Additionally, it is considered that improving conspicuity will mitigate the visibility issues on Wellington Road to the junction.

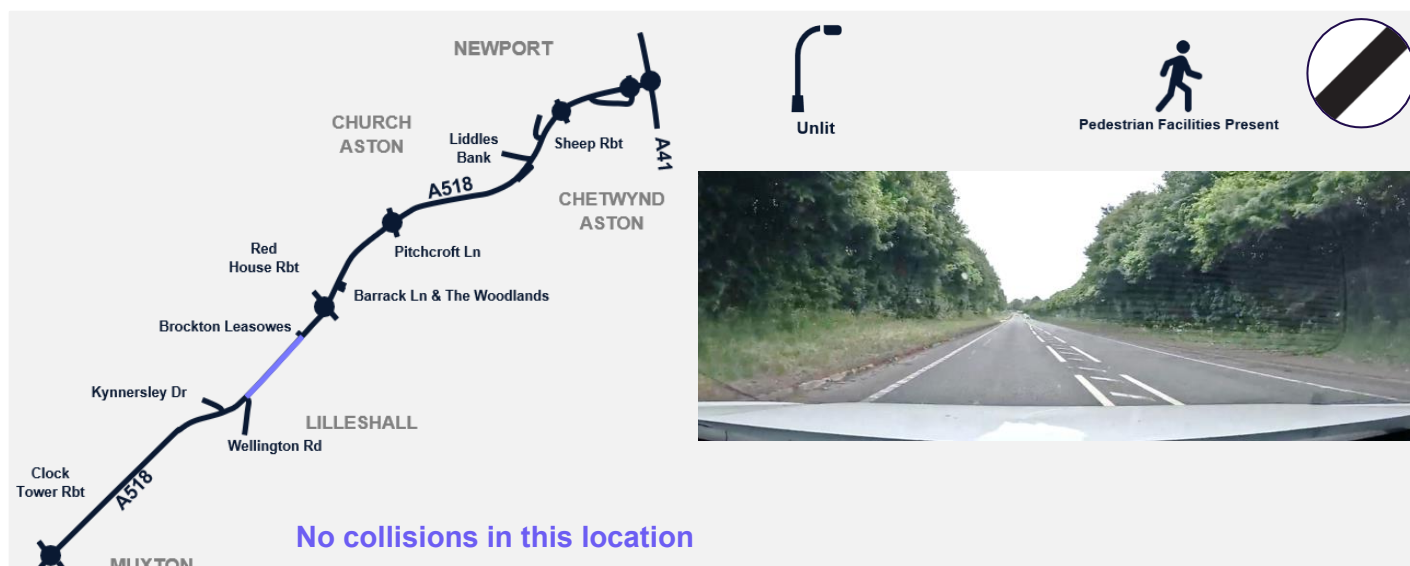
Figure 7: Kynnersley Dr / Wellington Rd to Brockton Leasowes Link

- 3.6.4 The carriageway appeared to be in a serviceable condition. Traffic signs and road markings also appeared to be in a serviceable condition except for:

- Some wearing to edge lines & deflection arrows.

- 3.6.5 There was 593 metres (approximately 84%) of the northbound direction at or below the IL, and 128 metres (approximately 18%) of the southbound direction at or below the IL.
- 3.6.6 There were two collisions related to vehicles turning out of Wellington Road resulting in vehicles on the A518 skidding (likely attempting to avoid collision). There are permanent Slippery Road warning signs present which cover this location. Continued monitoring would be recommended at this location to determine if further action or mitigation is needed.

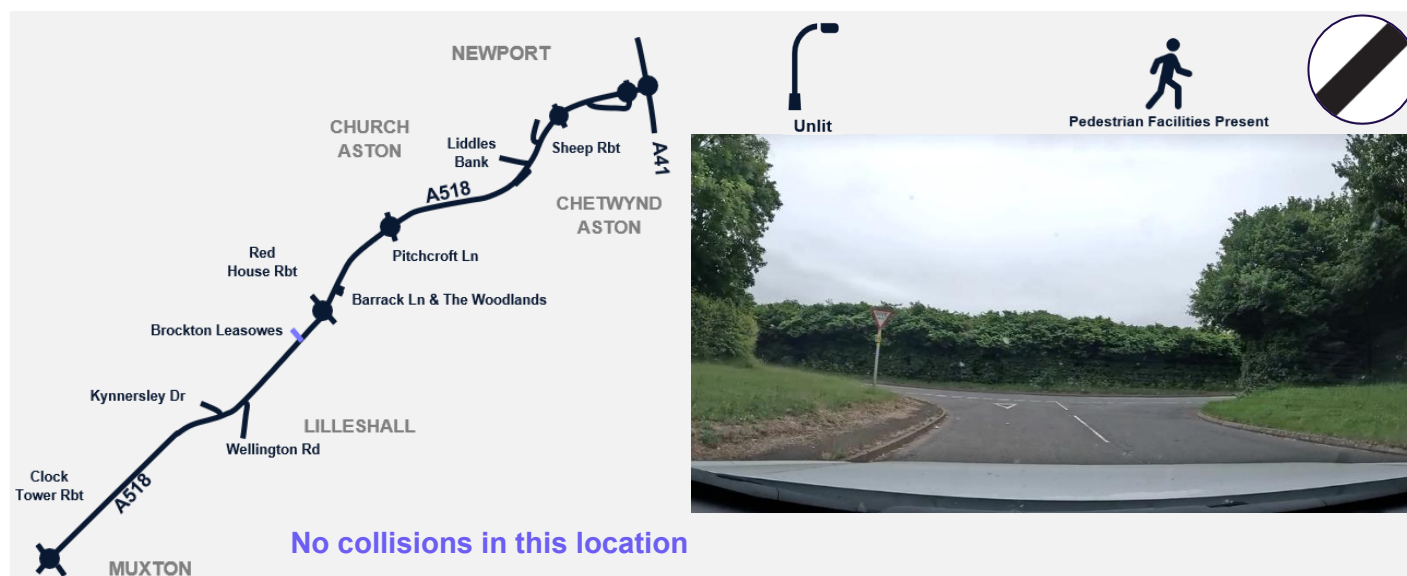
Figure 8: Brockton Leasowes Junction

3.7.3 The carriageway appeared to be in a serviceable condition. Traffic signs and road markings also appeared to be in a serviceable condition except for:

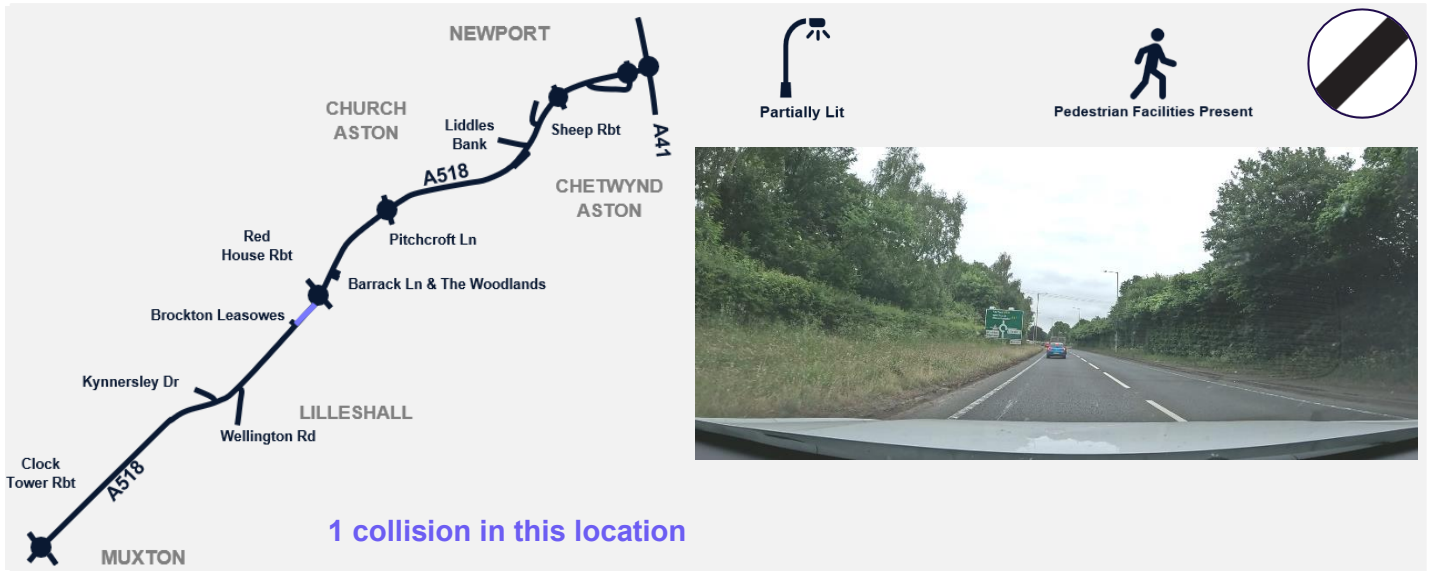
Figure 9: Brockton Leasowes to Red House Roundabout Link

- 3.8.3 The carriageway appeared to be in a serviceable condition. Traffic signs and road markings also appeared to be in a serviceable condition except for:

- Condition: Mostly Present with some wearing to edge lines & deflection arrows.
- Type: One comment to raise regarding the A518 approach to Red House Roundabout which was previously marked as a two-lane approach. Following resurfacing works, it has been noted that the lane lines on this approach were not reinstated, resulting in an excessively wide approach at the roundabout entry.

- 3.8.4 There was 187 metres (approximately 96%) of the northbound direction at or below the IL, and 151 metres (approximately 80%) of the southbound direction at or below the IL. There were no skid related collisions recorded in the data provided that relate to this location. Considering this and the level of SCRIM deficiency, continued monitoring would be recommended at this location to determine if further action or mitigation is needed.

2. It is considered appropriate to reinstate the lane markings on the northbound approach to the Red House Roundabout junction.
3. There are potential benefits from improvements that could be made to the conspicuity of the section of the A518 approaching and through the Liddles Bank Junction. It is considered that improving conspicuity could aid in calming traffic through this section and enhance the warning to users of the potential for vehicles slowing and turning.

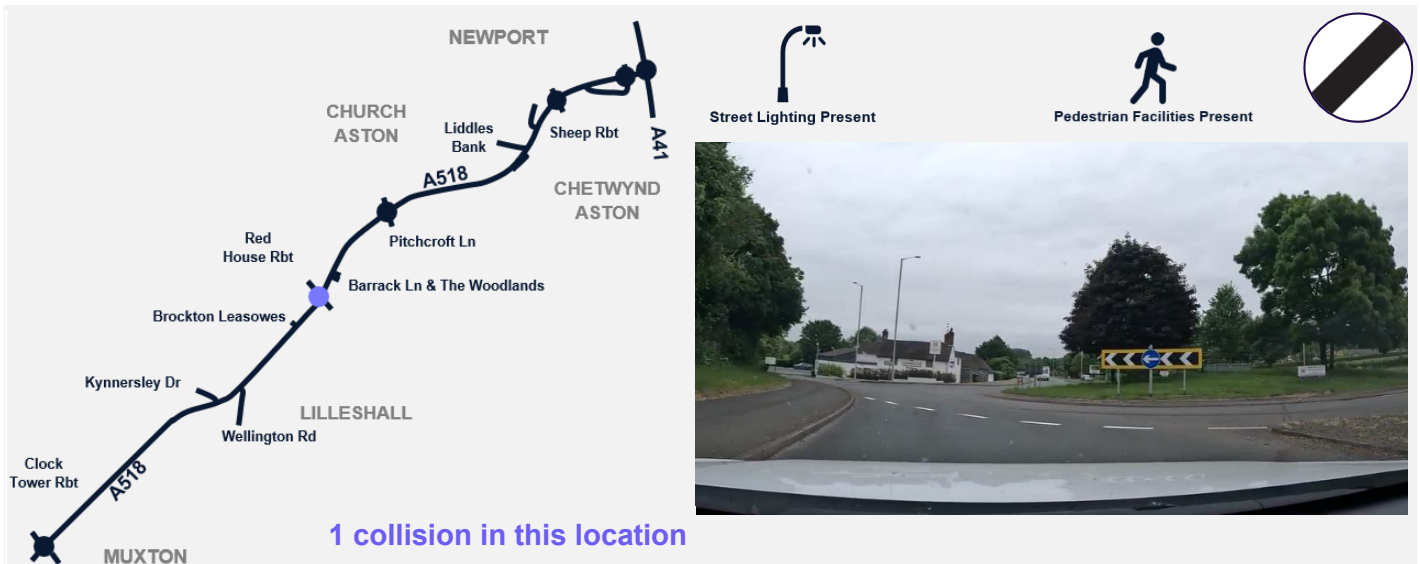
Figure 10: Red House Roundabout Junction

- 3.9.2 Visibility meets the requirements of CD 116 Geometric Design of Roundabouts for the following:
- Visibility to the right (measured at the give way line) for all approaches
 - Visibility to the right (measured at 15m from the give way line) for all approaches
 - Forward visibility (measured at 15m from the give way line) for all approaches
- 3.9.3 The exit kerb radius of the A518 northbound exit was found to be below the requirements of CD 116. A sharper exit could present issues for larger vehicles. However, there were no collisions related to this.

- 3.9.4 Some visual deterioration of the carriageway was noted along the construction joint. However, this deterioration is not considered to present a safety concern. Traffic signs and road markings appeared to be in a serviceable condition.

- 3.9.5 There was no 2024 survey data for this section, however the 2023 data shows that 10 metres (approximately 7.7%) of the roundabout section was at or below the IL. This section of road was resurfaced in 2022/23 and so the SCRIM deficiency could either relate to the previous road surface or the low skid resistance typically achieved in new surfacing immediately after it is laid (the new surface typically achieves the required skid resistance after a period of trafficking). There were no skid related collisions recorded in the data provided that relate to this location. Considering this and the level of SCRIM deficiency, continued monitoring would be recommended at this location to determine if further action or mitigation is needed.

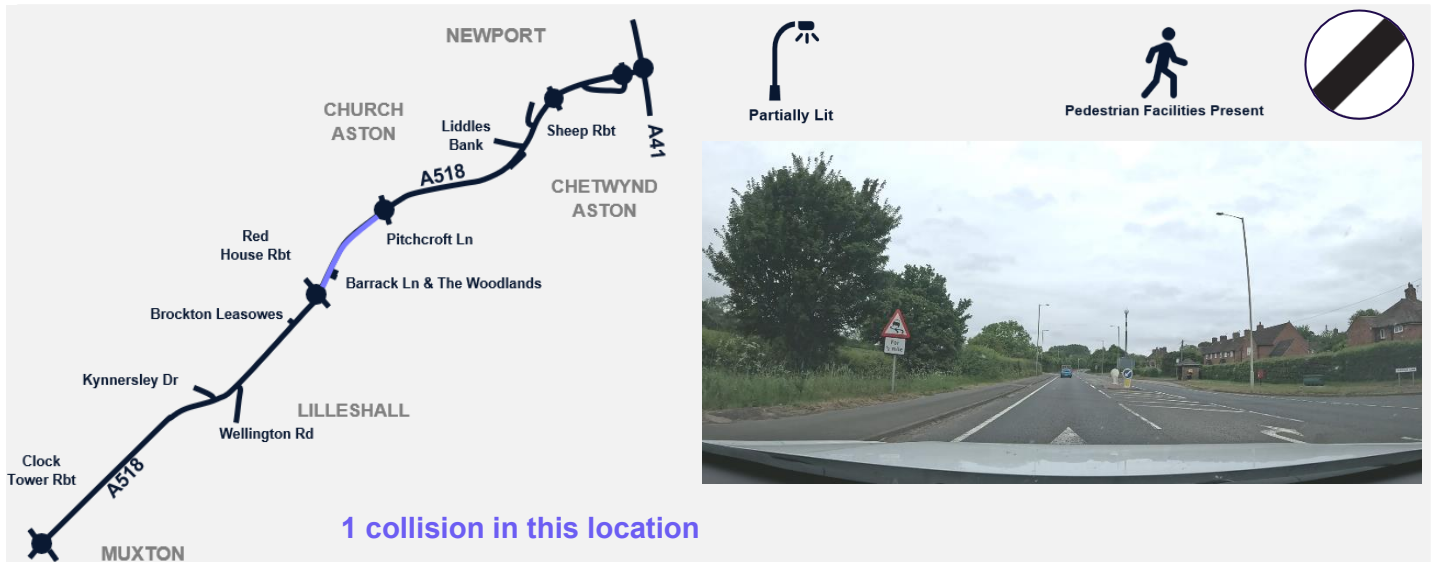
Figure 11: Red House Roundabout to A518 / Pitchcroft Ln Link

- 3.10.4 There was 663 metres (approximately 73.26%) of the northbound direction at or below the IL, and 396 metres (approximately 43.42%) of the southbound direction at or below the IL.
- 3.10.5 There were no skid related collisions recorded in the data provided that relate to this location. There are permanent Slippery Road warning signs present which cover this location. Continued monitoring would be recommended at this location to determine if further action or mitigation is needed.

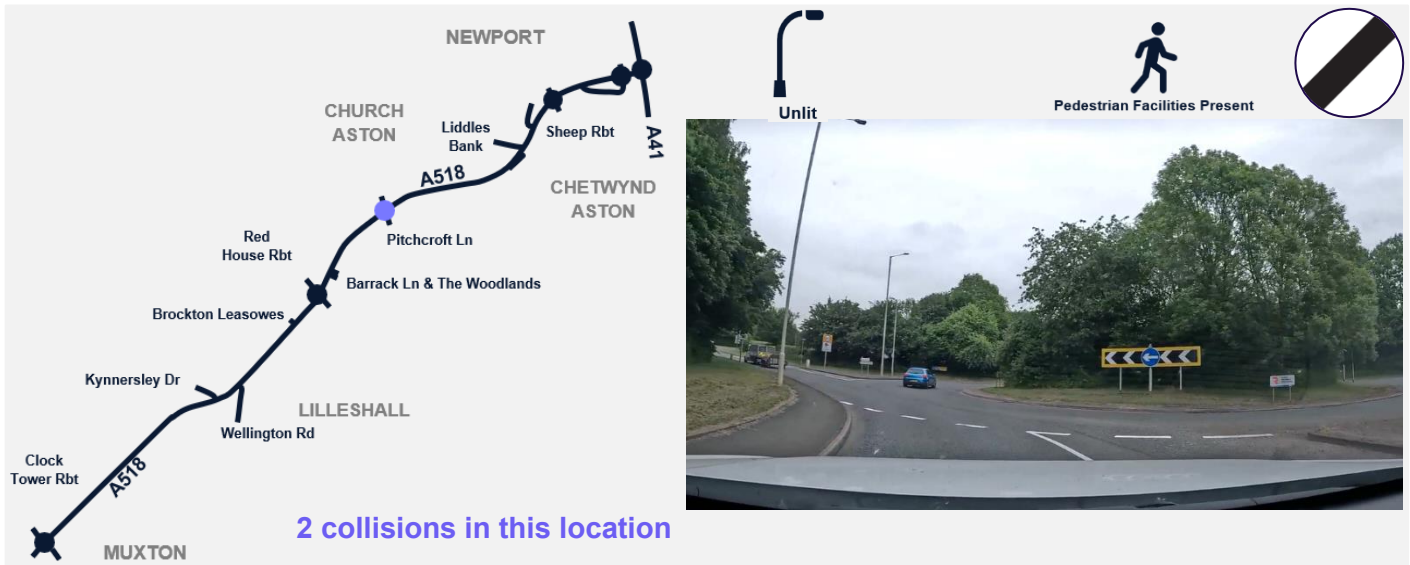
Figure 12: A518 / Pitchcroft Lane Roundabout

3.11.3 Some visual deterioration of the carriageway was noted around road gullies. However, the deterioration noted is not considered to present a safety concern. Traffic signs and road markings appeared to be in a serviceable condition.

3.11.4 There was no 2024 survey data for this section, however the 2023 data shows that the whole section was at or below the IL. There was one collision at this location which involved skidding, however it is not known if the skid resistance of the surface was the cause of the collision due to this occurring prior to the SCRIM survey. Given the occurrence of a collision involving skidding and the SCRIM data, further detailed monitoring and investigation would be recommended at this location to determine if further action or mitigation is needed.

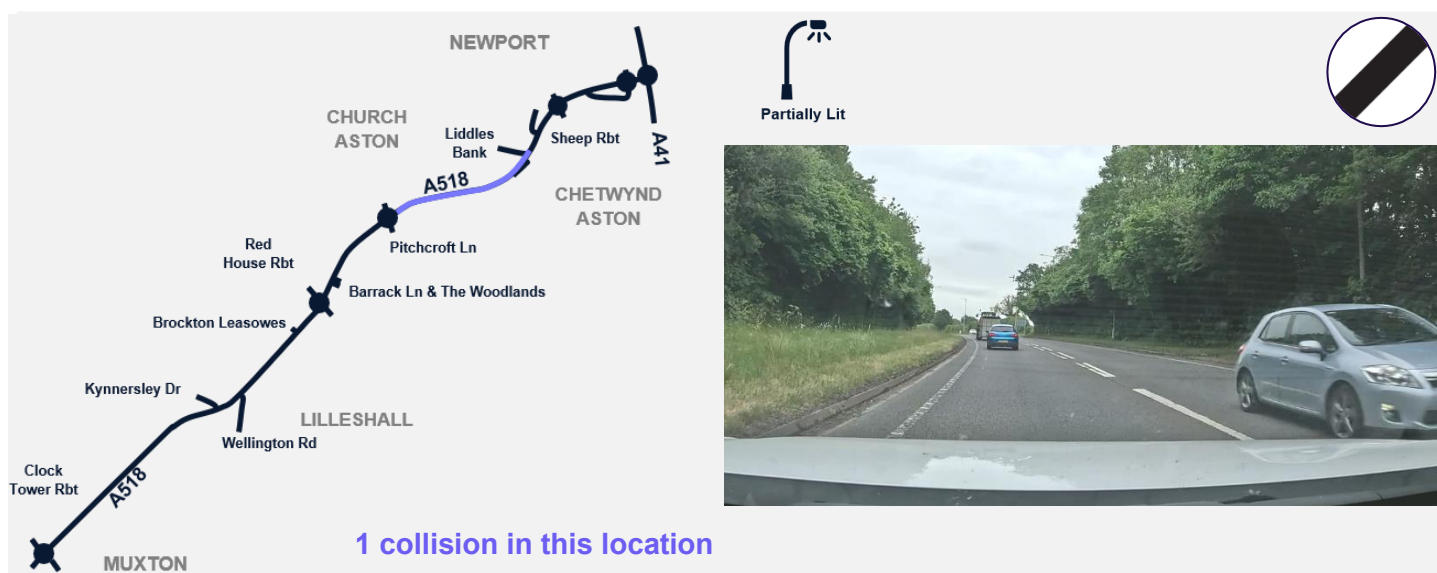
Figure 13: A518 / Pitchcroft Lane Roundabout to Liddles Bank Link

- 3.12.2 Visibility in respect of horizontal geometry meets the requirements of CD 109 Highway Link Design for the following:
- Stopping Sight Distance (SSD)
 - Full Overtaking Sight Distance (FOSD) for overtaking sections
- 1.1.2 From the site visit it was noted that the immediate northbound approach to the Liddles Bank junction appears to be the crest of a vertical curve. In conjunction with this and the profile of the verge, it is thought that the envelope of visibility is obscured for a low-height object. Therefore, the visibility in respect of vertical geometry may not meet the requirements of CD 109.

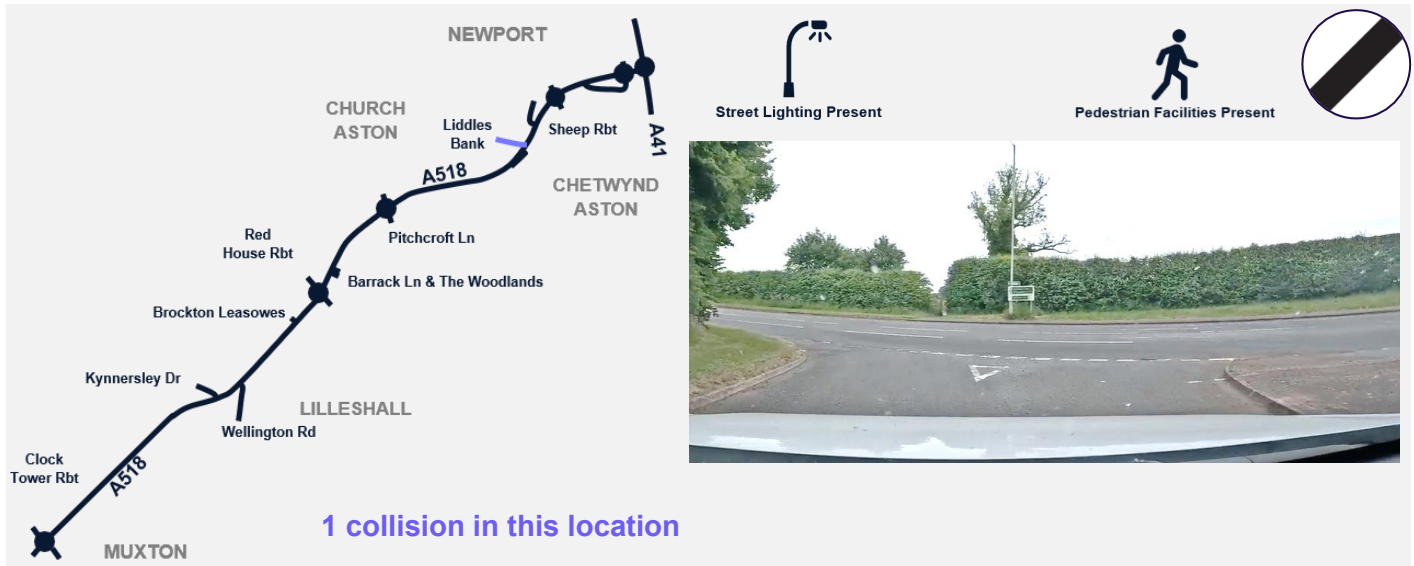
Figure 14: Liddles Bank Junction

3.13.3 As noted above, it is thought that the envelope of visibility when looking southwest is obscured for a low-height object due to the vertical alignment of the A518.

3.13.4 The carriageway appeared to be in a serviceable condition. Traffic signs and road markings also appeared to be in a serviceable condition, although the road markings are becoming worn at the give way. Additionally, there is no Give Way traffic sign present.

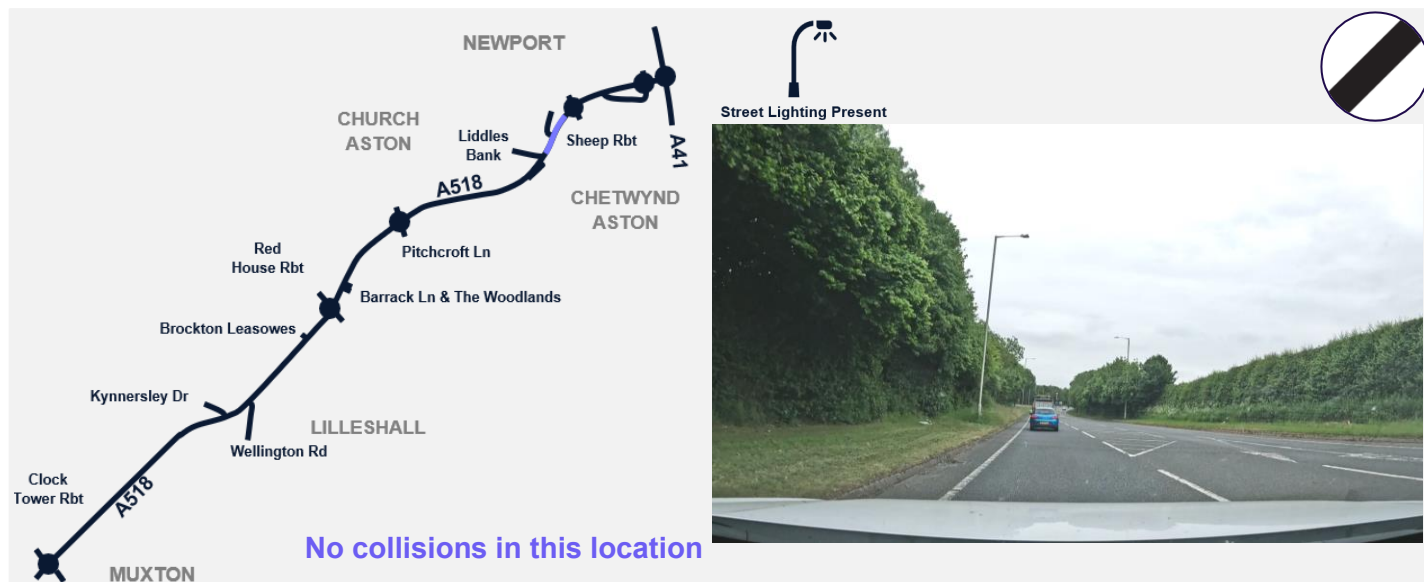
Figure 15: Liddles Bank to Sheep Island Roundabout Link

3.14.3 The carriageway, traffic signs and road markings all appeared to be in a serviceable condition. Although, the direction and bifurcation arrows on approach to Liddles bank junction are heavily worn.

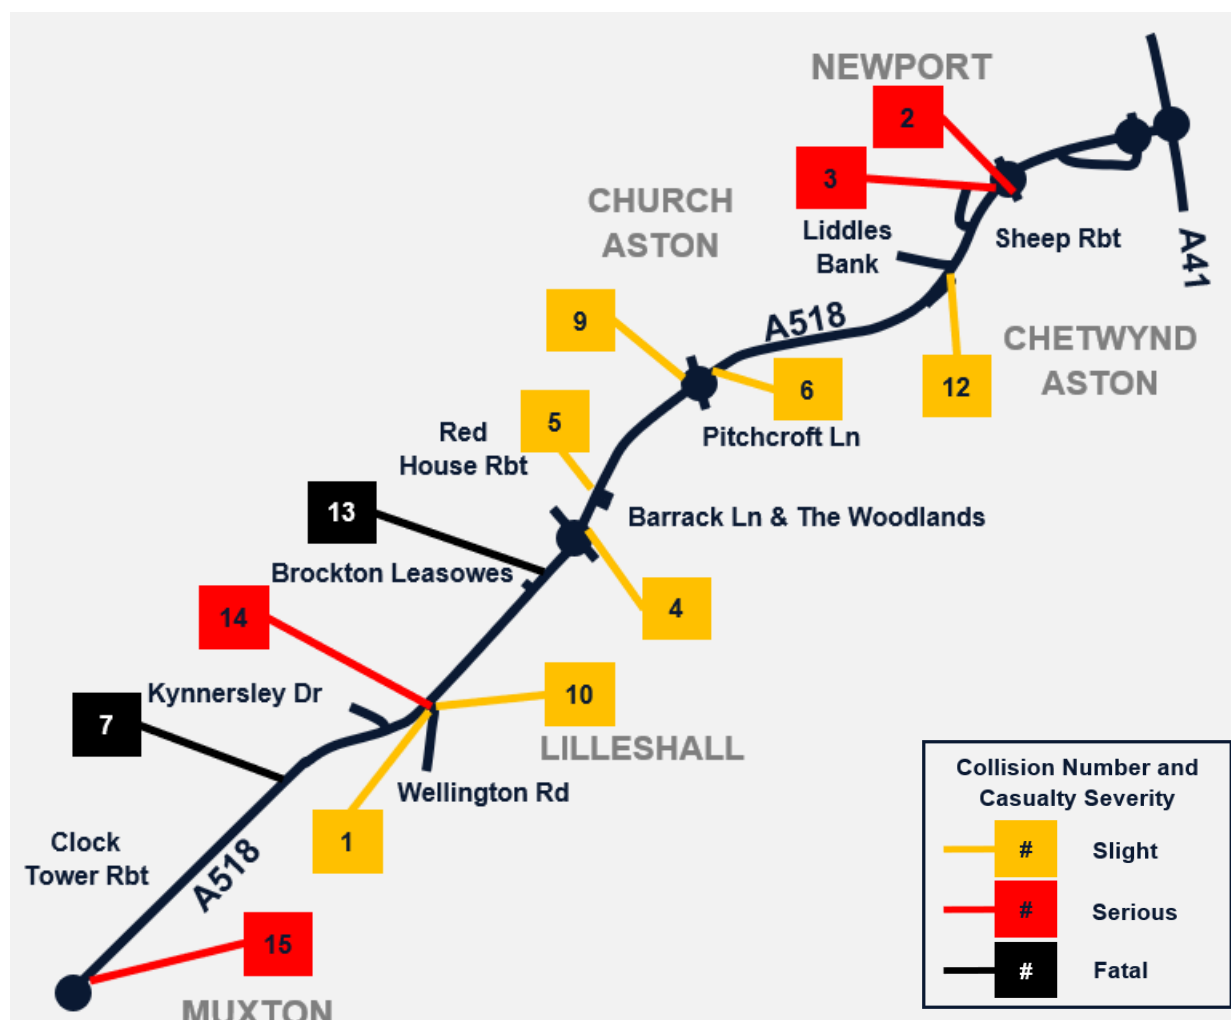
Figure 18: Collision Locations

5.1.2 The locations of the collisions were reviewed to identify any clusters and therefore locations where occurrence of collisions could be more likely. Typically, sites are considered to be clusters where 4 or more injury collisions occur. None of the locations in this study experienced 4 or more collisions. However, due to the relatively small number of collisions and short study lengths, sites where more than one collision occurred were noted:

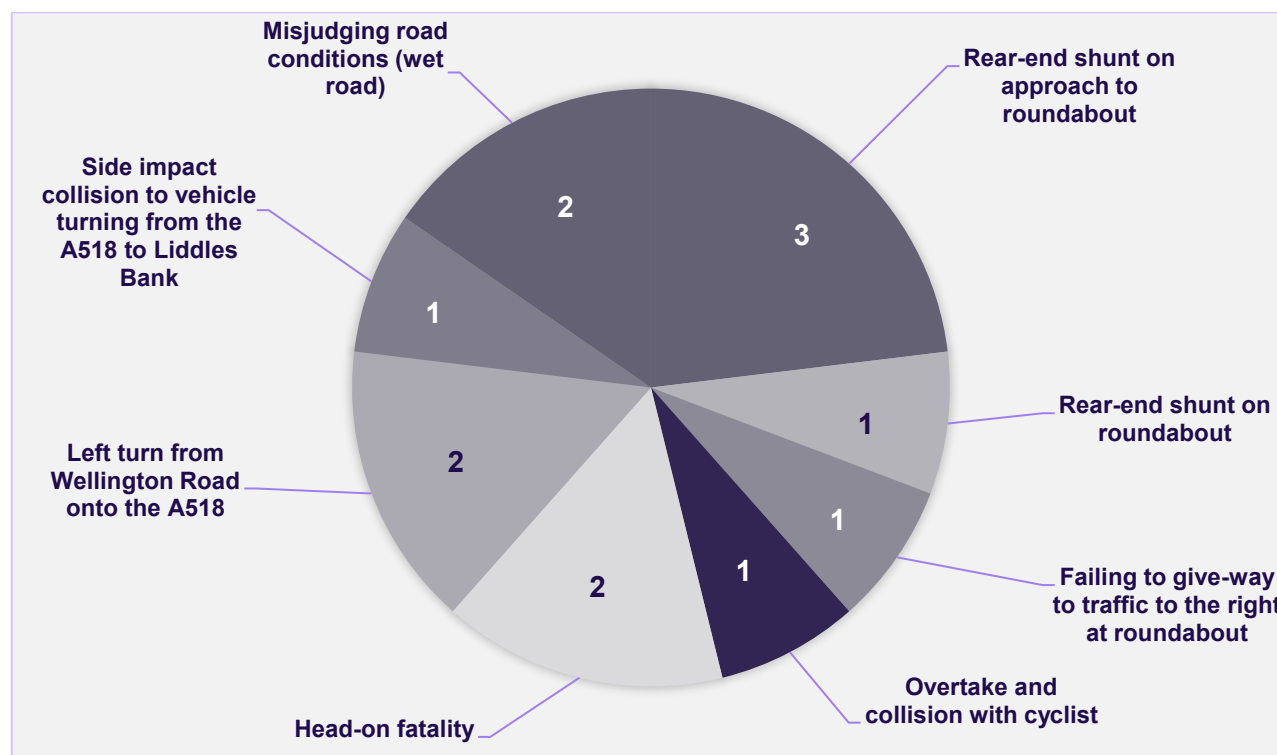
Figure 19: Collision Type Summary

5.1.5 The most common type of collision involved rear-end shunt type collisions at roundabouts.
