Options Study Report

A41 Route Study COMHA1T&W038 / OS-001 / P02 07/07/2025

REPORT TITLE:	Options Study Report		
REPORT NUMBER:	OS-001		
PROJECT NAME:	A41 Route Study		
PROJECT NUMBER:	COMHA1T&W038

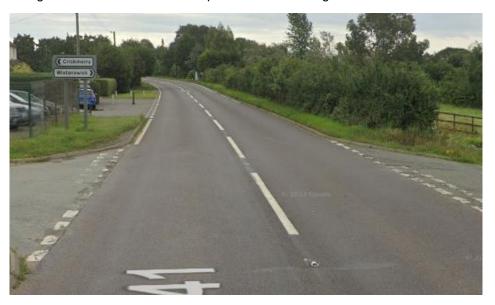
Figure 2 Wistanswick Crossroads (Source: Google Maps)

- 5.1.7 This crossroads at Wistanswick has 5 private accesses on either side of it, one of which is a commercial car business. A centre hatch is recommended here which would Highlight accesses in advance via gaps in hatching and pushing vehicles to the outside of the carriageway providing drivers more time to react and create more clear space in the middle for manoeuvring, reducing the chance of an incident related to vehicles entering or exiting the main road. This should reduce the likelihood of common junction collisions categorised as rear shunts and bad turns.

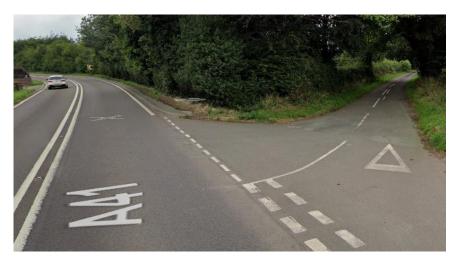
Figure 16 Junction Beside Cluster Site 7 Blooming Barkers (Source: Google Maps)

- 6.6.8 These side roads which join at a sharp angle, also do not have the required increase in carriageway width which comes with such an angle. Guidance details that a junction at 90 degrees would have a width of 3.8m for each lane, totalling 7.6m (DMRB CD123, 5.10). However, for a junction at 50 degrees this width requirement would rise to 8.7m with a slightly wider inside lane to account for vehicles taking the turn. Consequently, this requirement should be noted for future works if they are carried out.
- 6.6.9 There are also a few side roads where the exit is too narrow or sharp, Aychley Farm has a simple junction shown in Figure 17.

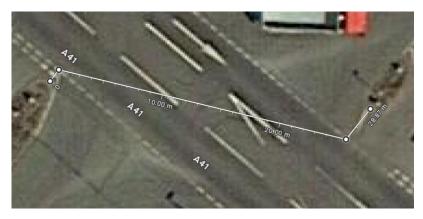
Figure 18 Cluster Site 5 Warrant Road Junction (Source: Google Maps)

6.6.13 The Warrant Road junctions are close enough that islands were put in to prevent diagonal crossings from the minor-minor road traffic. The design and use of these is within standards, however it would be beneficial to maintain the same offset distance from the main carriageway. Here in Figure 18, one island appears to have twice the offset distance of the other which also results in the bollards being inconsistently placed.

- 6.6.14 Correction of this difference in the positioning of the island could be carried out as part of future maintenance.
- 6.6.15 For ghost islands used to create right hand turn lanes, the design speed of the road dictates the taper of the carriageway widening as well as a deceleration length given in Table 11. The taper length should develop:
 - 1) Symmetrically on straight sections of road.
 - 2) Asymmetrically towards the outside of the curve on curved sections of road.
 - 3) Asymmetrically away from the climbing lane on climbing lane sections (DMRB CD123, 6.1.2).

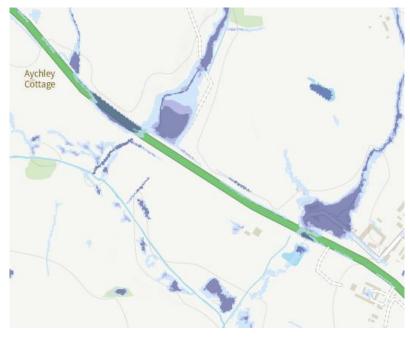
Figure 27: Culvert Overcapacity Event Near Bletchley (Source: Floodmaps)

- 6.8.4 This shows two flooding events, both appearing to be caused by a small watercourse surpassing the capacity of a culvert crossing below the road. To the north the flood map suggests that the drainage system discharging to the watercourse is backing up due to surcharge at the outfall, causing flooding of the carriageway. To the south the flood map suggests that the watercourse maybe overtopping the carriageway.
- 6.8.5 The second type of event identified has an example located just south of the southern A518 roundabout pictured below.

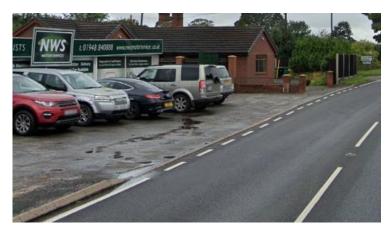
Figure 29 Example Wide Access (Source: Google Maps)

- 7.1.10 If green studs were to be placed along the private accesses edge lines. This would pose an issue with the extremely wide access for the conjoined commercial and residential properties as the long row of green studs could appear as a diverge, and so an entrant vehicle could exit the carriageway and hit the brick wall of the dwelling.

- 7.1.11 Consequently, if green studs are chosen to be used it may make sense to only apply them to the last few metres of the edge line to highlight the private dwelling access.
- 7.1.12 Furthermore, although it has only happened once recently, a serious collision occurred because of drivers not expecting the private accesses to be used and the lack of warning for them may have been worsened by the crossroads hazard warning signs correctly sited for the crossroads and not before. This may give drivers the expectation that the crossroads is the next or only hazard in the area. Unfortunately, no options for appropriate warning signage exist and so the only additions to be made are marker posts and double white lines as per the whole route treatments.

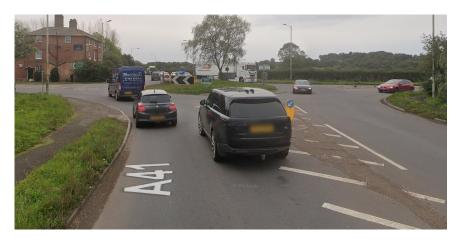
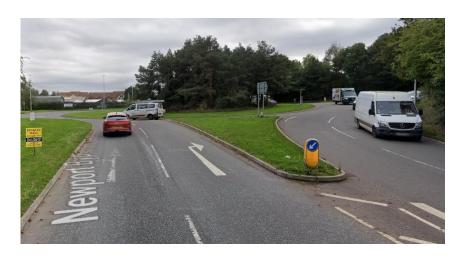
- 7.2.11 Another issue with the roundabout is the site constraints, making it impossible to address both the lack of deflection as well as the consistent queuing due to the high traffic flow. A quick comparison of the approach to Ternhill compared to the other roundabouts used to intersect other A roads shows a stark comparison between Figure 30 and Figure 31.

- 7.2.12 Considering that the Ternhill roundabout experiences almost a third more traffic volume than the A518 roundabout, the current layout is unlikely to be suitable if traffic volumes continue to rise. Although the arrangement itself can handle the throughput, the increased traffic will continue to result in a greater degree of constant interaction and queuing, resulting in collisions (although likely to be minor) becoming more and more likely.

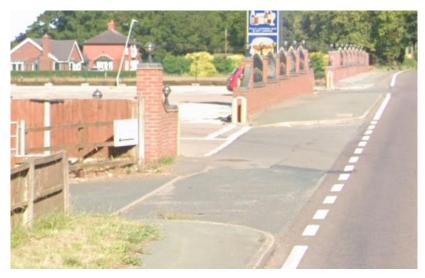
Figure 32 Existing Visibility of Exiting Vehicles for Approaching Traffic (Source: Google Maps)

7.4.6 The overall road condition here is good with some exceptions. The edge lines on the southbound direction to the north of the cluster site are partially covered by verge encroachment. Both junctions for the shop set the give way line at the back of the footway and then provide an additional dashed line following the edge line. Although technically correct by the guidance, vehicles stationary at the give way line have their vision greatly impeded by the brick wall on both sides which means they have to crawl forward before committing to a manoeuvre regardless.

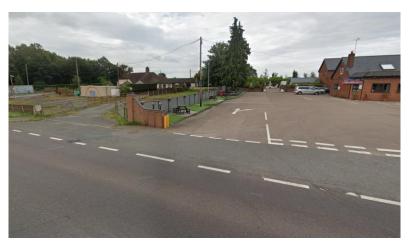
Figure 33 Existing Private Access and Chip Shop Junction (Source: Google Maps)

- 7.4.11 The shop junctions could reduce the number of potential hazards along this straight by removing the ability for vehicles to enter and exit at both openings and instead implement a one-way system. This also ensures vehicles attempt to leave by the same junction and not block each other's view.

7.4.12 Although not to standard, the lay-by here may reduce southbound traffic turning into the shop, especially HGV's and so its closure remains an open suggestion.

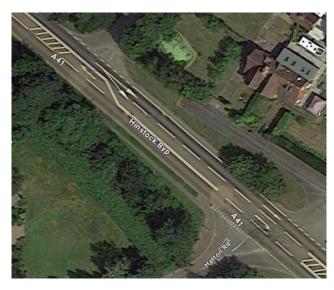
Figure 34 Existing Centre Arrangement North of Hatton Road Junction (Source: Google Maps)

- 7.6.5 Just north of the junction the dedicated right turn lane for southbound switches over to an equivalent for northbound for an offside private access. The full width centre lane here is only about 12m in length with a very sharp taper of the double white lines. The ghost island goes back to hatching and begins tapering out after this turn. A satellite image of the staggered right turn lanes is provided below.

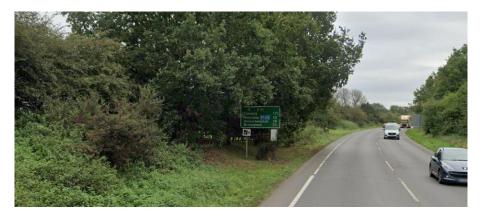
Figure 35 Mileage and Hazard Signs Under Cover (Source: Google Maps)

7.8.6 Drawing COMHA1T&W038-AMY-GEN-A41-DR-CH-0017 has been provided showing recommended proposals for this cluster site in Appendix D. The roundabout hazard warning sign and its adjacent mileage sign shown in Figure 35 are situated between two large trees which even when cutback will still be overshadowed. It would be possible to extend the power from a nearby roundabout lamp post and install a lighting unit for the signs however, an alternative would be to move them forward to avoid the consistent maintenance from the vegetation entirely.

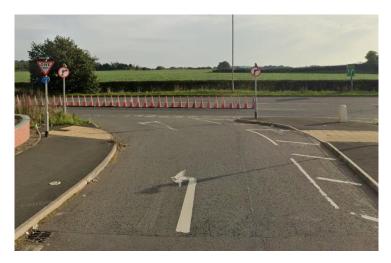
Figure 39 Existing Arrangement Using Cones (Source: Google Maps)

8.1.4 The existing temporary arrangement seen in Figure 39 has been to put a line of traffic cones in place along the edge of the carriageway and auxiliary lane to block vehicles making such a manoeuvre in the short term. A permanent solution has been requested.

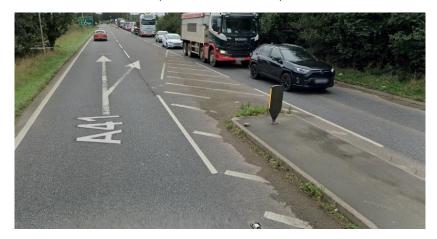
Figure 42 Existing Northern Spitter Island Hatching Arrangement (Source: Google Maps)

8.1.13 The main carriageway to the north tapers out from the centre to a spitter island which gives way to the right turn lane shown in Figure 42. This spitter island could have a kerb line extended along the edge of the right turn lane all the way down across the minor road exit forming a narrow central island. The existing width of the centre lane is currently around 4m which allows for some space to be taken up by a narrow centre kerb line as it can be reduced to 2.5m as a minimum (DMRB CD123, 6.10).

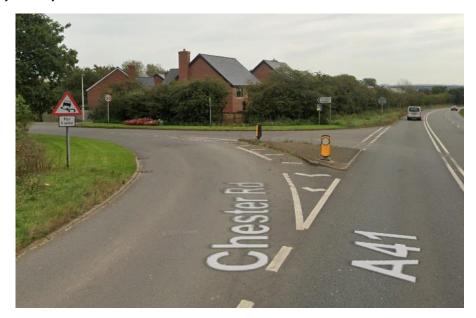
Figure 45 Chester Road Junction Existing Arrangement (Source: Google Maps)

8.2.2 An errant vehicle entered the back garden of the corner dwelling shown below by the gap in the tree line and the junction has since reportedly been plagued by many near misses or minor collisions causing consternation about the safety of the junction with residents.

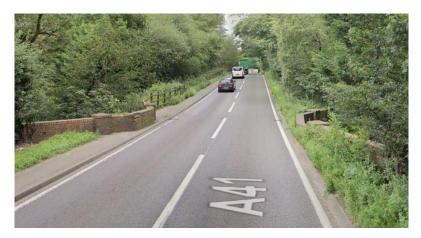
Figure 46 Rosehill Bridge Existing Arrangement (Source: Google Maps)

8.3.1 During the site visit the structure over the culvert at Rosehill was identified as having a damaged and low parapet. The site is situated between cluster sites six and seven along a straight stretch of road shown in Figure 46. The carriageway here has edge lines, centre lines in a warning arrangement and a footway adjoining the western side with an unrestricted speed limit. To the north there are two bodies of water, Colehurst Lake and Rosehill Carp Lake which then travel underneath the A41 to continue to join a nearby stream which then feeds into the River Tern. This site is consequently a flood risk location identified in the flooding section as Rosehill 006.
