## **Technical note:** AGA Rangemaster Ltd, Coalbrookdale Foundry, Scope for Remedial Works at WS114

### 1.1 Background

August 2019 Doc Ref: 40048-WOOD-XX-B10-RP-OC-0001\_S11\_C01

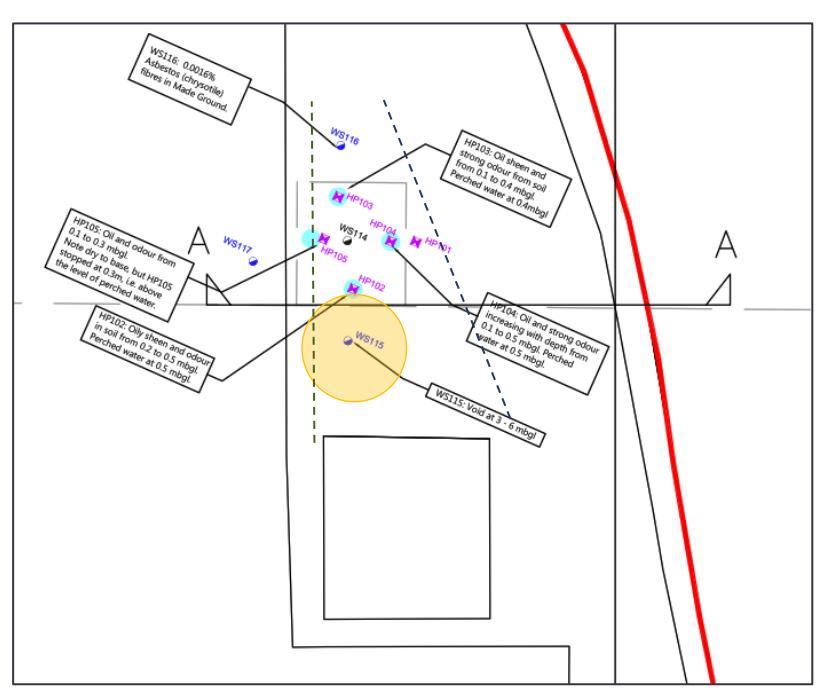
#### Figure 1 Plan view of the constraints and previous excavation locations

An area of oil contamination at a window sample borehole (WS114) was encountered during the ground investigation in 2018, which was laterally delineated in shallow ground during a supplementary investigation in 2019 to assess the extent of the oil contamination. Subsequent geophysical surveying (ground penetrating radar and microgravity) was completed in 2019 to assess the size and extent of a void identified during the supplementary investigation.

• A void at WS115 was encountered at 3 m depth, extending to 6 m. It has been modelled by TerraDat from geophysical data to be no wider than 2.0 m. A minimum stand-off of 2.0 m from the position of WS115 shall be maintained, with no mechanical plant or vehicles to operate in this area, and no stockpiling of material or excavation to take place within the stand-off.

- A Severn Trent gravity-fed combined sewer runs within the site close to its eastern boundary. The route of the sewer has been confirmed by services clearance specialists and the TerraDat 2019 GPR survey, and manhole access points to the sewer are present on the site in proximity to WS114, providing visible indicators of its position. A minimum 3.0 m stand-off for any remediation work shall be maintained along the length of the Severn Trent sewer.
- Work within the remediation area shall be depth limited in order to mitigate the risk of undermining the Severn Trent sewer. The maximum remediation depth shall be no greater than 1.6 m bgl (invert level of the sewer at c.1.7 m bgl).

The contaminated ground shall be removed within the constraints to the east, south and west to a maximum depth of 1.60 m bgl. The remediation may cease at shallower depths if there is clear evidence that the contamination has been removed.

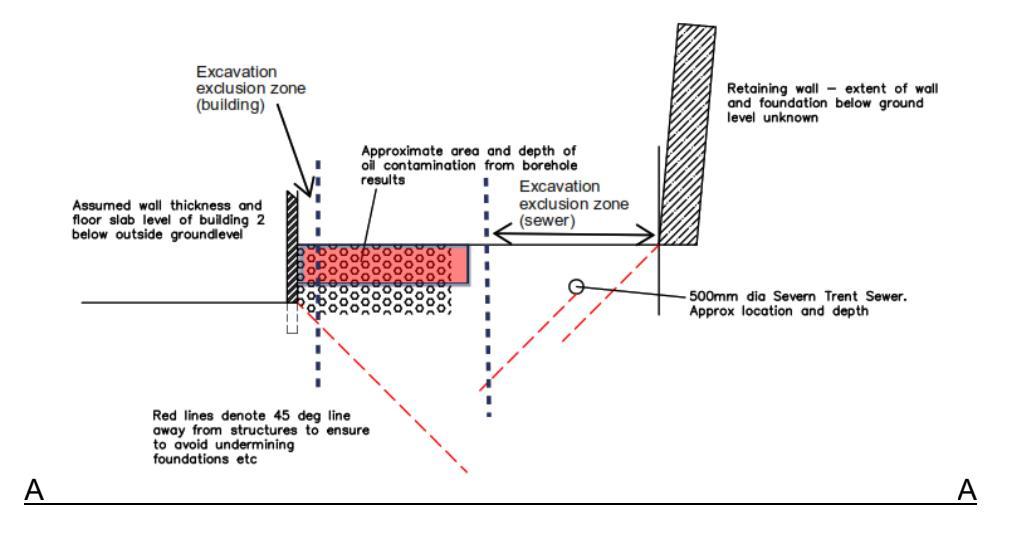
#### Figure 2 Preliminary schematic of constraints and possible remediation area

- A void from 3.0 to 6.0 m below ground level (bgl) close to the south of the proposed remediation area;
- A Severn Trent 525 mm gravity-fed combined sewer to the east;
- The adjacent warehouse building to the west; and
- Buried services (drainage).

- The lateral extent of the remediation area will be strictly limited by the stand-offs applied to the building, the sewer (which will also address risk to the retaining wall at Wellington Road as the sewer is closer) and the void (as presented in Drawing 1).

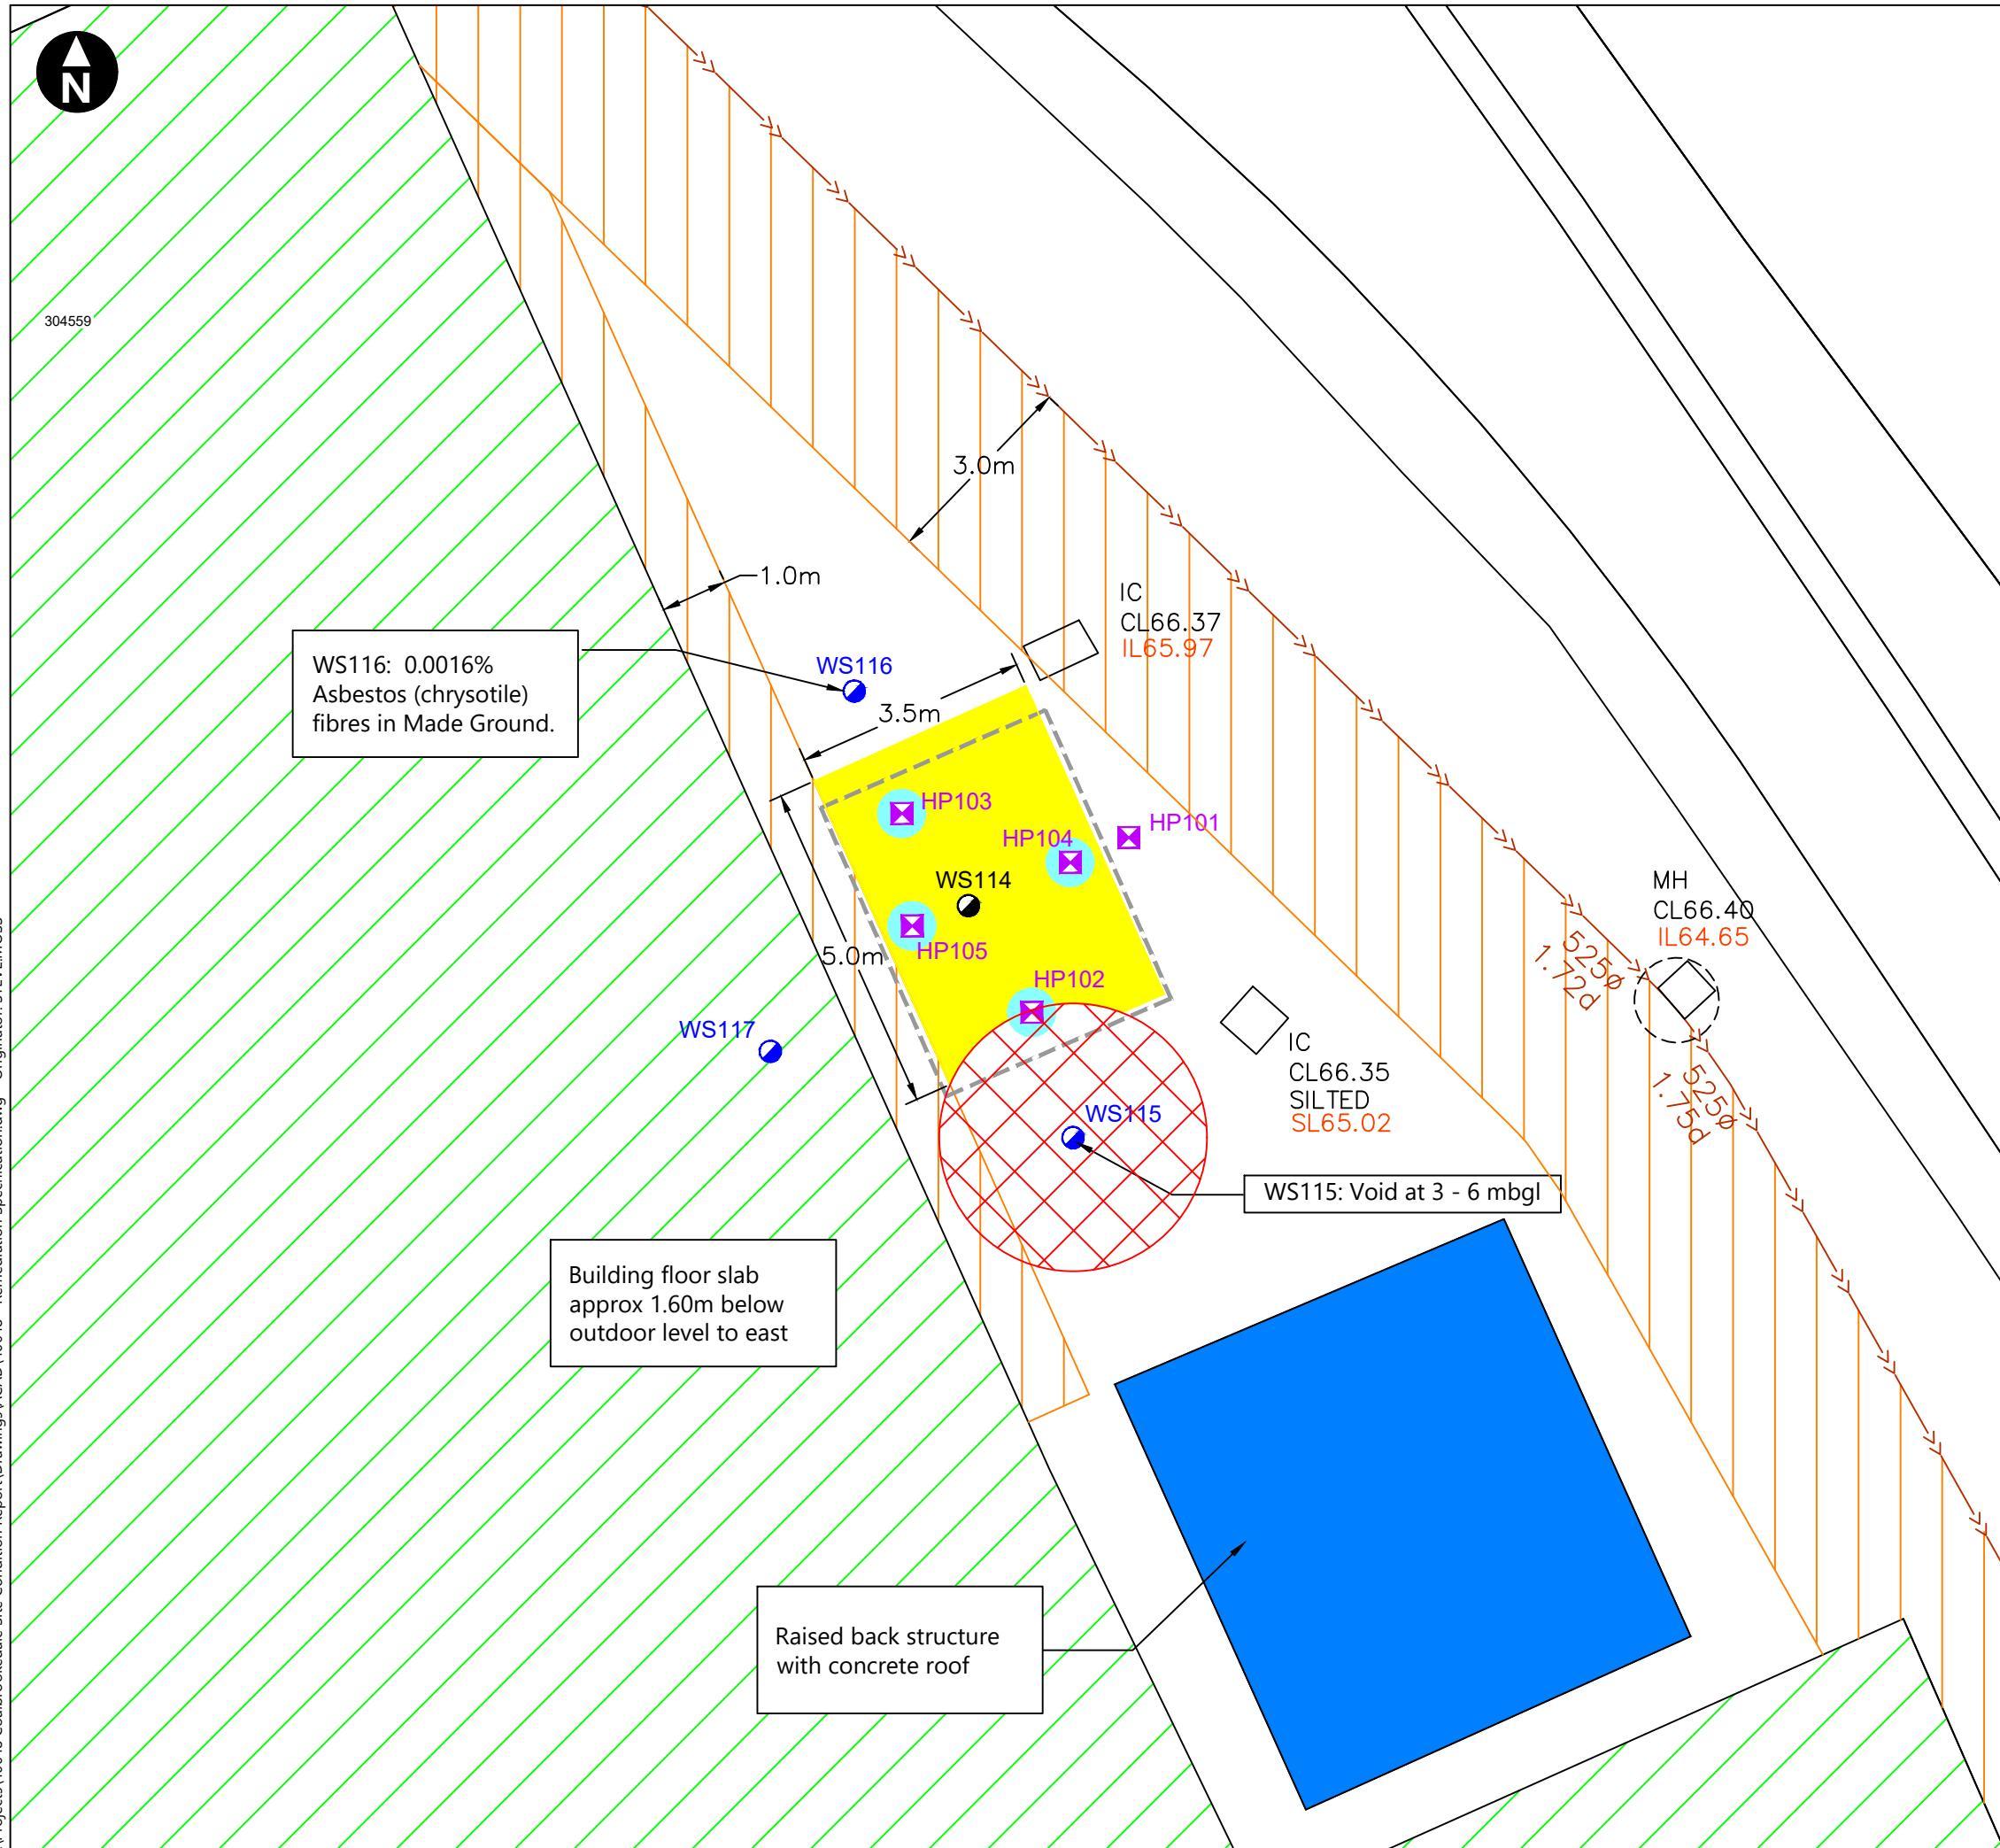
# Appendix A Drawing

Each of these constraints are identified on Drawing 1 and discussed further in the Scope of Work presented in Section 3.

Identified constraints and initial design recommendations to reduce risks when undertaking the proposed remediation are outlined below (subject to amendments as needed during detailed design of the remediation). A constraints plan is presented as Drawing 1 in Appendix A.
