WZ Packaging Ltd  
Halesfield 18  
Telford  
TF7 4JS

We now have pleasure in enclosing the results of the Local Exhaust Ventilation (LEV) thorough examination & tests recently carried out on your various extract ventilation systems.

**LEV Thorough Examination & Test – February 2019**

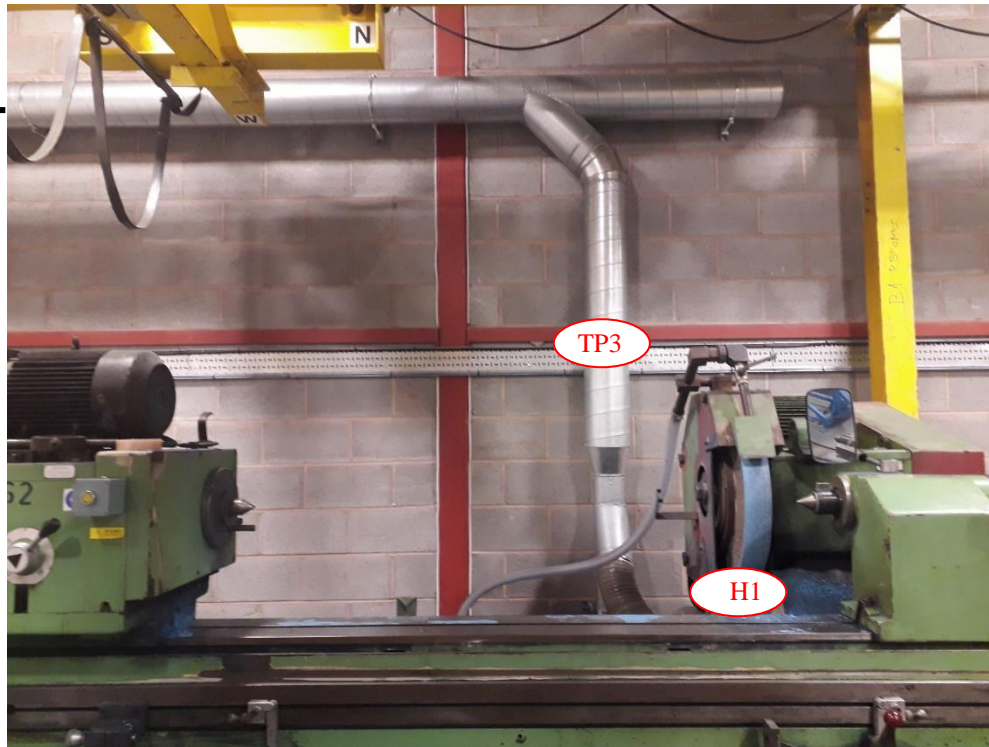
LOCAL EXHAUST VENTILATION EXAMINATION & TEST (SCHEMATIC 1)  
WZ Packaging – Engineering Workshop

| <b>13. Is the LEV plant, when working at its designed performance, sufficient to control the hazardous substances?</b> | Yes<br>Good capture and containment demonstrated using smoke and observed with Tyndall Illumination |
| <b>15. Any other observations:</b> | Dust accumulation directly adjacent to hood requires clearing. |

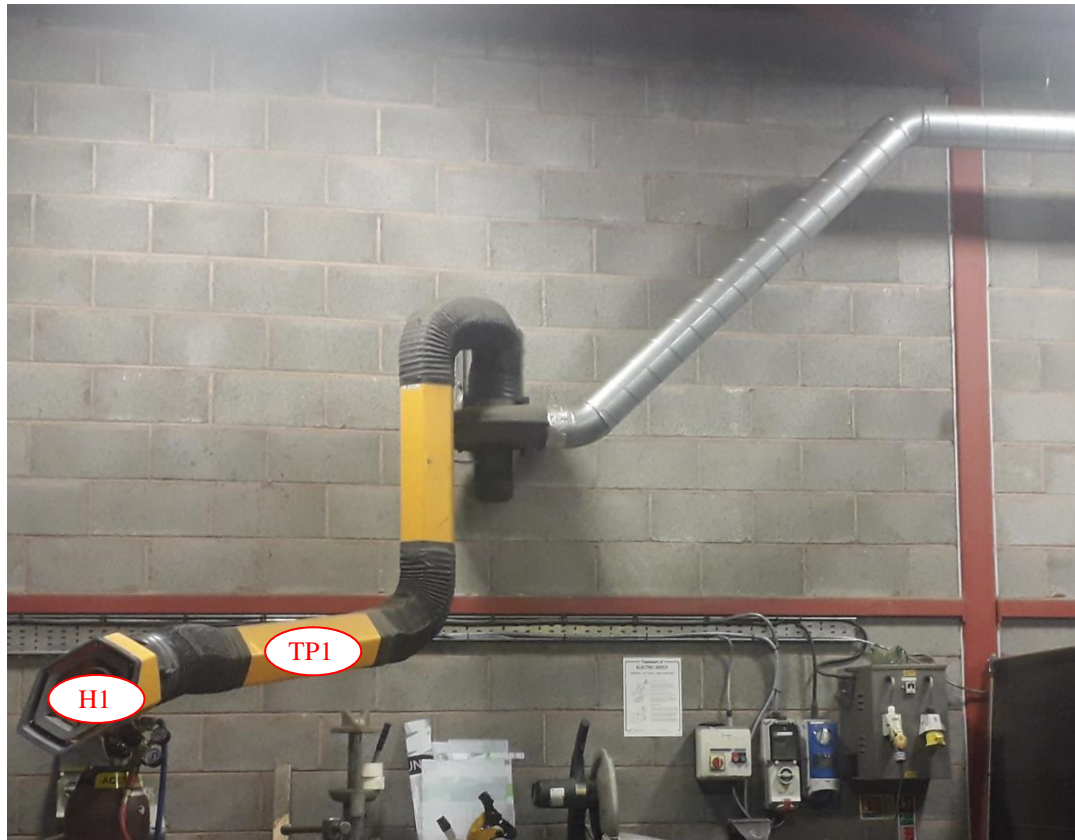
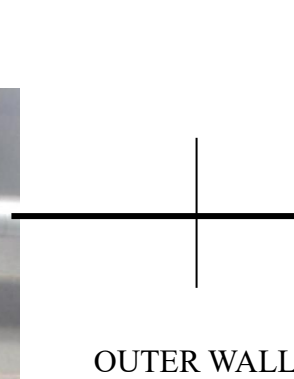
LOCAL EXHAUST VENTILATION EXAMINATION & TEST (SCHEMATIC 2)  
WZ Packaging – Engineering Workshop

| <b>12.2. Any repairs required to maintain the intended operating performance?</b> | Adjustable arm requires tightening to enable hood to hold its position. |
| <b>15. Any other observations:</b> | 250mm capture distance established. |

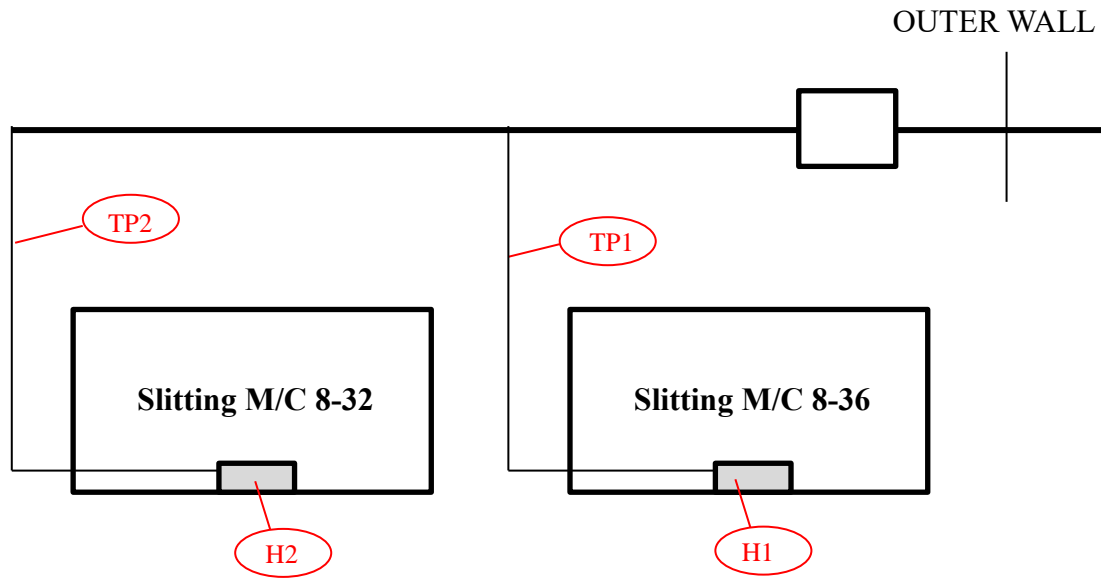
LOCAL EXHAUST VENTILATION EXAMINATION & TEST (SCHEMATIC 3)  
WZ Packaging – Finishing Area

| <b>13. Is the LEV plant, when working at its designed performance, sufficient to control the hazardous substances?</b> | No commissioning data provided for performance comparison. Exposure monitoring should be carried out during normal slitting machine production to further validate this assessment. The exposure levels should be reviewed annually alongside the thorough examination and test to ensure adequate control. |

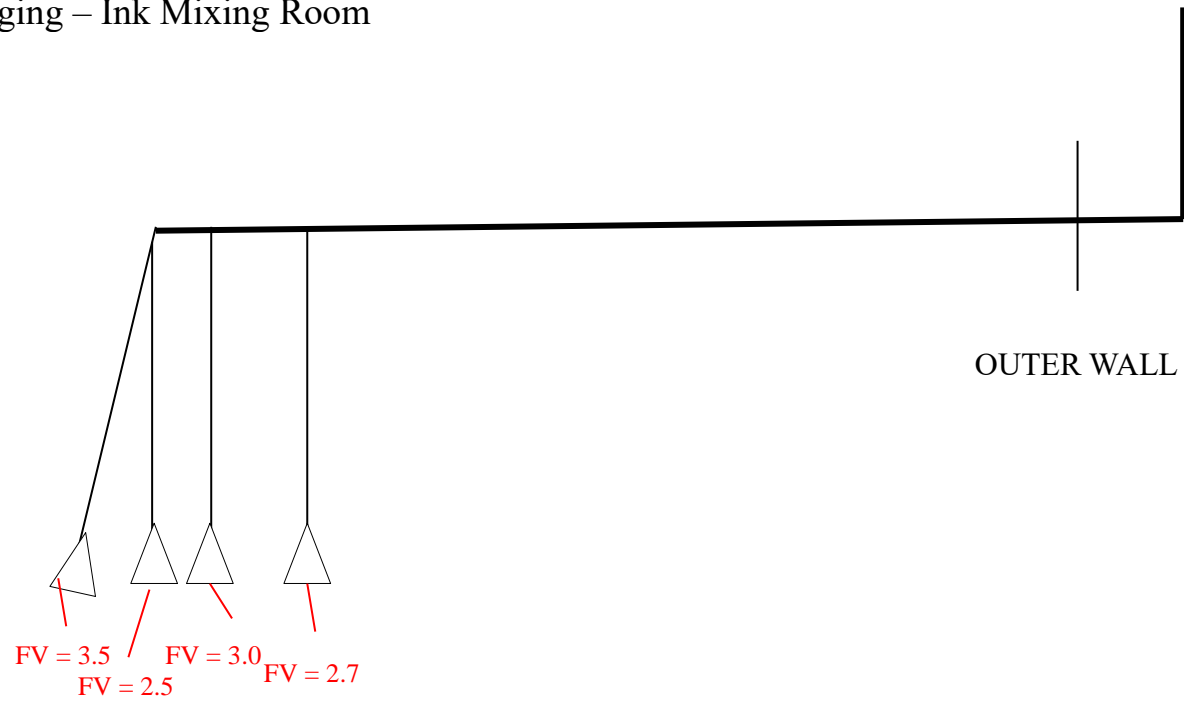
LOCAL EXHAUST VENTILATION EXAMINATION & TEST (SCHEMATIC 4)  
WZ Packaging – Ink Mixing Room

| <b>13. Is the LEV plant, when working at its designed performance, sufficient to control the hazardous substances?</b> | Yes<br>Good capture and containment demonstrated using smoke and observed with Tyndall Illumination. No commissioning data provided for performance comparison. |
| <b>15. Any other observations:</b> | Personal exposure monitoring was carried out to further validate this assessment. The exposure levels should be reviewed annually alongside the thorough examination and test to ensure adequate control. |

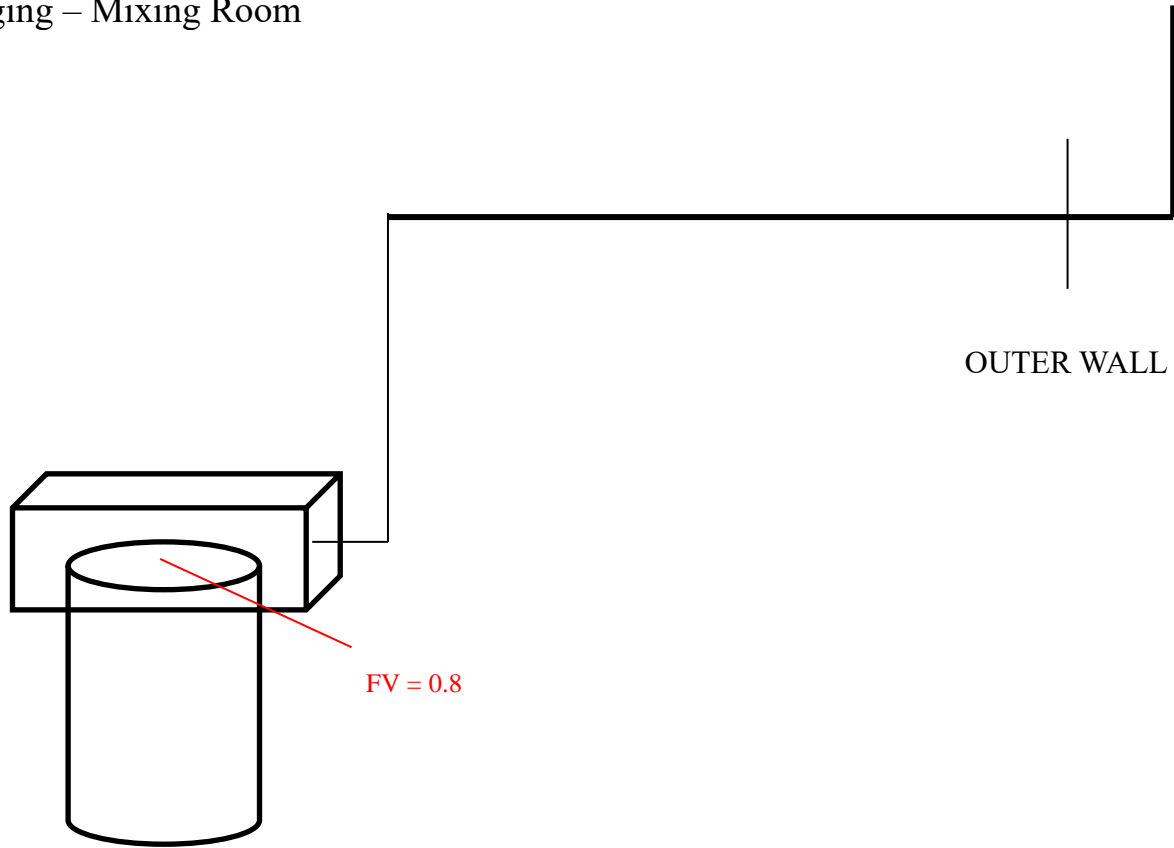
LOCAL EXHAUST VENTILATION EXAMINATION & TEST (SCHEMATIC 5)  
WZ Packaging – Mixing Room

| <b>13. Is the LEV plant, when working at its designed performance, sufficient to control the hazardous substances?</b> | Yes<br>Good capture and containment demonstrated using smoke and observed with Tyndall Illumination. No commissioning data provided for performance comparison. |
| <b>15. Any other observations:</b> | Personal exposure monitoring was carried out to further validate this assessment. The exposure levels should be reviewed annually alongside the thorough examination and test to ensure adequate control. |

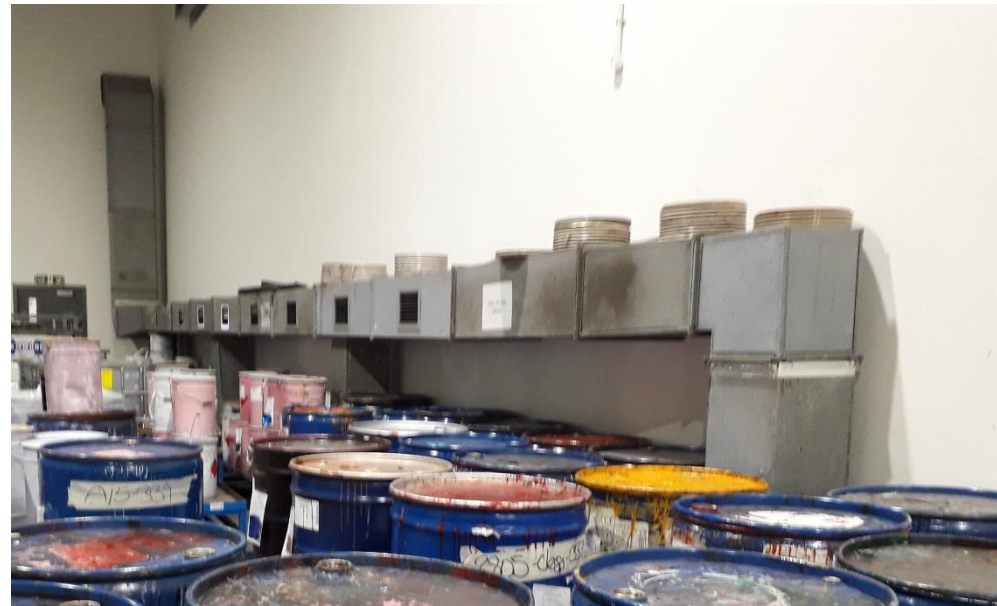
# LOCAL EXHAUST VENTILATION EXAMINATION & TEST (SCHEMATIC 6)

<b>11. Condition of LEV plant at time of test - normal production or special conditions?</b>	Normal production
<b>12. Is the LEV plant continuing to operate at its designed performance?</b>	Yes - Satisfactory, Adequate face air velocities measured
<b>12.1. If no, give reasons:</b>	N/A
<b>12.2. Any repairs required to maintain the intended operating performance?</b>	No
<b>13. Is the LEV plant, when working at its designed performance, sufficient to control the hazardous substances?</b>	System provides general ventilation, not LEV. No commissioning data provided for performance comparison. Personal exposure monitoring was carried out to further validate this assessment. The exposure levels should be reviewed annually alongside the thorough examination and test to ensure adequate control.
<b>14. Does this system return exhaust air to the workplace?</b>	No
<b>15. Any other observations:</b>	None.

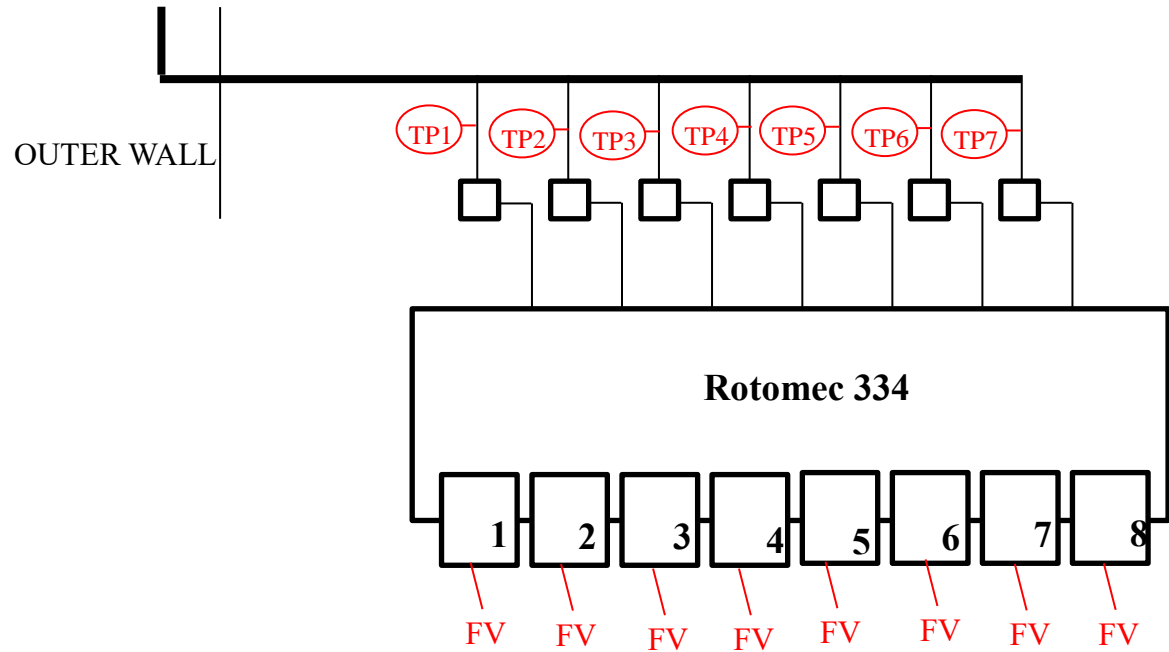
LOCAL EXHAUST VENTILATION EXAMINATION & TEST (SCHEMATIC 7)  
WZ Packaging – Printing Press Area

| <b>13. Is the LEV plant, when working at its designed performance, sufficient to control the hazardous substances?</b> | No commissioning data provided for performance comparison. Personal exposure monitoring was carried out to further validate this assessment. The exposure levels should be reviewed annually alongside the thorough examination and test to ensure adequate control. |

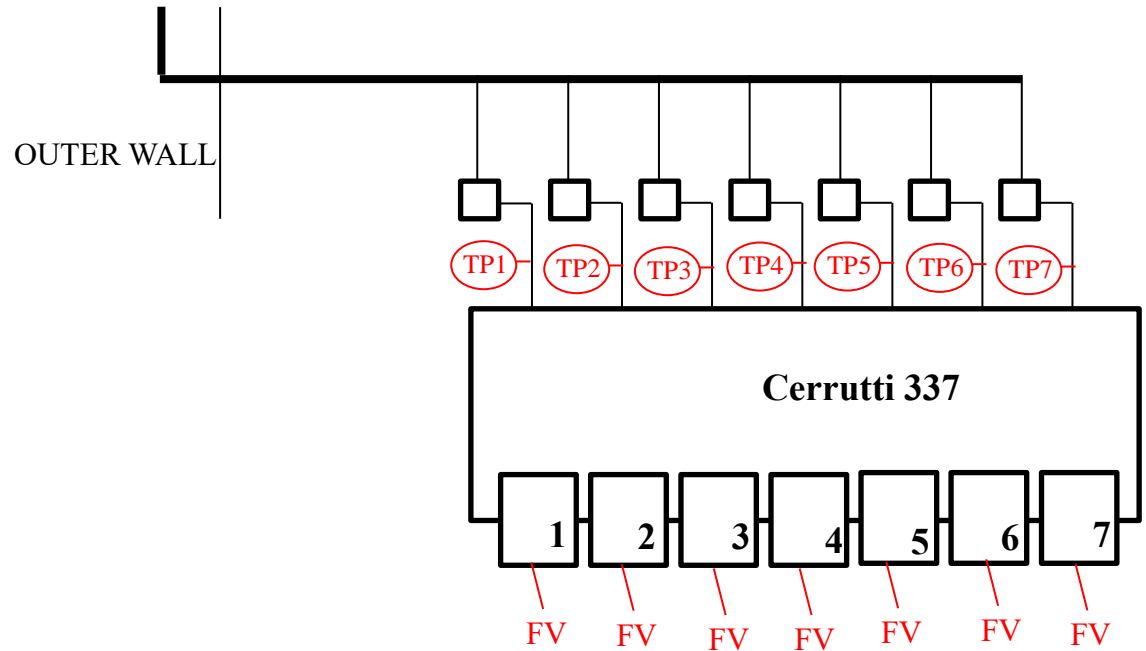
LOCAL EXHAUST VENTILATION EXAMINATION & TEST (SCHEMATIC 8)  
WZ Packaging – Printing Press Area

<b>11. Condition of LEV plant at time of test - normal production or special conditions?</b>	Test Conditions
<b>12. Is the LEV plant continuing to operate at its designed performance?</b>	Yes - Satisfactory, Adequate transport and face air velocities measured
<b>12.1. If no, give reasons:</b>	N/A
<b>12.2. Any repairs required to maintain the intended operating performance?</b>	No
<b>13. Is the LEV plant, when working at its designed performance, sufficient to control the hazardous substances?</b>	No commissioning data provided for performance comparison. Exposure monitoring should be carried out during normal printing machine production to further validate this assessment. The exposure levels should be reviewed annually alongside the thorough examination and test to ensure adequate control.
<b>14. Does this system return exhaust air to the workplace?</b>	No
<b>15. Any other observations:</b>	None.

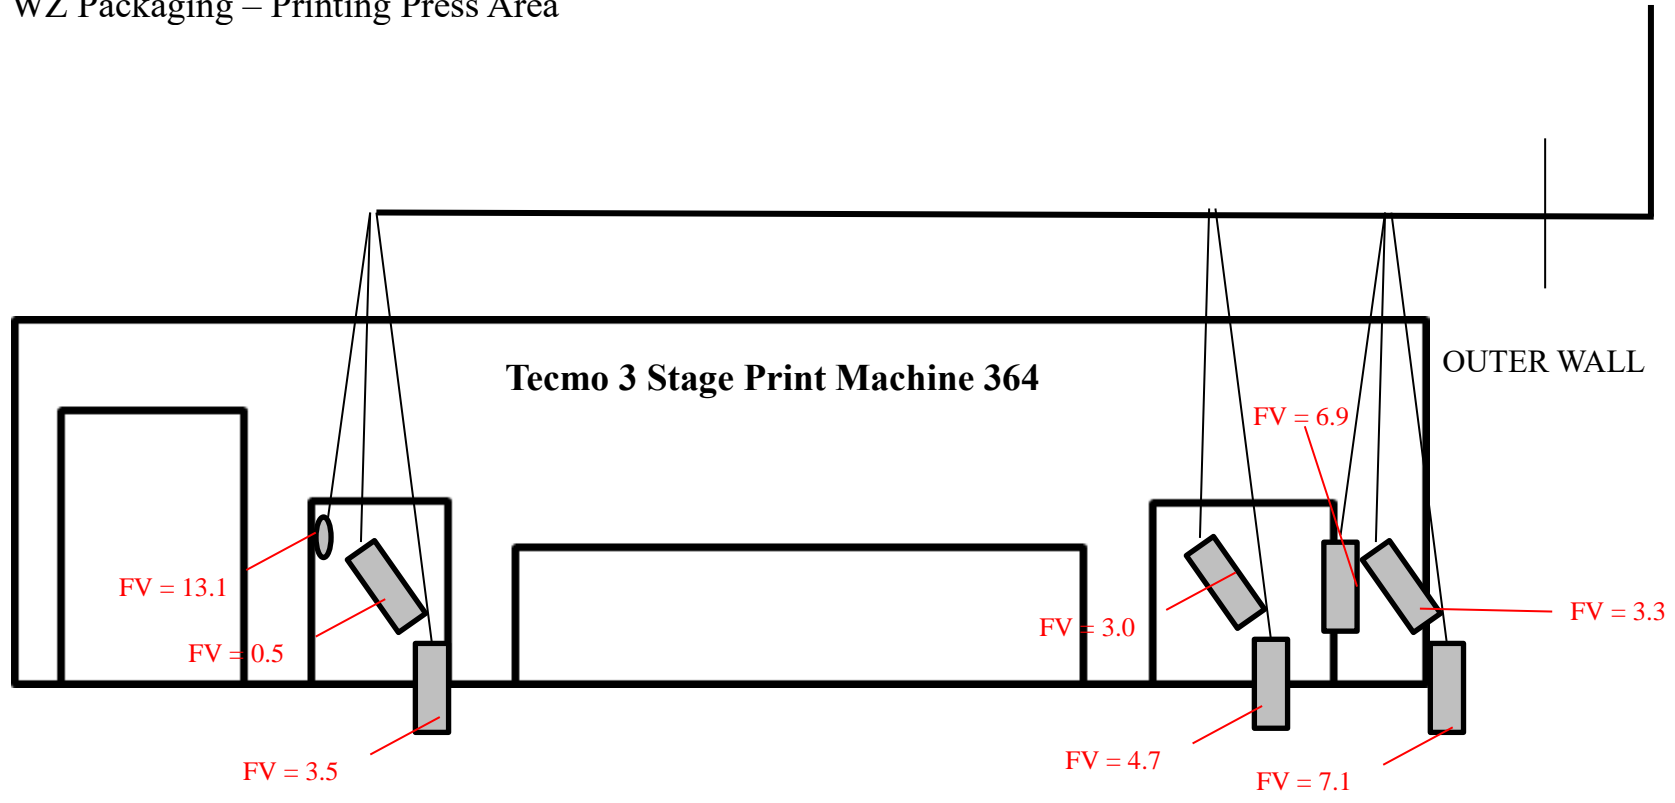
LOCAL EXHAUST VENTILATION EXAMINATION & TEST (SCHEMATIC 9)  
WZ Packaging – Printing Press Area

| <b>13. Is the LEV plant, when working at its designed performance, sufficient to control the hazardous substances?</b> | No commissioning data provided for performance comparison. Exposure monitoring should be carried out during normal printing machine production to further validate this assessment. The exposure levels should be reviewed annually alongside the thorough examination and test to ensure adequate control. |
| <b>15. Any other observations:</b> | Poor hood positioning observed, it is recommended the hoods are moved closer to the source of the volatile organic compound (VOC) vapour. |

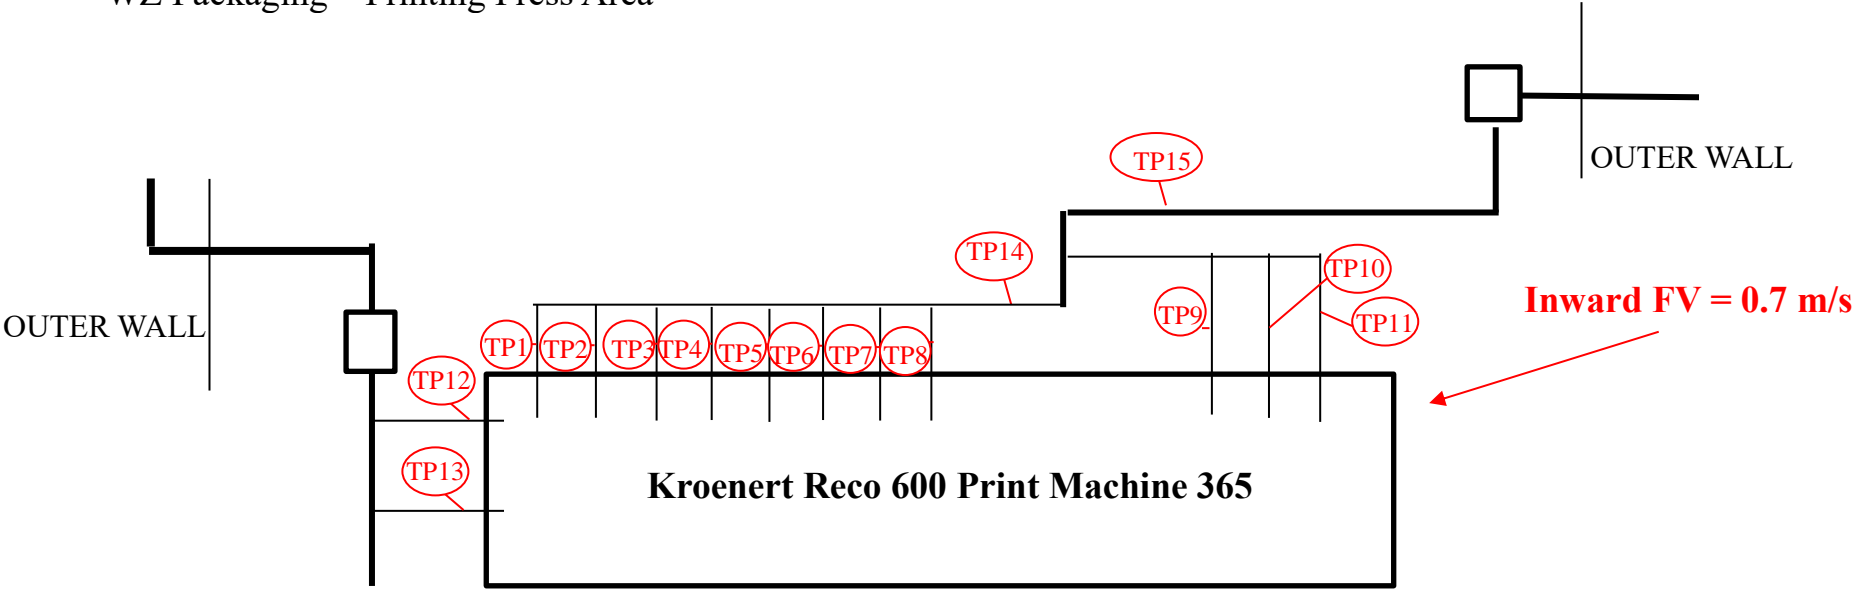
LOCAL EXHAUST VENTILATION EXAMINATION & TEST (SCHEMATIC 10)  
WZ Packaging – Printing Press Area

| <b>13. Is the LEV plant, when working at its designed performance, sufficient to control the hazardous substances?</b> | No commissioning data provided for performance comparison. Exposure monitoring should be carried out during normal printing machine production to further validate this assessment. The exposure levels should be reviewed annually alongside the thorough examination and test to ensure adequate control. |

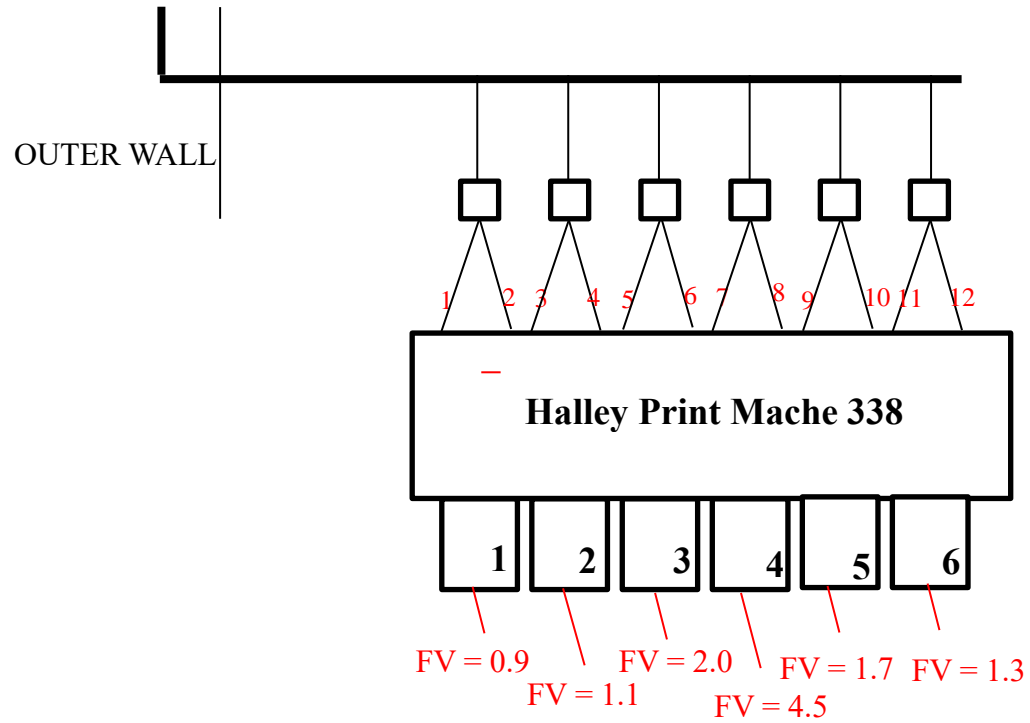
LOCAL EXHAUST VENTILATION EXAMINATION & TEST (SCHEMATIC 11)  
WZ Packaging – Printing Press Area

<b>11. Condition of LEV plant at time of test - normal production or special conditions?</b>	Test.
<b>12. Is the LEV plant continuing to operate at its designed performance?</b>	Yes - Satisfactory, Low transport and face air velocities measured
<b>12.1. If no, give reasons:</b>	N/A
<b>12.2. Any repairs required to maintain the intended operating performance?</b>	No
<b>13. Is the LEV plant, when working at its designed performance, sufficient to control the hazardous substances?</b>	No commissioning data provided for performance comparison. Exposure monitoring should be carried out during normal printing machine production to further validate this assessment. The exposure levels should be reviewed annually alongside the thorough examination and test to ensure adequate control.
<b>14. Does this system return exhaust air to the workplace?</b>	No
<b>15. Any other observations:</b>	Airflow dampers restrict the system performance to prevent the foil product from being drawn into the extraction.

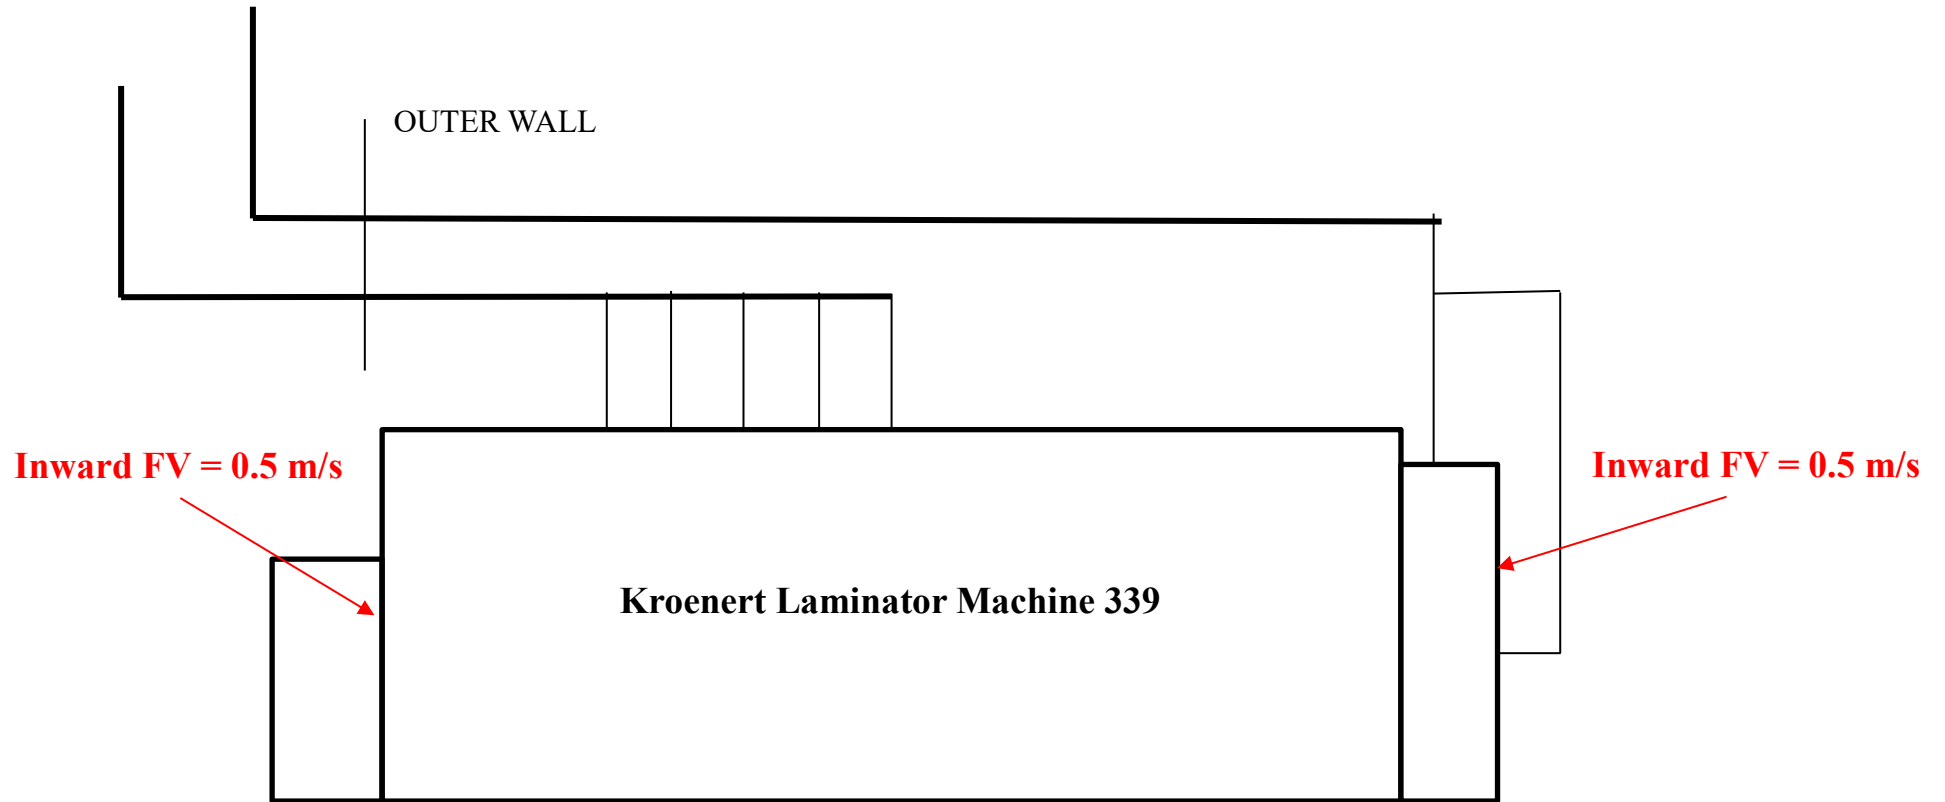
LOCAL EXHAUST VENTILATION EXAMINATION & TEST (SCHEMATIC 12)  
WZ Packaging – Printing Press Area

<b>11. Condition of LEV plant at time of test - normal production or special conditions?</b>	Normal
<b>12. Is the LEV plant continuing to operate at its designed performance?</b>	Yes - Satisfactory, Adequate face air velocities measured
<b>12.1. If no, give reasons:</b>	N/A
<b>12.2. Any repairs required to maintain the intended operating performance?</b>	No
<b>13. Is the LEV plant, when working at its designed performance, sufficient to control the hazardous substances?</b>	No commissioning data provided for performance comparison. Personal exposure monitoring was carried out to further validate this assessment. The exposure levels should be reviewed annually alongside the thorough examination and test to ensure adequate control.
<b>14. Does this system return exhaust air to the workplace?</b>	No
<b>15. Any other observations:</b>	None.

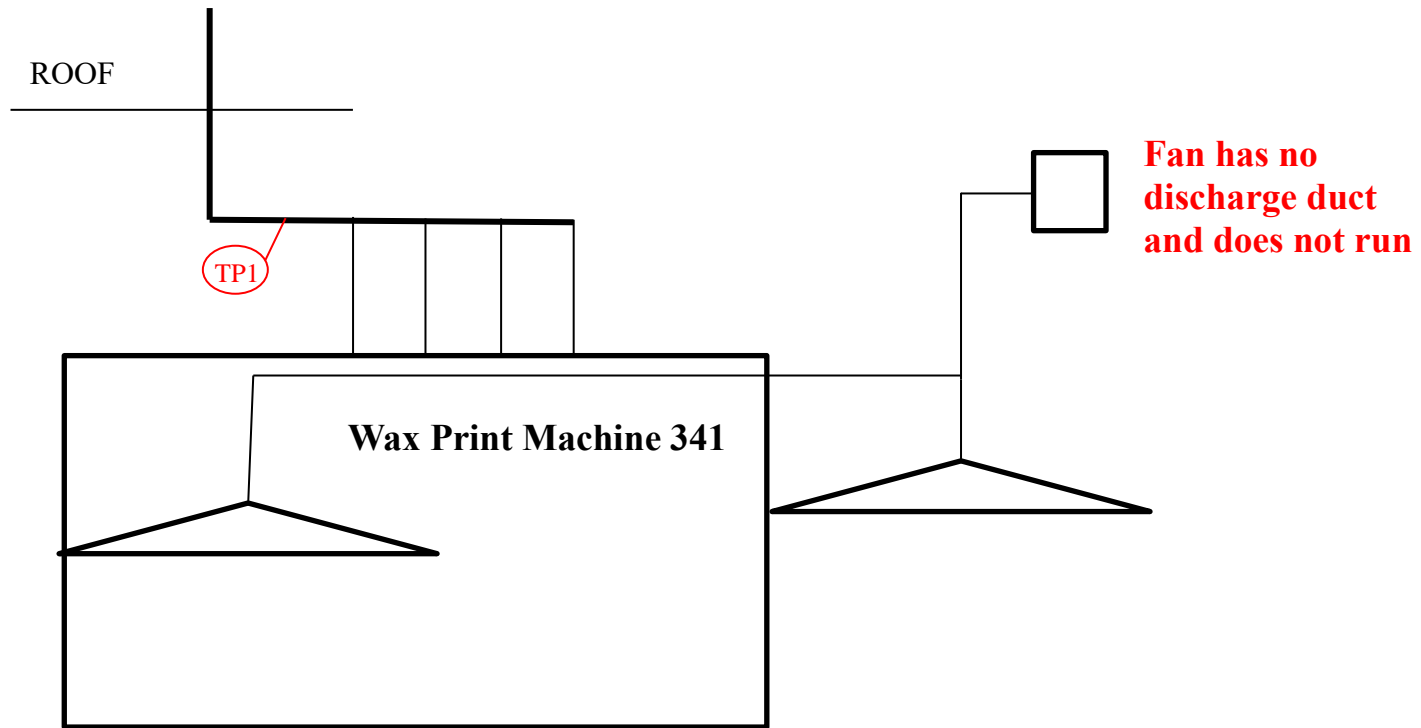
LOCAL EXHAUST VENTILATION EXAMINATION & TEST (SCHEMATIC 13)  
WZ Packaging – Printing Press Area

| <b>13. Is the LEV plant, when working at its designed performance, sufficient to control the hazardous substances?</b> | No commissioning data provided for performance comparison. Exposure monitoring should be carried out during normal printing machine production to further validate this assessment. The exposure levels should be reviewed annually alongside the thorough examination and test to ensure adequate control. |
| <b>15. Any other observations:</b> | Qualitative smoke test demonstrated poor capture and control. |

| <b>12.2. Any repairs required to maintain the intended operating performance?</b> | Install discharge duct and ensure that the fan is operational and has sufficient performance to control the VOCs. |

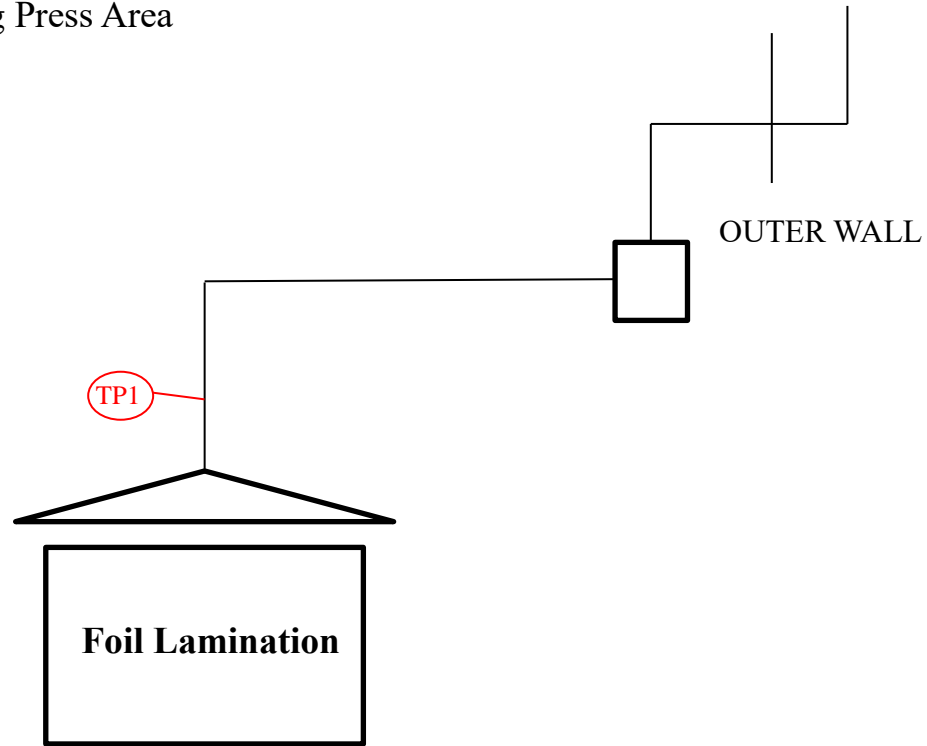
LOCAL EXHAUST VENTILATION EXAMINATION & TEST (SCHEMATIC 14)  
WZ Packaging – Printing Press Area

| <b>13. Is the LEV plant, when working at its designed performance, sufficient to control the hazardous substances?</b> | No commissioning data provided for performance comparison. Exposure monitoring should be carried out during normal printing machine production to further validate this assessment. The exposure levels should be reviewed annually alongside the thorough examination and test to ensure adequate control. |

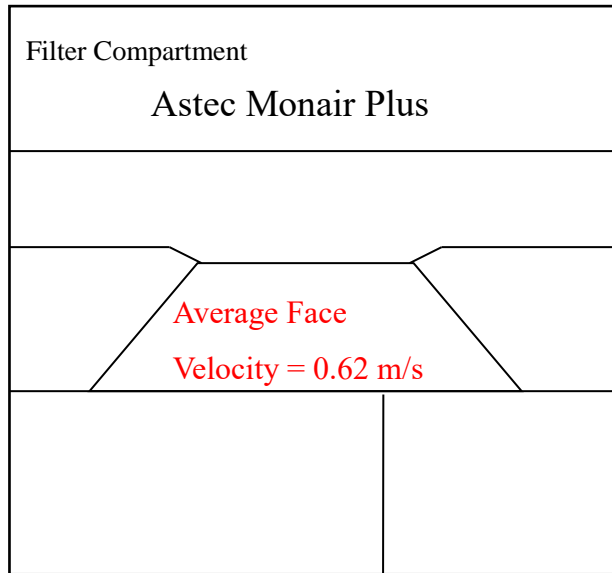
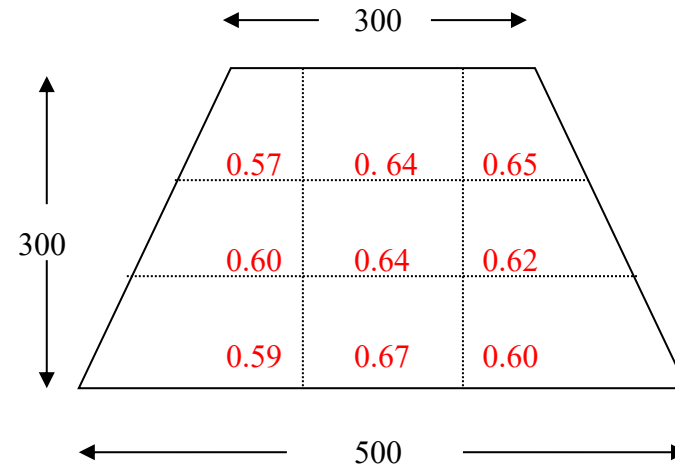
LOCAL EXHAUST VENTILATION EXAMINATION & TEST (SCHEMATIC 16)  
WZ Packaging – Lab Area

| <b>15. Any other observations:</b> | No saturation test has been carried out on the main carbon filter. It is recommended that the filters are changed at regular intervals: The pre-filter every 3 months and the main carbon filter every 3 years (or to manufacturer's specific guidelines). Records should be made of all changes. Filters last changed: <b>Unknown (&gt;3 Years)</b> |

| <b>12.2. Any repairs required to maintain the intended operating performance?</b> | Replace filter! |

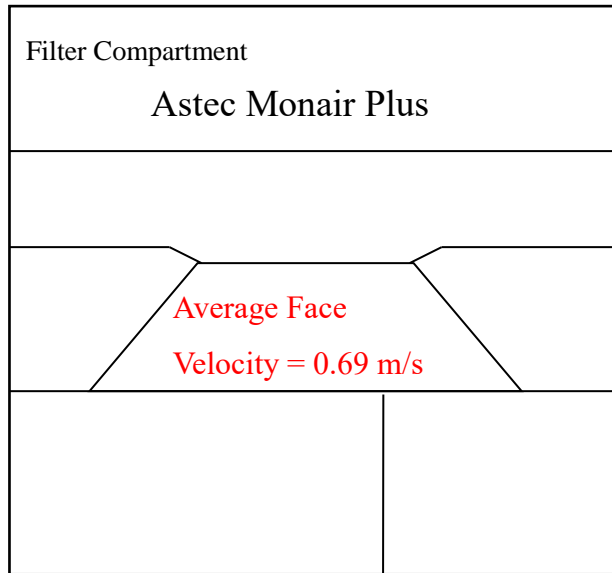
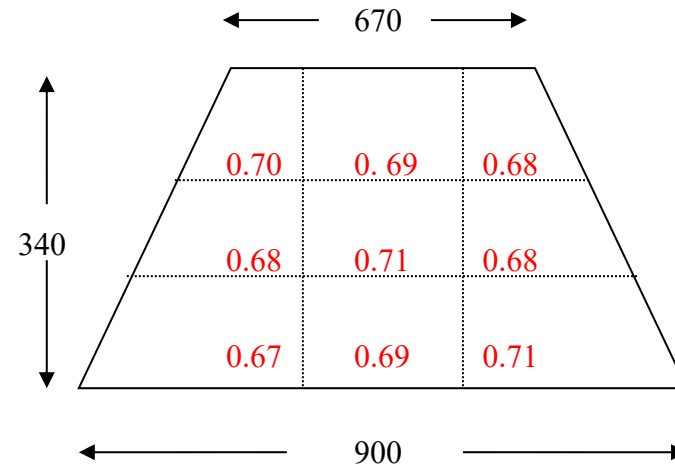
LOCAL EXHAUST VENTILATION EXAMINATION & TEST (SCHEMATIC 16)  
WZ Packaging – Lab Area

| <b>15. Any other observations:</b> | No saturation test has been carried out on the main carbon filter. It is recommended that the filters are changed at regular intervals: The pre-filter every 3 months and the main carbon filter every 3 years (or to manufacturer's specific guidelines). Records should be made of all changes. Filters last changed: <b>Unknown (&gt;3 Years)</b> |

| <b>12.2. Any repairs required to maintain the intended operating performance?</b> | Replace filter! |
