PHASE I ENVIRONMENTAL ASSESSMENT, HALESFIELD 18, TELFORD, UK

Moneta Packaging Ltd

December 2014

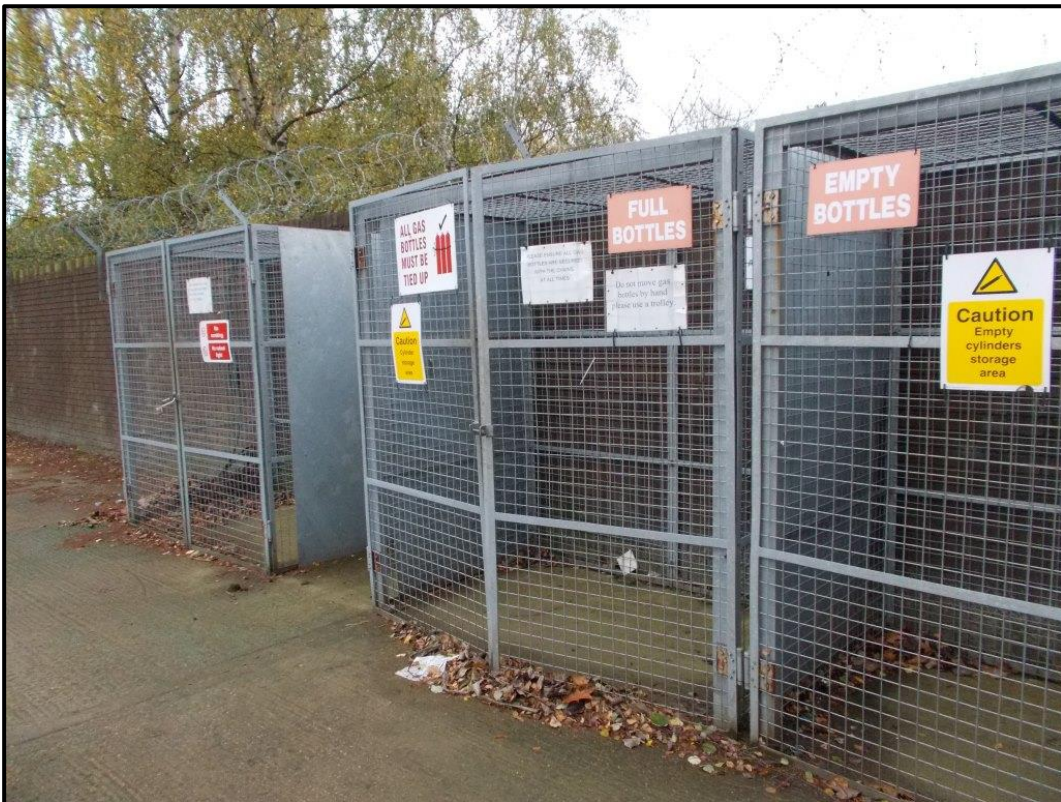
- A diesel tank is located in the east of the site (see Bulk Hazardous Materials Storage section below).
- Empty storage cages for acetylene, argo-sheild and propane and an empty porta cabin are located in the south-east of the site (see Plate 2 Appendix B).

PLATE 2: EMPTY STORAGE CAGES FOR ACETYLENE, ARGOSHEILD AND PROPANE.

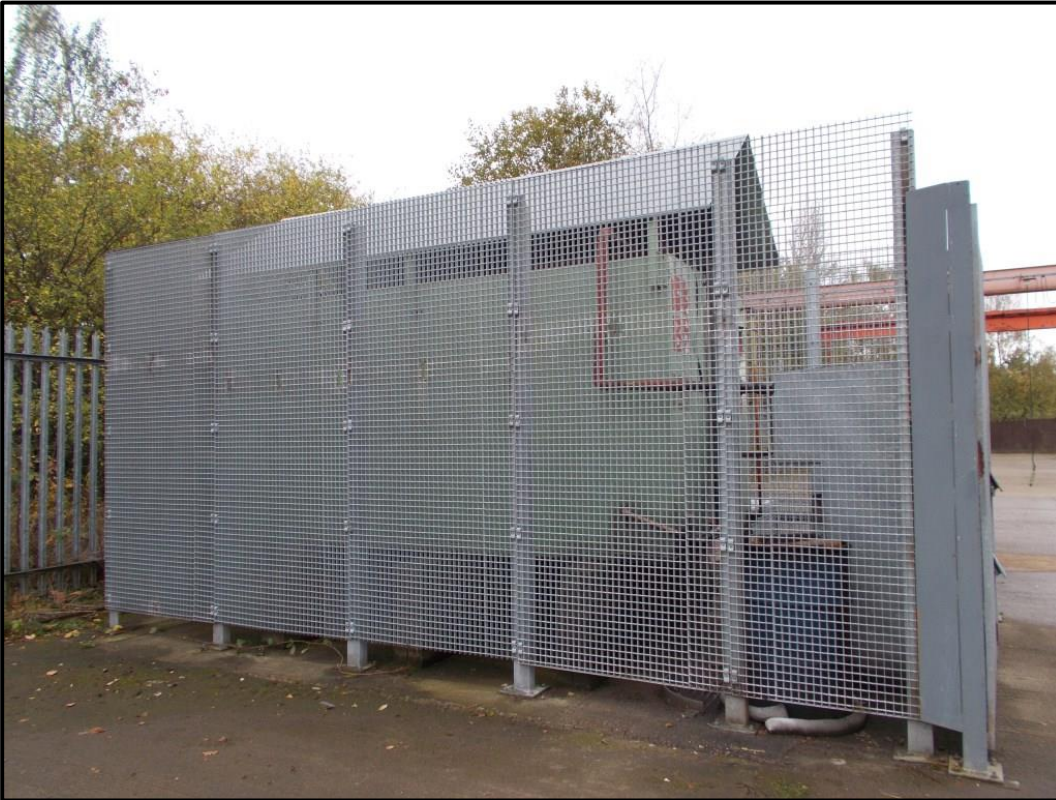
- An approximately 6,000 litre above ground diesel oil storage tank (AST) for powering the site's heating system and fuelling the forklift trucks is located in the east of the site (see Plate 3 Appendix B). The AST was raised on bricks approximately 0.5 metres above ground level and enclosed within a metal cage. Although no access was provided inside the cage area, no evidence of hydrocarbon staining was observed on the good condition concrete hardstanding beneath the AST. The tanks is assumed to be single skinned, and was not provided with any secondary containment. A pitched metal roof was observed above the tank to reduce rainwater ingress. A dispensing point was observed to extend from the tank to the front of the cage with a metal drum located below it containing stained spill rags (see Plate 4 Appendix B). Below ground pipework connects the tank to the industrial unit.

PLATE 3: ABOVE GROUND DIESEL OIL STORAGE TANK

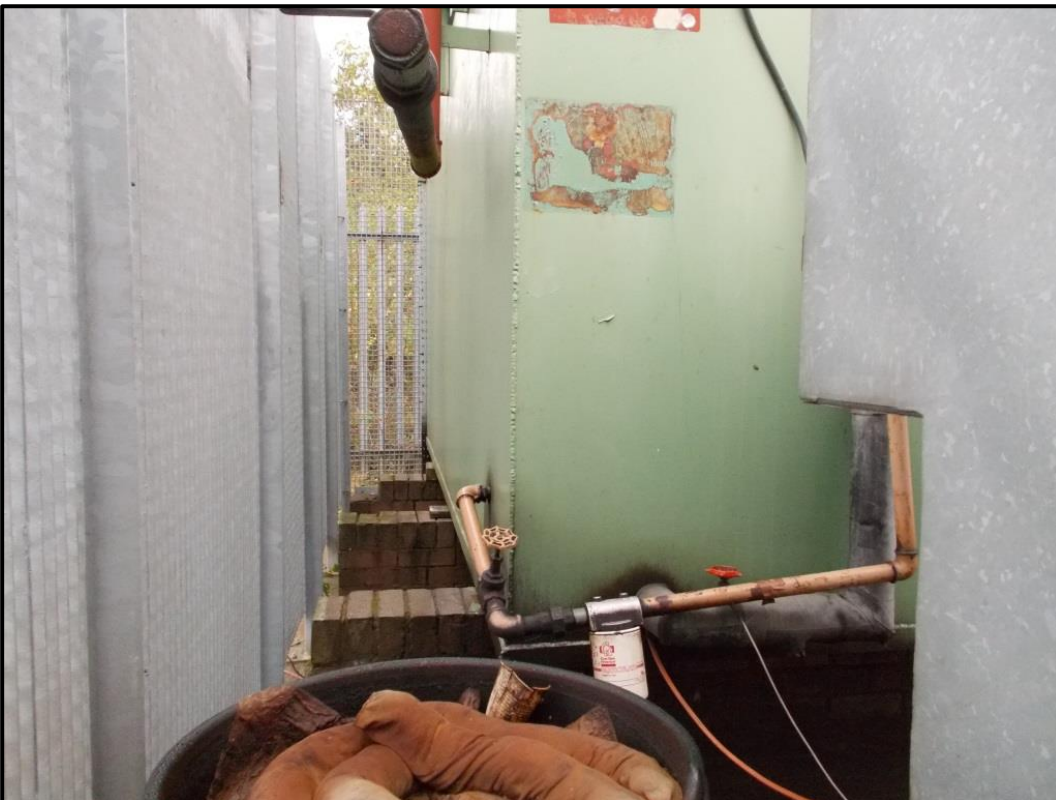
An above ground diesel storage tank (AST) for powering the site’s heating system and fuelling the forklift trucks is located externally on concrete hardstanding without the provision of secondary containment, which represents a potential source of contamination.

PLATE 4: STAINED SPILL RAGS LOCATED BELOW DISPENSING POINT.
