Telford & Wrekin Council
**Kynnersley
Conservation
Area Appraisal &
Management Plan**

2021

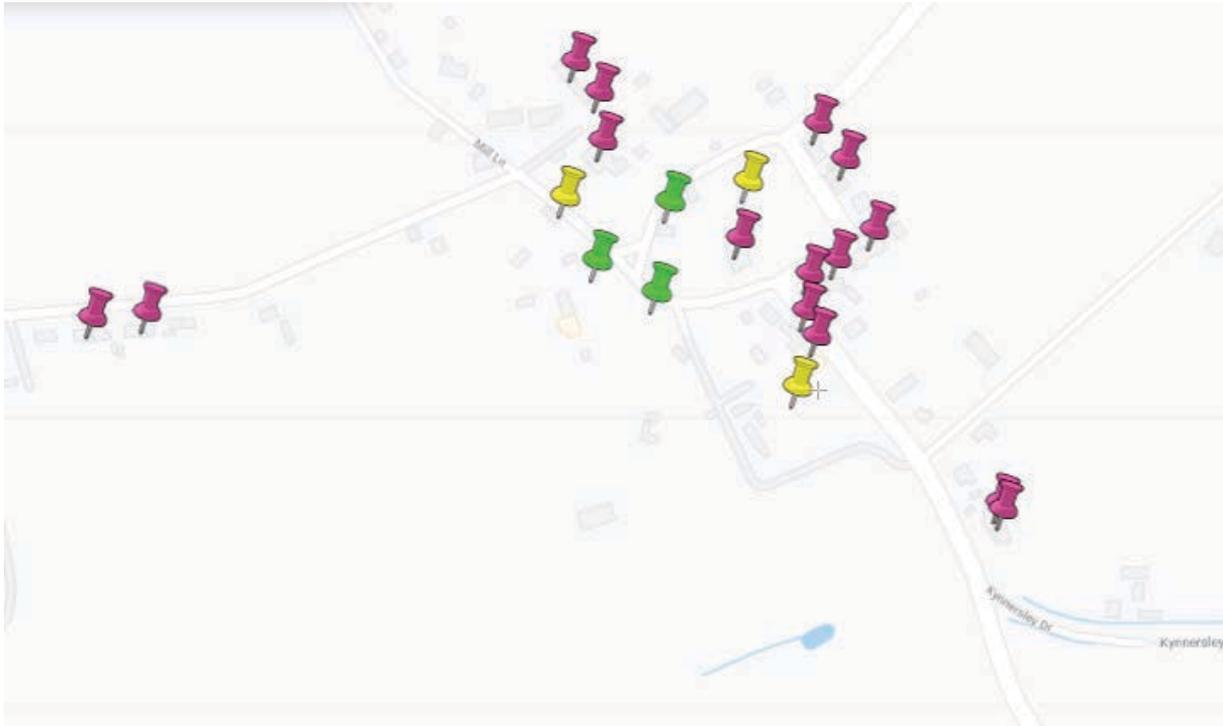
Figure 6: Location of Prominent Buildings

- **Note:** Green - Listed Buildings, Yellow - Former Agricultural Buildings and Purple - Other Important Prominent Buildings

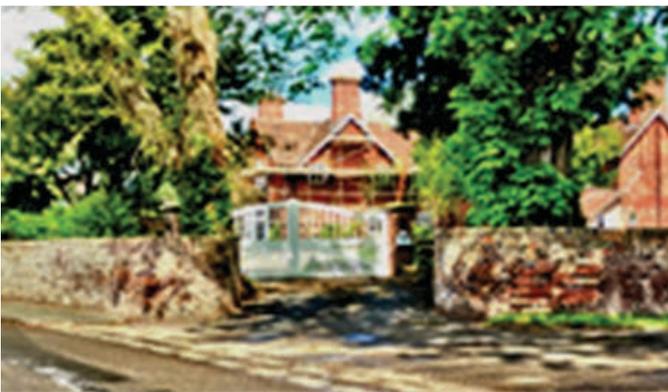
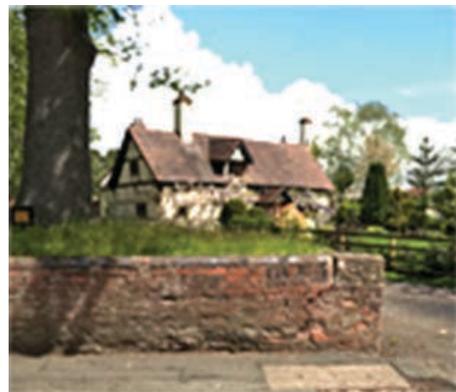
Figure 8: Kynnersley Manor (left) and Wyhm Cottage (right)

5.19 Opposite to the church is a triangular raised piece of land which dissects the lane running west from the main road. This is enclosed by a brick and stone wall retaining wall and in the centre is a mature tree. This area is called the Whim and the Oak tree in the middle is said to be the hanging tree related to the court house. This court house is now part of Kynnersley Manor Farm buildings. To the left of the triangle is found the entrance to Kynnersley Manor (Fig 8). To the right of the triangle and set slightly back is Wyhm Cottage (Fig 8).

5.20 This area with the Church, triangle, grouping of trees, manor entrance and Wyhm Cottage makes a strong central feature within the village.

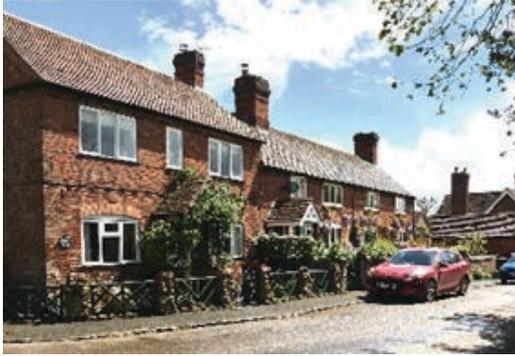
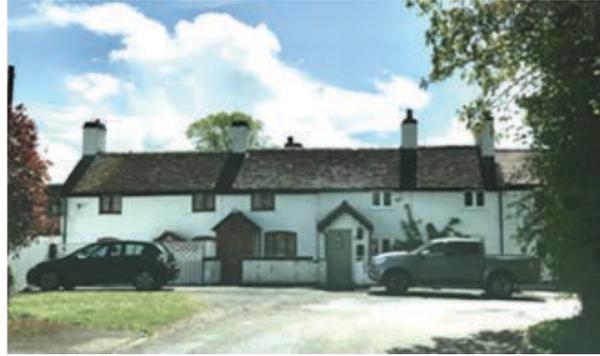
Figure 10: Row of Cottages (left) and Painted Brickwork with Steeper Pitched Roofs (right)

5.27 The farm buildings are constructed in the usual palette of the mid-19th century development period. Whereas the early building is painted brick work with steeper pitched roofs (Fig 10).

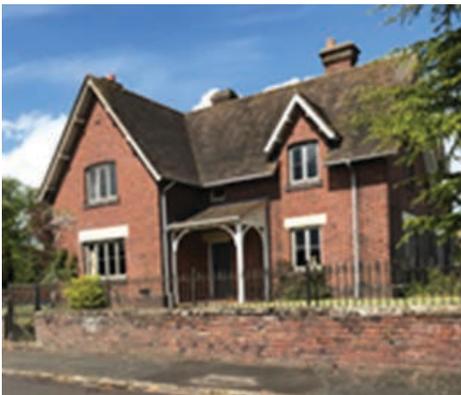
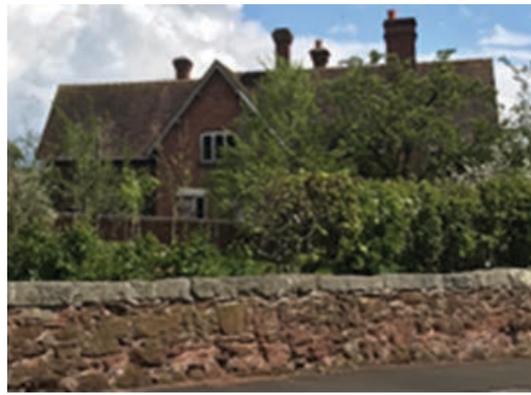
Figure 11: Former Crown Public House

5.28 At the top of the lane where it re-joins the main road running through the village is sited the large mid Victorian farmhouse (the former Crown Public House) with the adjacent former farm buildings was associated with. It is a fine house and represents all the features found on other development of this time. It has a fine low brick wall with original decorative metal railings on top. This building forms a focal point at the end of the lane and as you turn the corner of the main road towards the church (Fig 11).

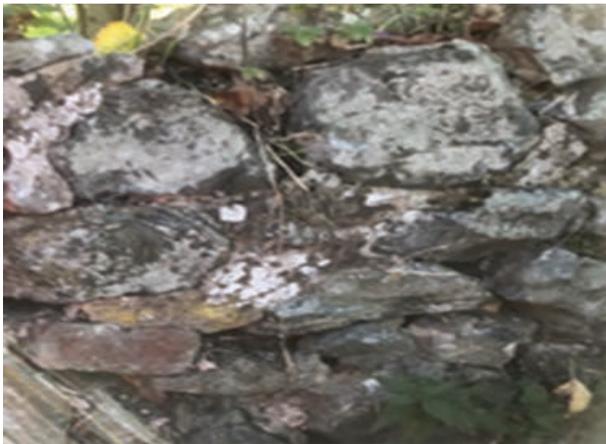
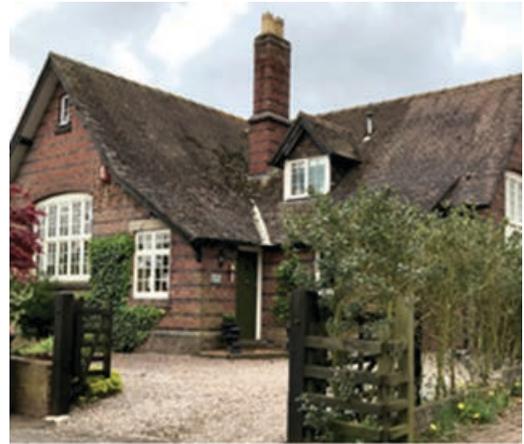
Figure 13: Clinker Built Walls and the Old School House

5.33 As you follow the road down into the village again you pass the entrance to the former agricultural buildings on the left marked with post and rail fencing. The low stone wall on this side of the road is a majorly significant feature and one of last surviving clinker built walls (Fig 13) and continues until the old School House.

5.34 By the old School House a brick wall marks the boundary between public realm and private front gardens. The Old School House is a striking building with sweeping roofs and black and red striped polychrome brick work (Fig 13). Next to The Old School House is a row of Victorian estate cottages one of which was the school teacher house. Many of the architectural details seen on the other buildings of this period (Fig 14) are found on this cottages.

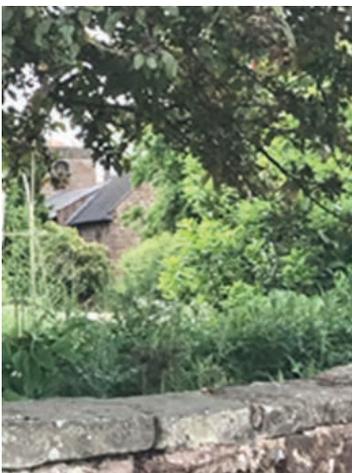
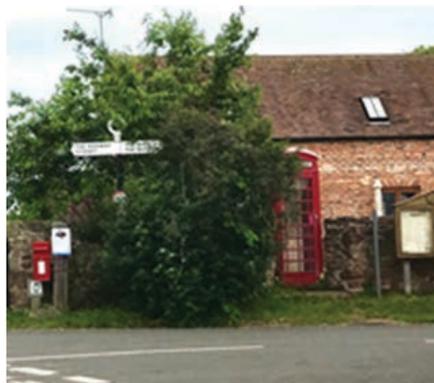
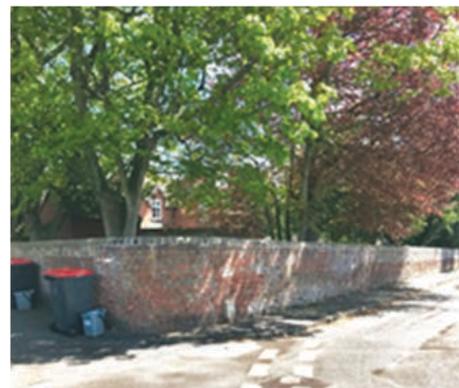
Figure 15: View of Crown House (left) Street Furniture (middle) and Manor Boundary Wall (right)

5.35 As you pass the old school house on your left to the right is another set of Victorian estate cottages (Fig 15) and the remaining red brick barn that related to the 1738 property. As you approach the corner where the two lanes meet, turning left passing Crown House on your right. There are glimpses across the corner on left of the church (Fig 15) and a clear view is seen of the street furniture next to Crown House on the right (Fig 15).

5.36 Turning the corner the Church and the Wyhm come into view. Passing down this road Whym Cottage stands on your and Kynnersley Manor on your right and the church on your left. Along this road on the right is the long tall red brick boundary wall of the Manor (Fig 15).

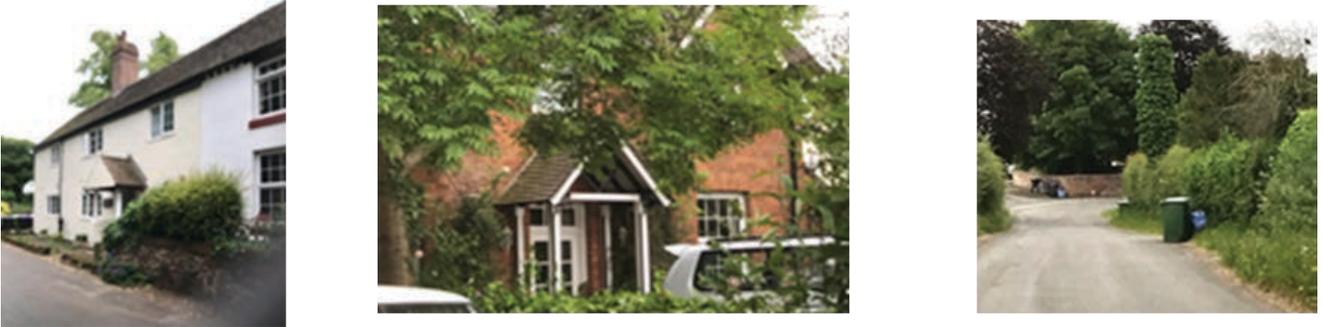
Figure 16: Grey Cottage and Red Brick Wall Boundary

5.37 As you pass the wall on the right, on the left is Grey Cottage and attached later house set gable end onto the street with a fine porch (Fig 16) and converted red brick former threshing barn and a converted timber frame barn which also has a red brick wall as its boundary (Fig 16). At the bottom of the brick wall where it turns into Manor House Farm you reach a Y junction where you can turn sharp left away from the village centre or straight on towards the old Mill area. At this point you can clearly see the two new detached executive dwellings that have been put up recently. The design of this large dwellings do not reflect the general character of the buildings within the proposed boundary. These very large and imposing dwelling should be resisted unless they form part of a comprehensively designed extension that takes into account a variety of house sizes, including farm buildings style and feature the appropriate detailing and materials to fit in with the village.

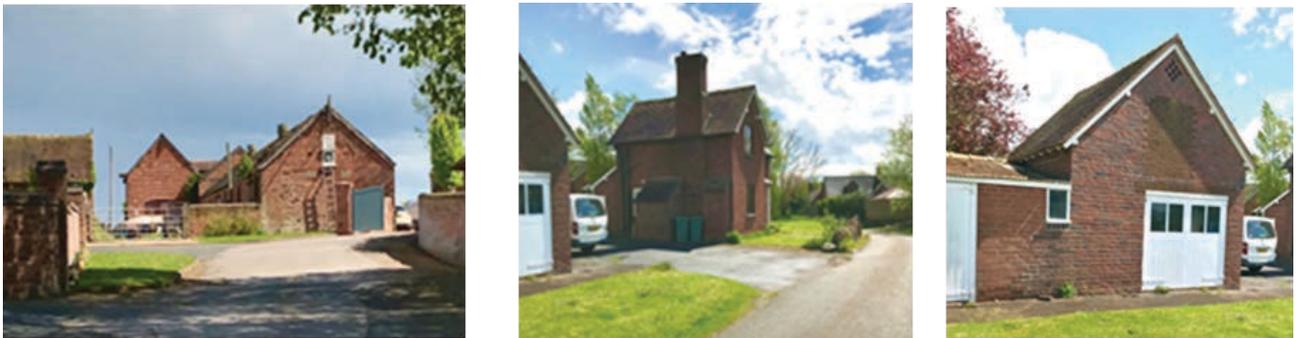
Figure 17: Kynnersley Manor (left) and Victorian Period Housing (middle and right)

5.39 Coming in from this direction into the village the view is of hedging and the start of the village is apparent because of the clear view of Kynnersley Manor's brick boundary wall and the early 18th century farm complex set next to the manor (Fig 17).

5.40 There are a few further buildings up the lane but only one notable dwelling and former coach house now a garage both dating from the Victorian period and the low brick wall on the left (Fig 17).

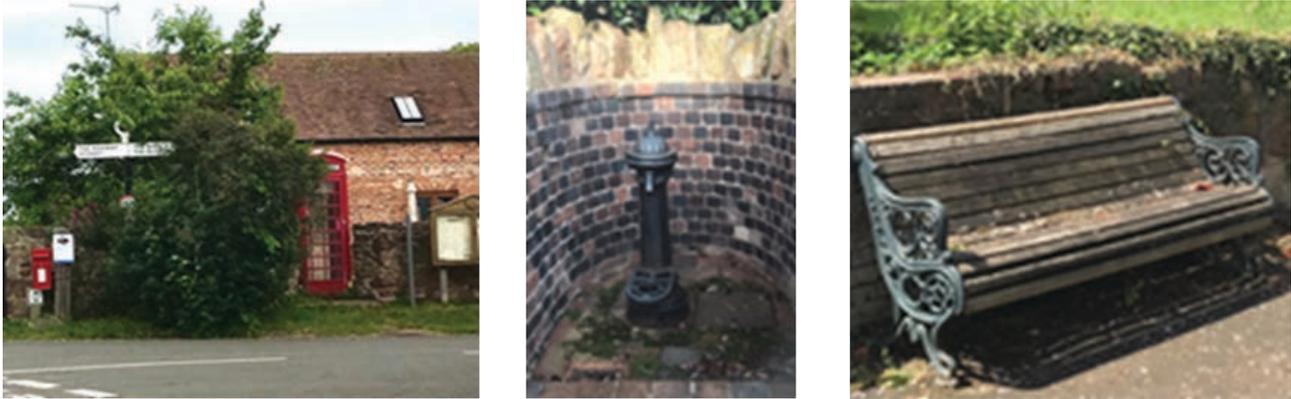
Figure 18: Telephone Box (left) Hydrant (middle) and Victorian Cast Iron Seat (right)

5.41 An old wooden road sign, parish notice board (now replaced with a new one, the old one is being refurbished and will be placed in some other location in the village) and an old red telephone box (Fig 18).

5.43 There is also a fine Victorian cast iron seat set along the wall by the church, placed there by kind donation of one of the Parish Councillors (Fig 18).

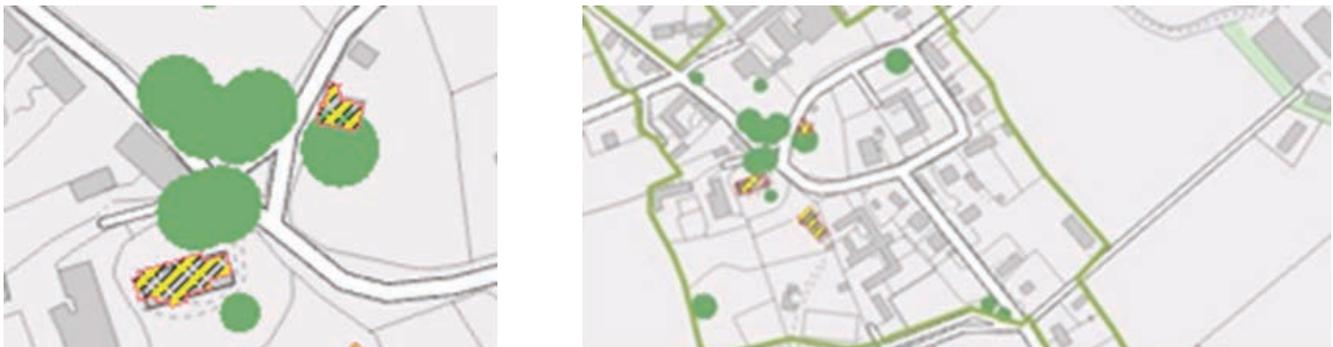
Figure 19: Tree Preservation Orders

5.44 Trees are in the abundance within the proposed boundaries the main Tree Preservation Orders are grouped around the church and Kynnersley Manor (Fig 19).

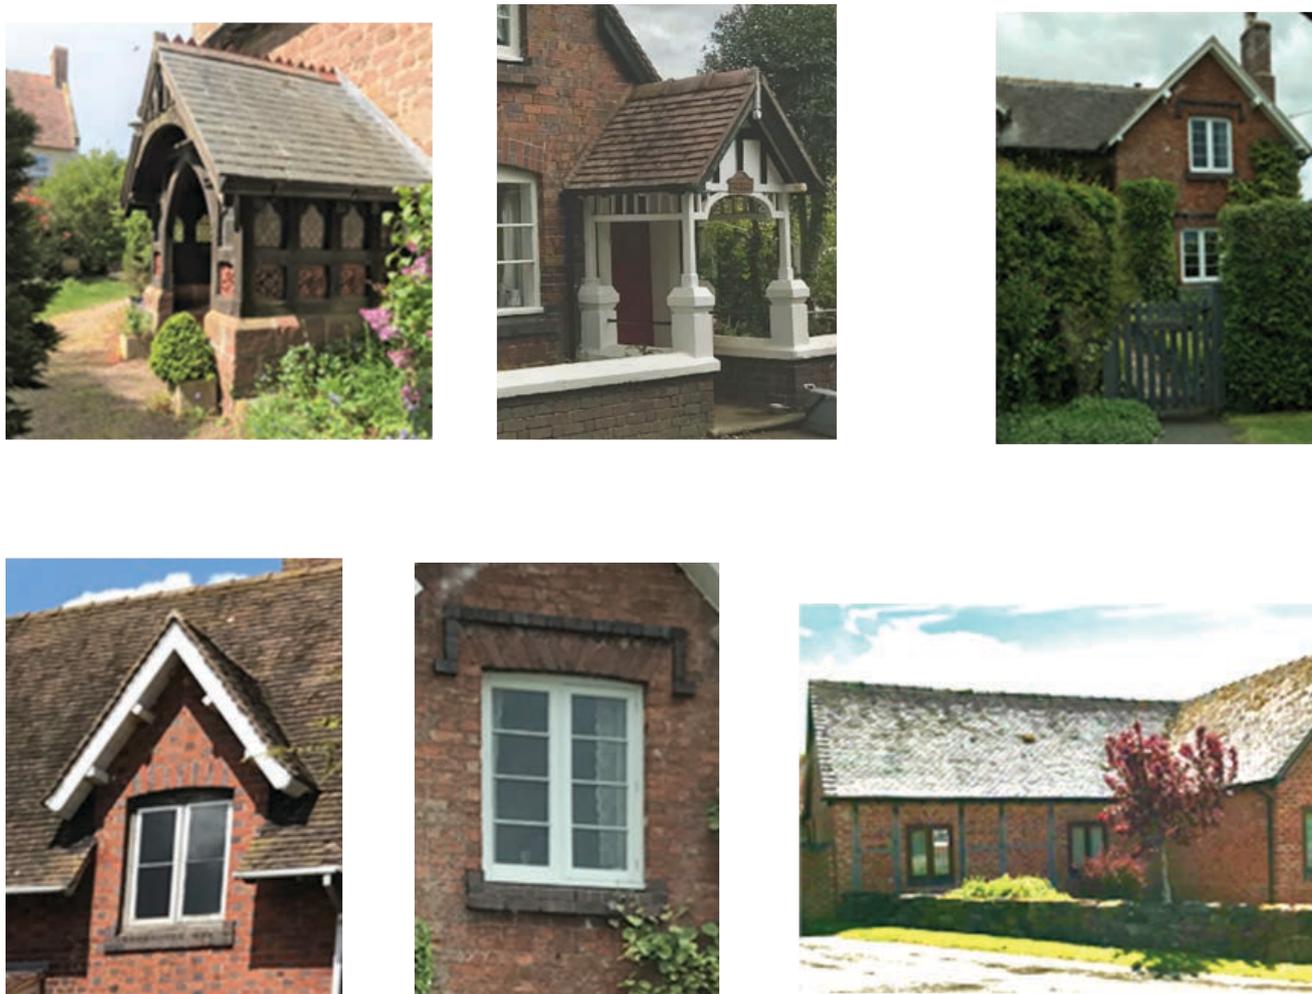
Figure 20: Porch (top left) The Villas (top middle) and converted farm buildings

7.4 The architectural influence is mid Victorian neo-gothic with gables and cut through dormers, drip moulds and decorative porches. The porches are more decorative the more important the house (Fig 20). The Villas, (Fig 20), was originally the village Blacksmith and shop.

7.6 The farm buildings were almost comprehensively replaced within the village by the mid-19th century investment. There is two exceptions one now is converted to a house in the late 20th century (Fig 20) and the barns next to the rear of the Kynnersley House with a date stone of 1816.

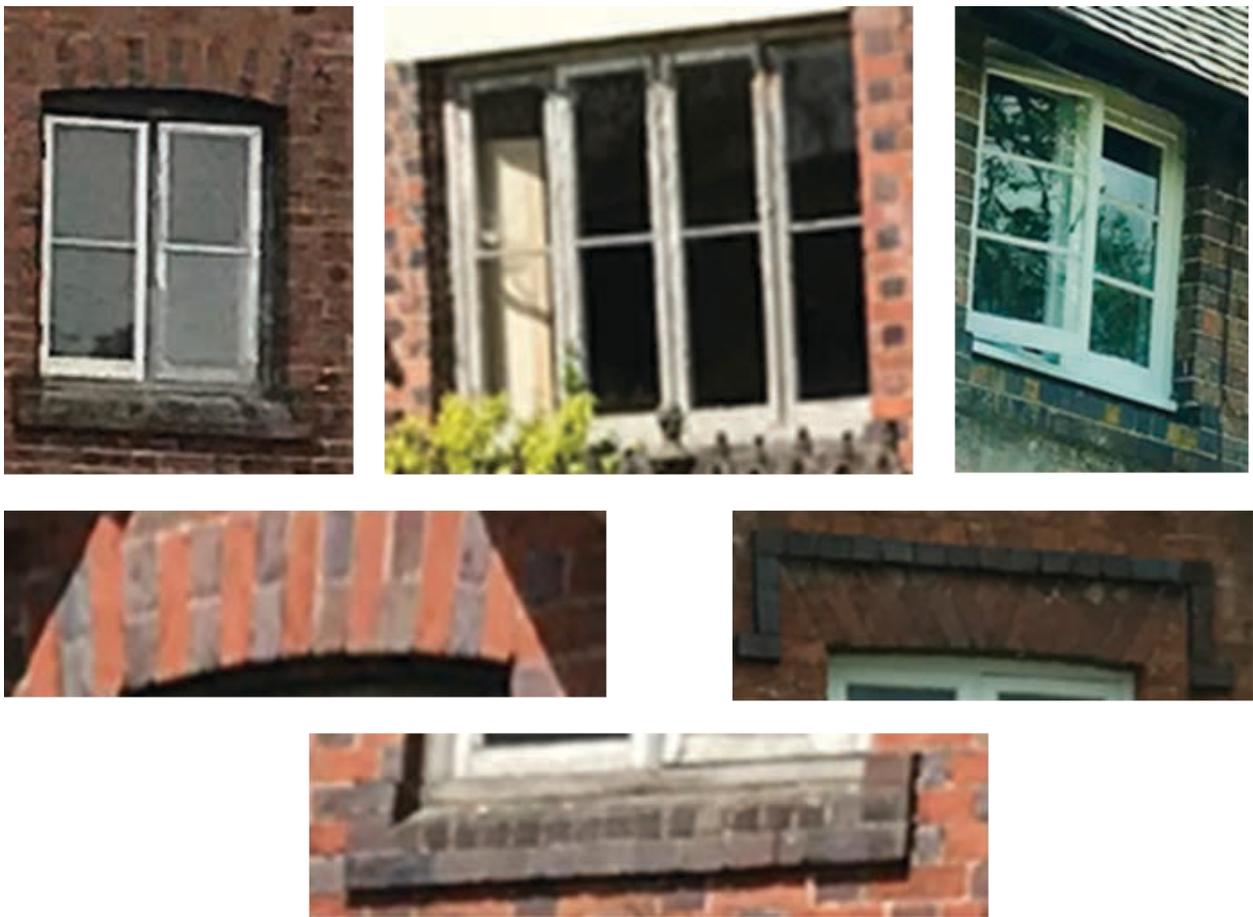
Figure 21 Windows and Brick Drip Mould

7.8 The original window styles follow the estate design in the Victorian buildings, mainly one over one side hung casement windows (Fig 21 top left) varying only in relation to the status of the building where it is the number of sashes side by side (some fixed) that create the sense of status these larger windows (Fig 21 top middle) are found on the more prominent elevations. The Old School House and Kynnersley Manor have small paned windows in difference to the other estate houses of the same period.

7.9 The windows are set close to the eaves on many of the earlier dwellings (Fig 21 top right) and on the Victorian estate cottages are mainly found with decorative rubbed brick arch using red and black bricks to create the decoration or a brick drip mould above and below (Fig 21 bottom three). The drip moulds project a half a brick to provide suitable shadow lines.

7.11 There have been many replacements of the original windows with uPVC windows some more successfully than others. This is a threat to the character of the conservation area.
