Telford & Wrekin Council Wellington Conservation Area Appraisal & Management Plan

2022

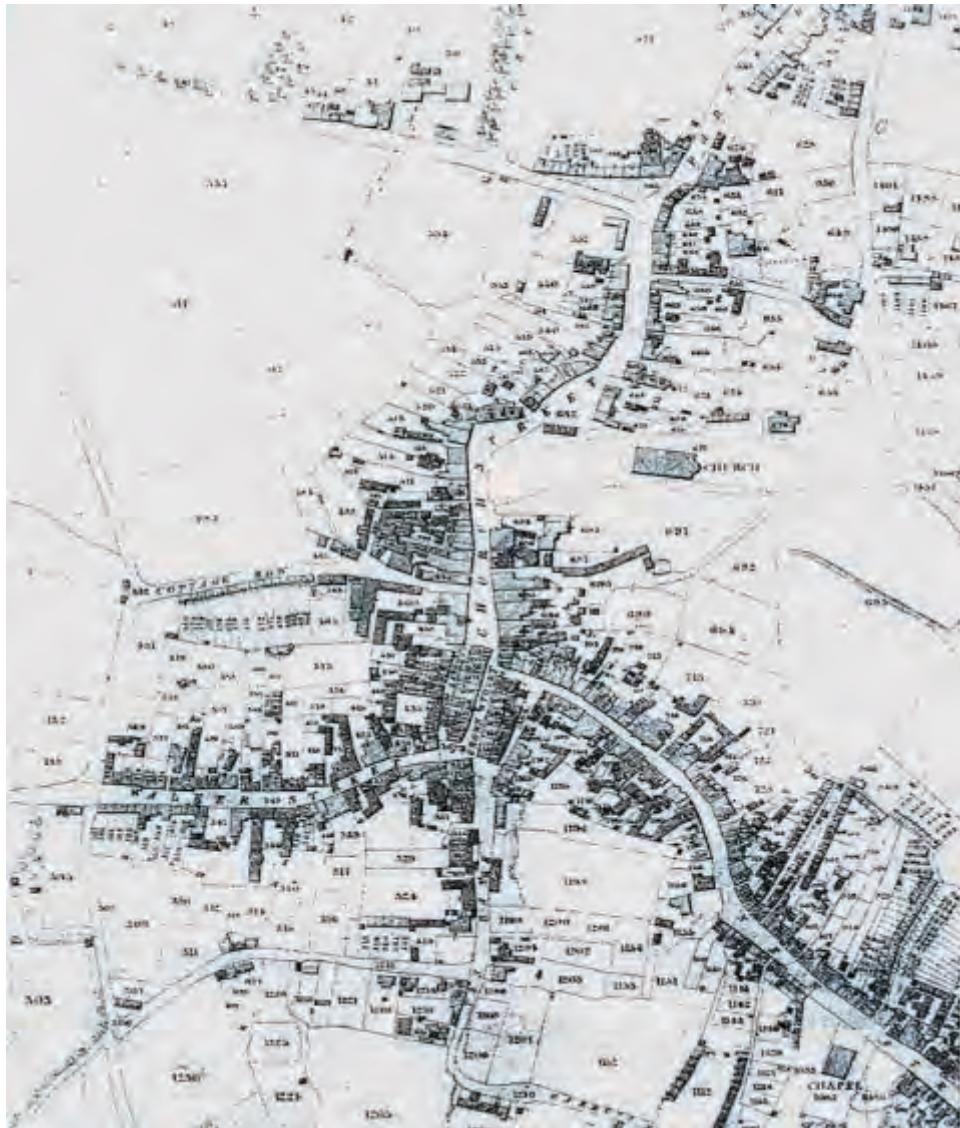
Figure 2: Historic Map of Wellington, 1840

4.7 The 1840 map in Fig. 2 below shows the layout of Wellington before the arrival of the railway line in 1849. Walker Street, New Street and Church Street radiate out from the cluster of narrow streets still evident today at the heart of the Conservation Area. Butchers Row (now Market Street), incorporates a long terrace of humble dwellings, all now demolished.

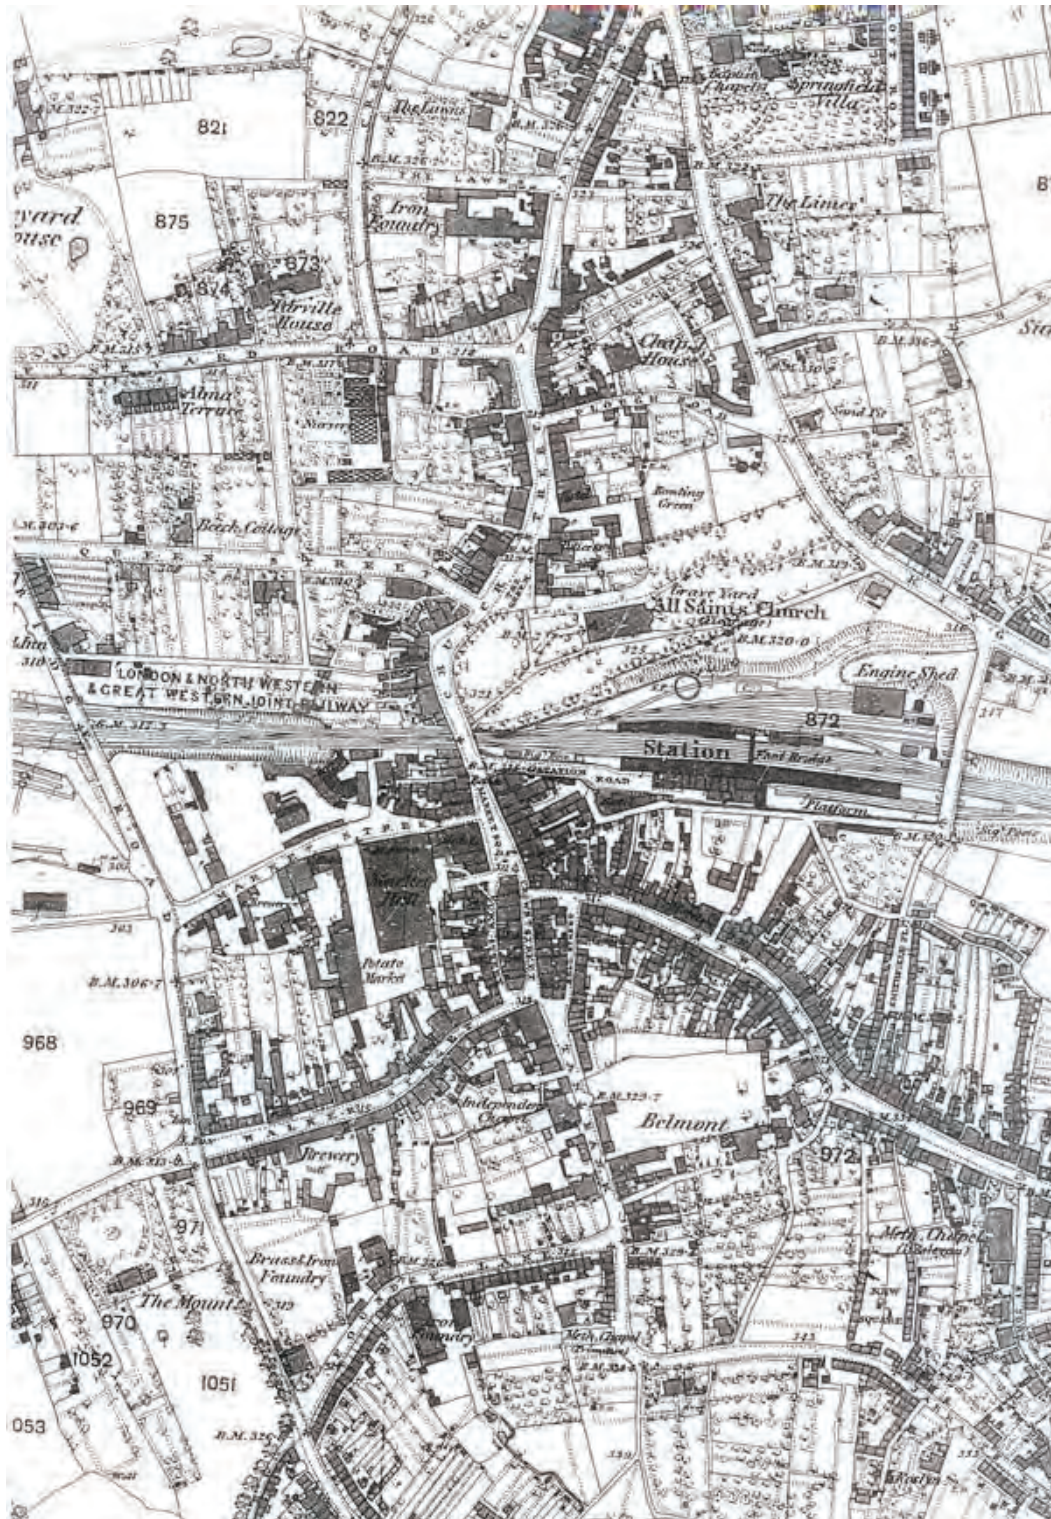
Figure 3: Historic Map of Wellington, 1882

4.8 The Ordnance Survey map of 1882 shown in Fig.3 below indicates the impact on Wellington of the railway and its associated sidings, turntable and engine shed. Wellington grew to be an important railway junction, with lines to Stafford, Crewe, Much Wenlock and the East Shropshire coalfield as well as the 'main' line train between Shrewsbury and Birmingham. The new Market Hall building is also evident.

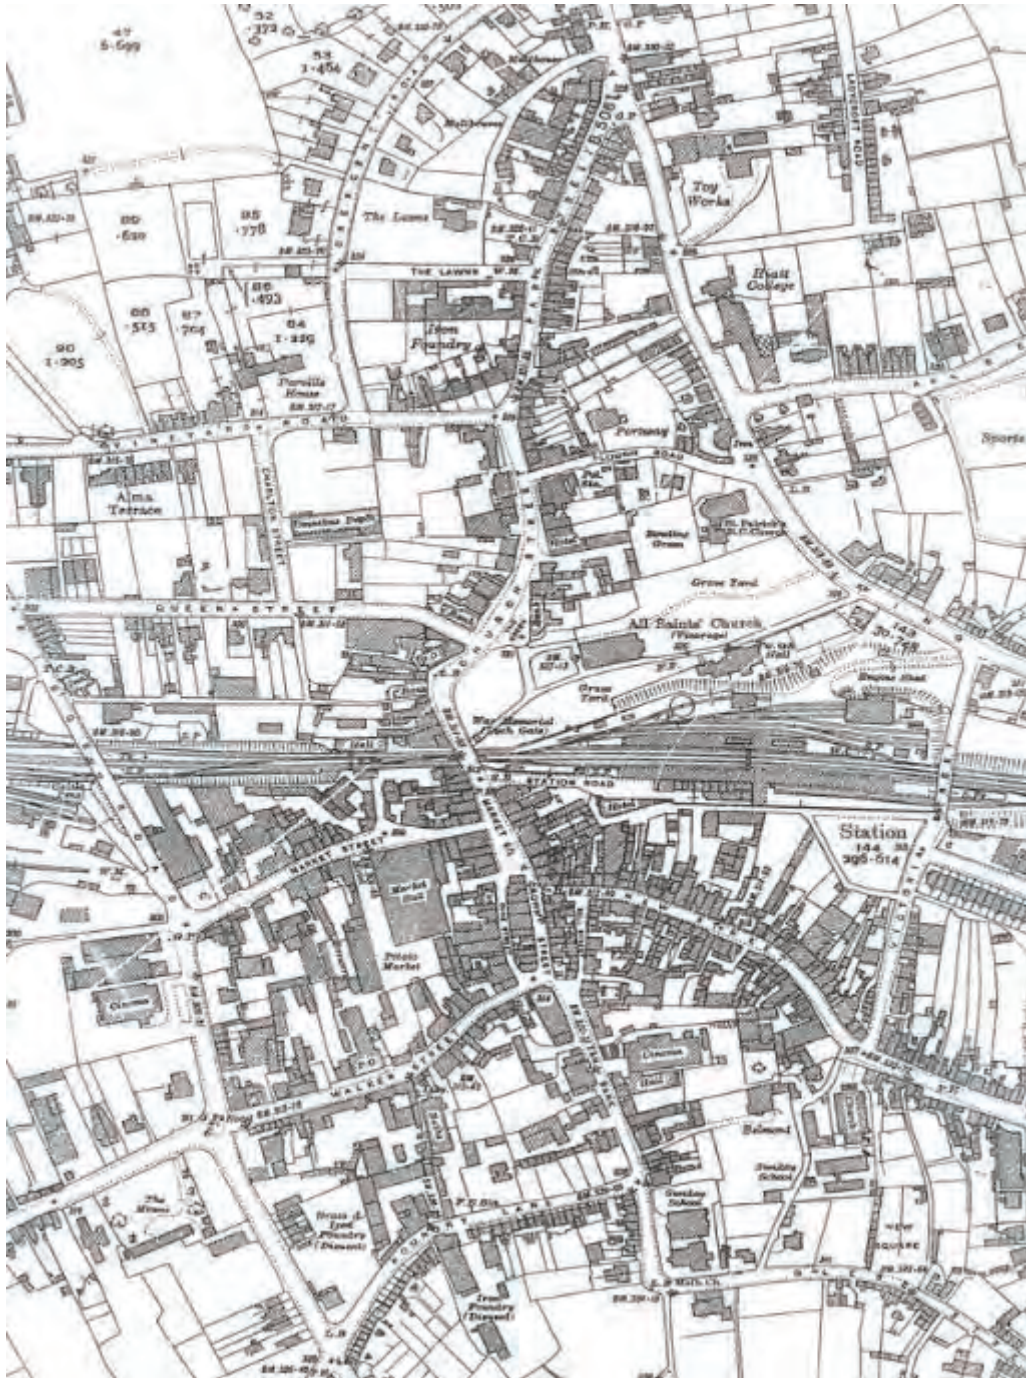
Figure 4: Historic Map of Wellington, 1939

4.10 Between 1882 and 1939 there is relatively little change in the Conservation Area, as seen in the Ordnance Survey map of 1939 shown below in Fig. 4. There is some intensification of development in Market Street, a new Post Office building in Walker Street and some development infilling around the periphery of the town centre. Outside the tight-knit cluster of streets which still form the core of the town, development is much looser and more suburban in character.

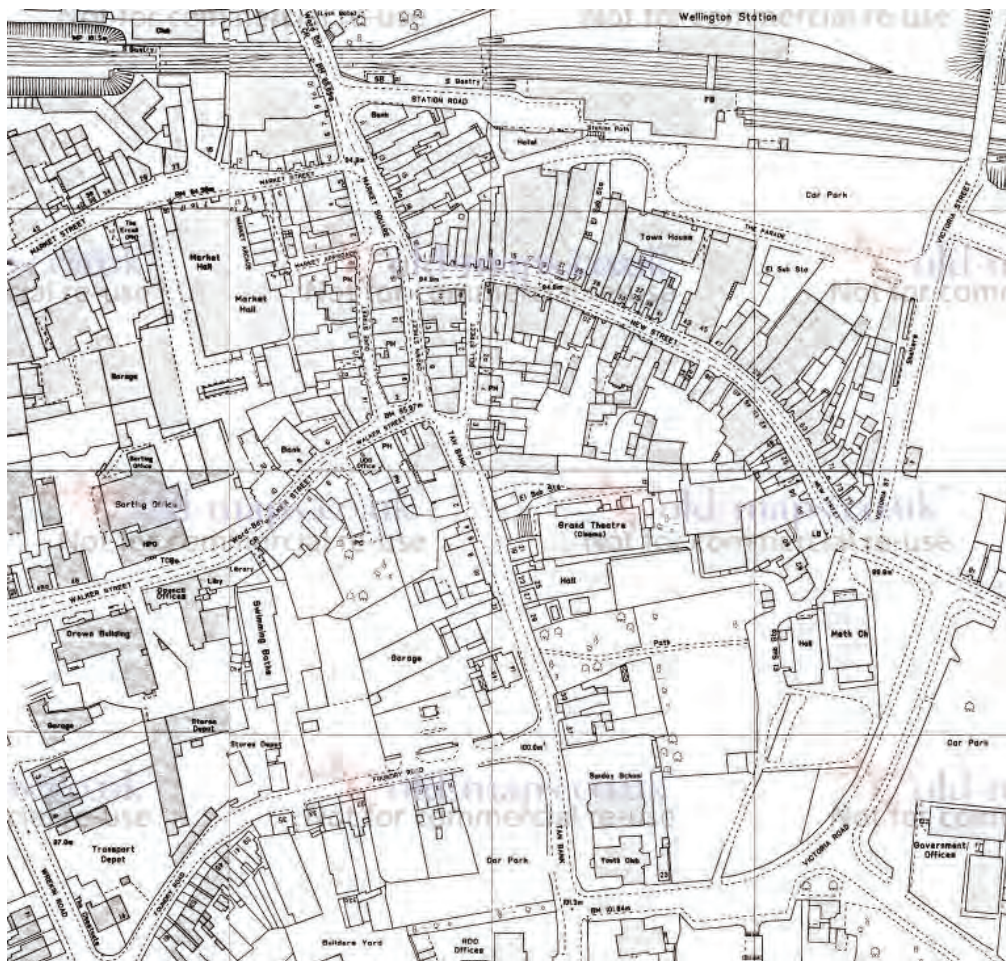
Figure 5: Historic Map, Plan of 1974 (1:1250)

4.15 The post-war period saw the most radical change to Wellington's built fabric, especially around the periphery of the town centre with the construction of the town centre ring road, as shown on the map in Fig. 5. By 1974, construction had commenced along the south-east periphery of the town (Victoria Road). This resulted in the demolition of buildings, especially terraced properties, though the medieval core has remained intact. Designation of the conservation area in 1982 may have been in reaction to further redevelopment pressure on Wellington. Such pressure was commonplace in many market towns during the 1960s and 1970s and led to some of the country's best historic buildings being added to the statutory list in 1983.

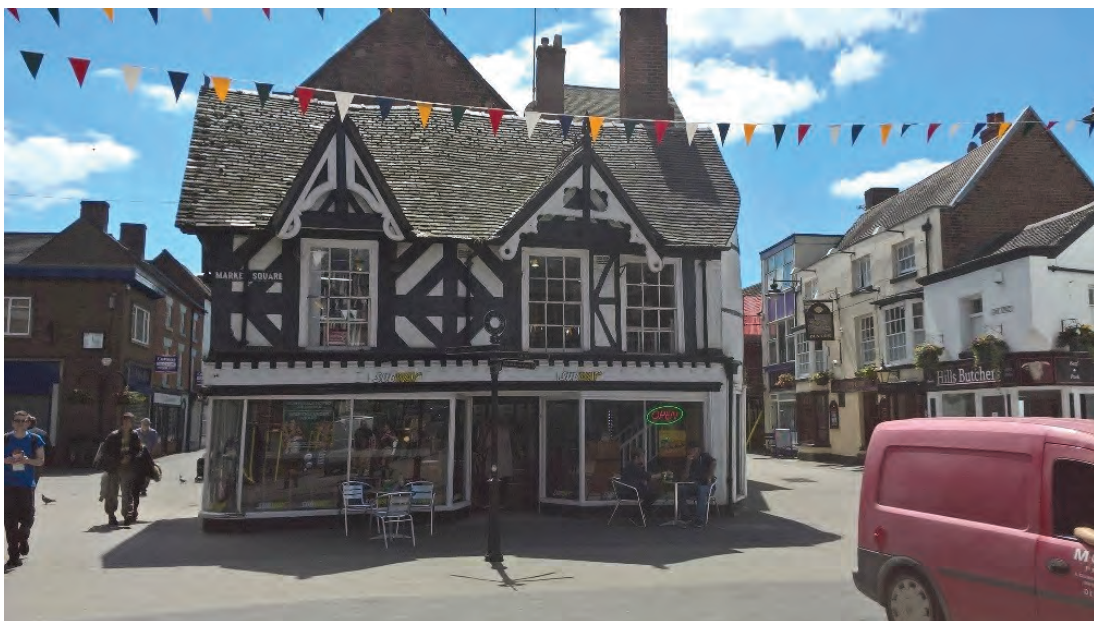
5.5 The Grade II listed building at No. 1 Market Square (southern end) forms an important landmark within the town centre with its distinctive black and white timber frame and decorative bargeboards on the upper storey dormers. It dates from the late 16th/early 17th century, with later 18th and 19th century alterations. The right hand end is in facing brick, although painted black and white to match the existing timber framed portion of the building.

Figure 7: No. 1 Market Square

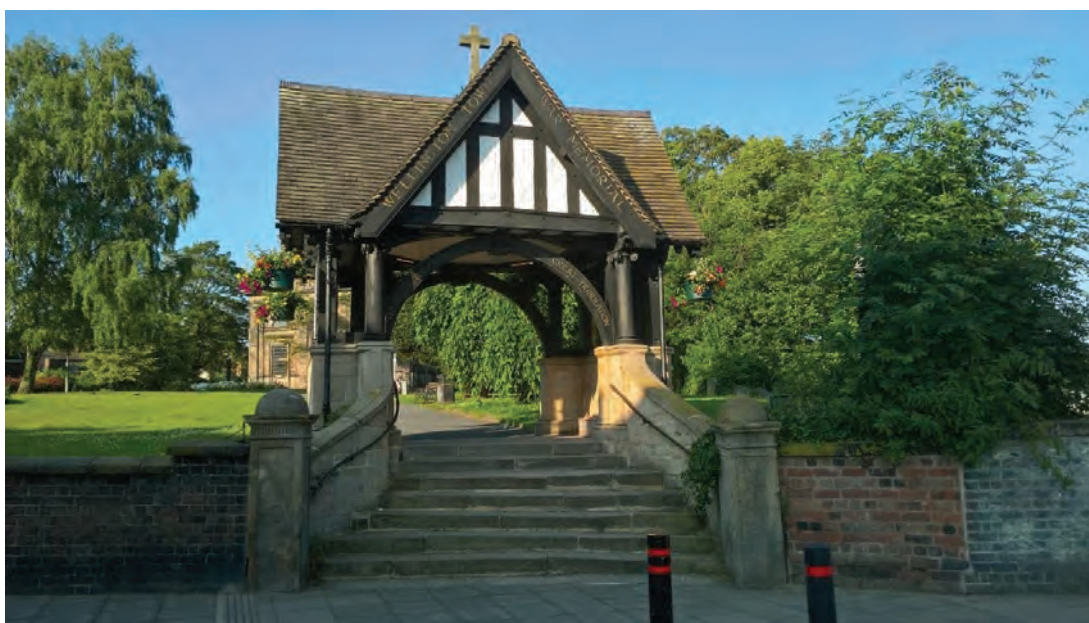
Figure 9: Lychgate Memorial

5.7 The Lychgate Memorial structure in the south western corner of the churchyard of All Saints' Church is a Grade II listed memorial to the fallen in the two World Wars of the 20th century. Built in the Arts and Crafts style and erected in 1922, it is a distinctive landmark and an attractive gateway to the open space beyond. It also forms a formal gateway to All Saints' Church and frames the church building.

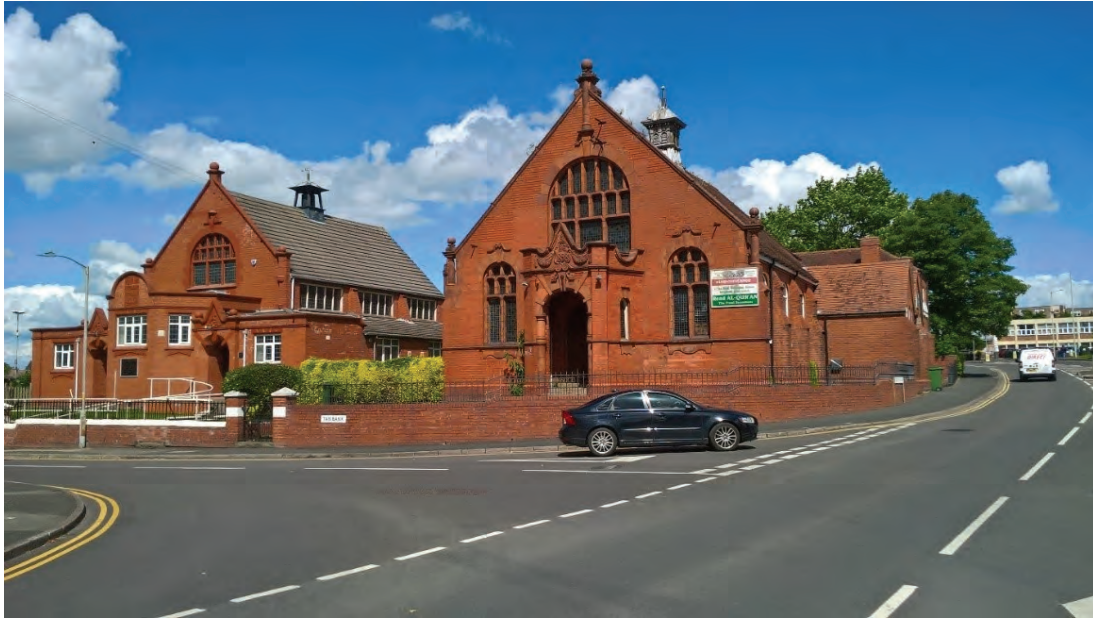
Figure 10: Bethel Apostolic Church (left) and Telford Central Mosque (right)

5.8 Prominently situated at the corner of Tan Bank and Victoria Road is a locally listed Arts and Crafts red brick chapel with teracotta dressings, a wooden bellcote over the roof and a porch with large voussoirs and bulbous pilasters. Built in 1898 as a Primitive Methodist chapel, it closed in 1966 and was sold to the Muslim Community. Adjacent to the chapel is the chapel's former Sunday School, which was built in 1906 and is now used by the Bethel Apostolic Church as a Sunday school and youth premises.

5.32 The south end of Tan Bank terminates abruptly at the junction with the ring road, with the previous remainder of Tan Bank now buried under modern development. Fortunately, the former Primitive Methodist Church and Sunday School (see Figure 10) were preserved and now sit proudly on the south eastern end of this truncated road.

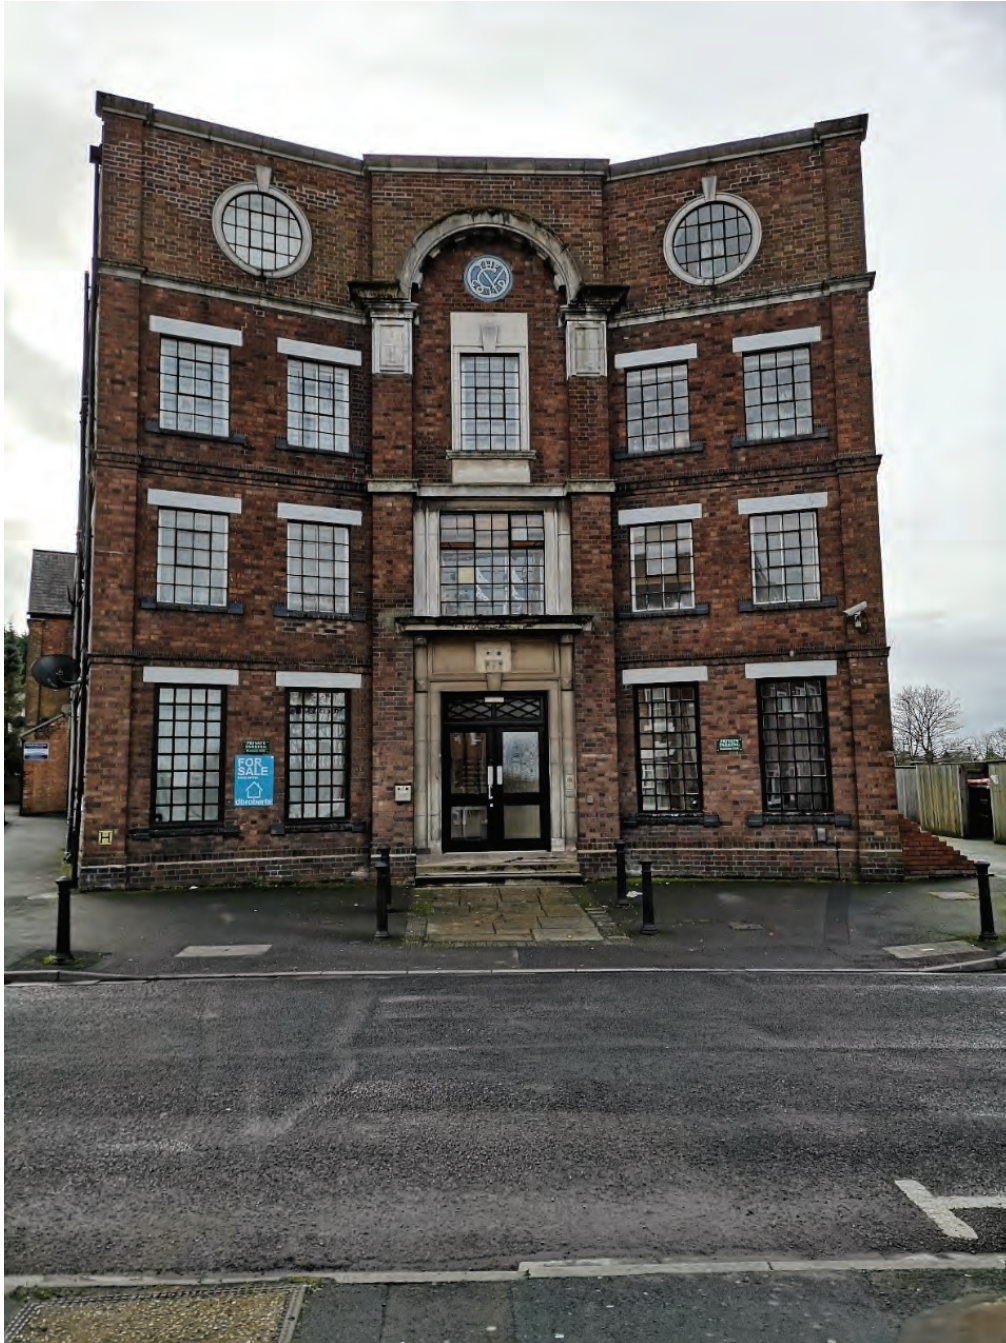
Figure 11: Former Chad Valley Toy Company Factory

5.9 Originally built in 1836 as a Methodist Chapel, the building was purchased in 1916 by Johnson Bros of Birmingham and became the Wrekin Toy Factory, later the Chad Valley Toy Company which produced the popular Sooty plush bear at this site until the factory's closure in 1975. Now a block of flats, the Chad Valley Toy Company logo is still visible on the front of this imposing four storey brick building, with its unusual angular concave façade featuring oculi on either side of a central arched projection.

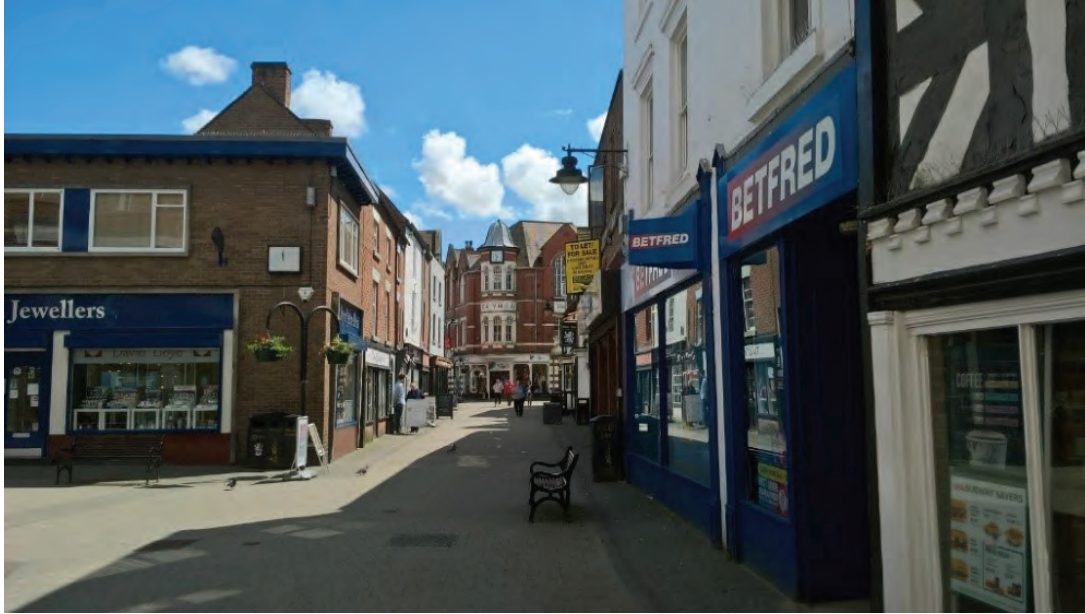
Figure 19: YMCA's distinctive cupola seen from Market Square

5.20 The YMCA building at the junction of Crown Street, Walker Street and Tan Bank, incorporates a distinctive corner treatment with a complex roof form, creating a landmark at the end of the vista along Crown Street. The building has a rich variety of architectural detailing and materials, including painted ashlar dressings, stained glass windows and a leaded cupola.

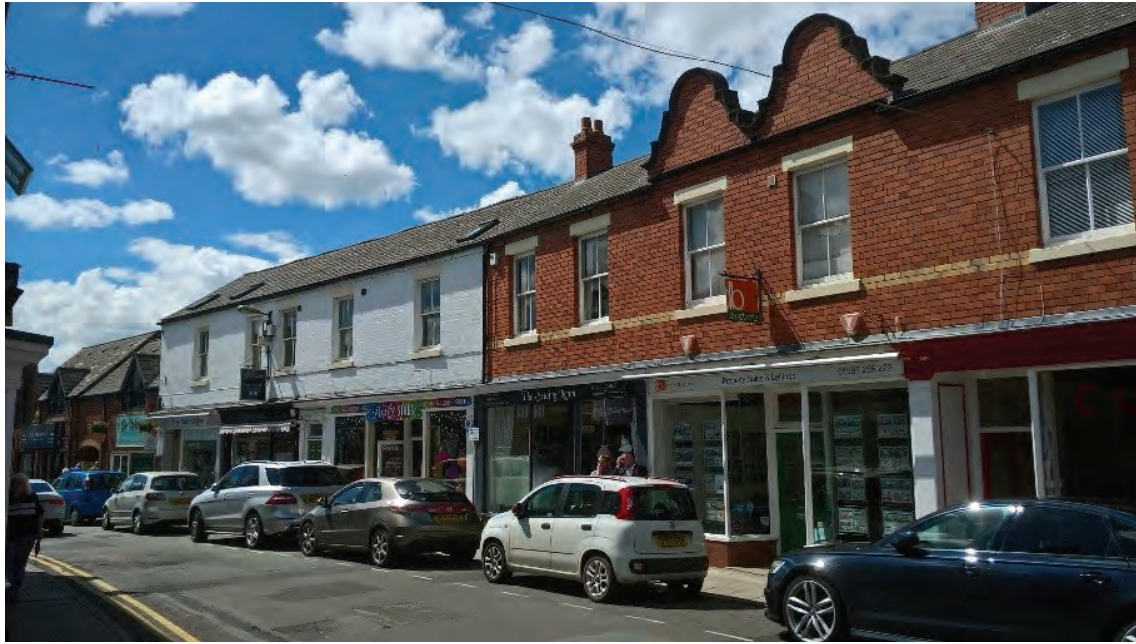
Figure 23: Sash windows and timber shopfronts on Market Street

5.23 The splayed building line with its varied street width creates an interesting space within Market Street. Particularly notable are the corner treatments of some plots and how the buildings ‘turn the corner’. The buildings also demonstrate a rich variety of building materials, consisting of facing red brick and ashlar dressings. Sash windows pre-dominate, giving a formal appearance along the street scene. A good number of historic timber shop fronts survive.

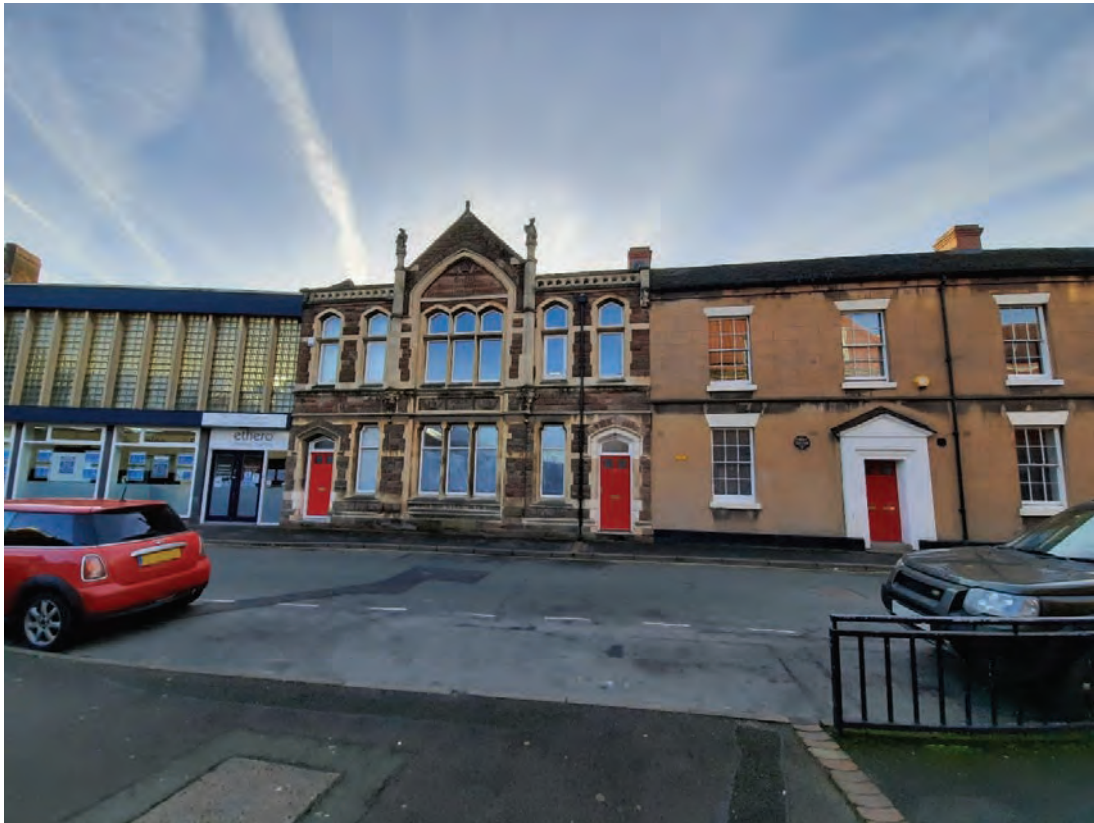
Figure 28: Walker Street Workhouse (right), Library (centre) and library extension (left)

5.28 The older part of the former Library was originally built as the Union Workhouse, and subsequently became the Union Brewery. The 20th century extension to the left was built on the site of two houses.

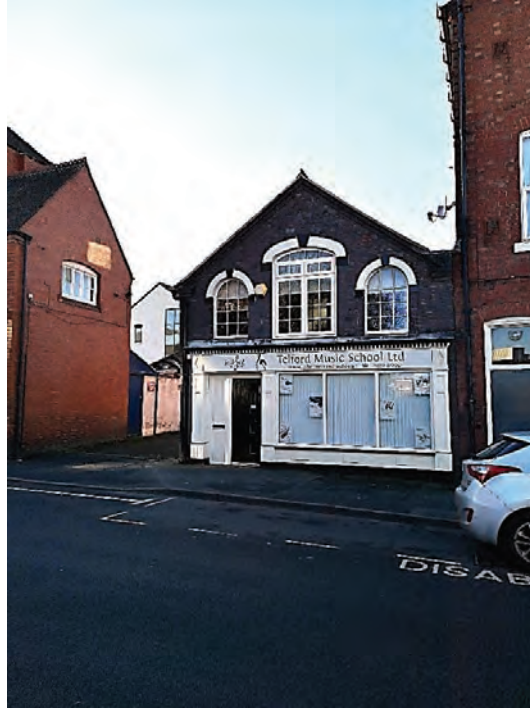
5.30 The buildings along Tan Bank are an indiscriminate mix of different scales and massing, with a varied roofline and inconsistent alignment of the street frontages. Nonetheless, the street retains a certain quirky charm as seen in the juxtaposition of tiny No. 4 Tan Bank (music school) dwarfed on either side by No. 2 and No. 8 Tan Bank.

Figure 30: No 4 Tan Bank is dwarfed by its neighbours on either side

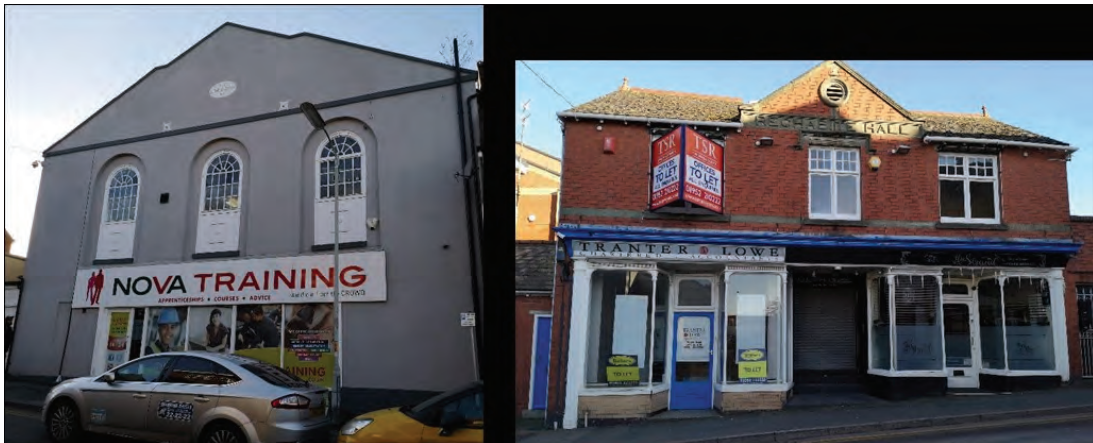
Figure 31: Noteworthy buildings on Tan bank include Nos. 8-10 (left) and 23-27 (right)

5.31 Notable early buildings which still survive on Tan Bank include the imposing Nova Training on the west side of the street building with its Regency windows, built in 1825 as an Independent Congregationalist chapel and the 1927 Rechabite Hall on east side of the street with its handsome red brick Flemish bond upper story and charming original shop frontage at ground level. The signage here is of an appropriate scale and style, making a pleasing change from the poor quality shop fronts often found in the town centre.

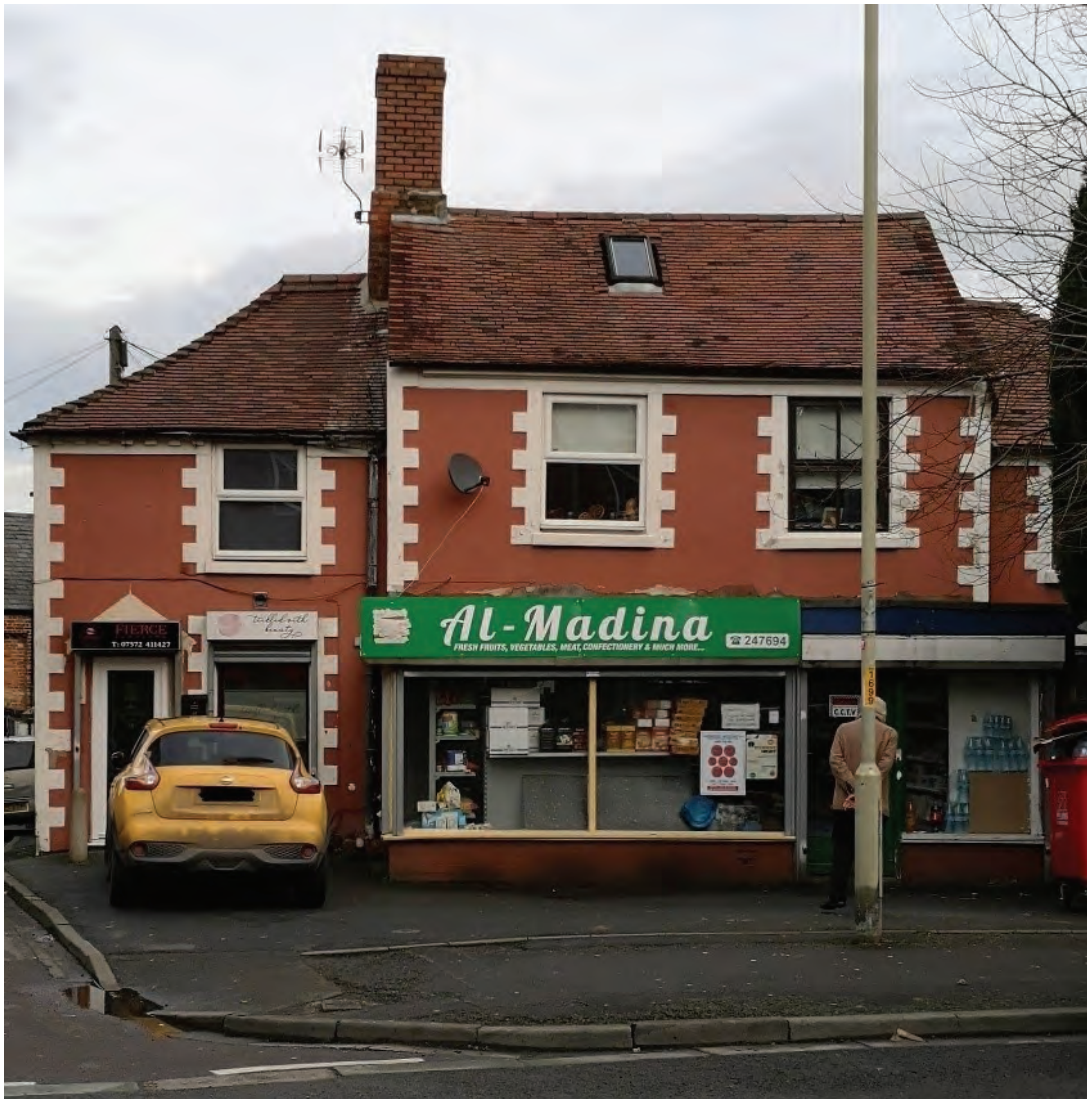
Figure 34: 49-53 High Street appears delightfully out of step with its neighbours

5.35 The High Street's frontage retains a consistent alignment and character similar to that found in New Street, with the notable exception of No. 49-53 High Street, which is set back from the street front and tucked up tightly against New Hall Road instead. The fact that the building is also architecturally very different from its neighbours makes it all the more interesting.

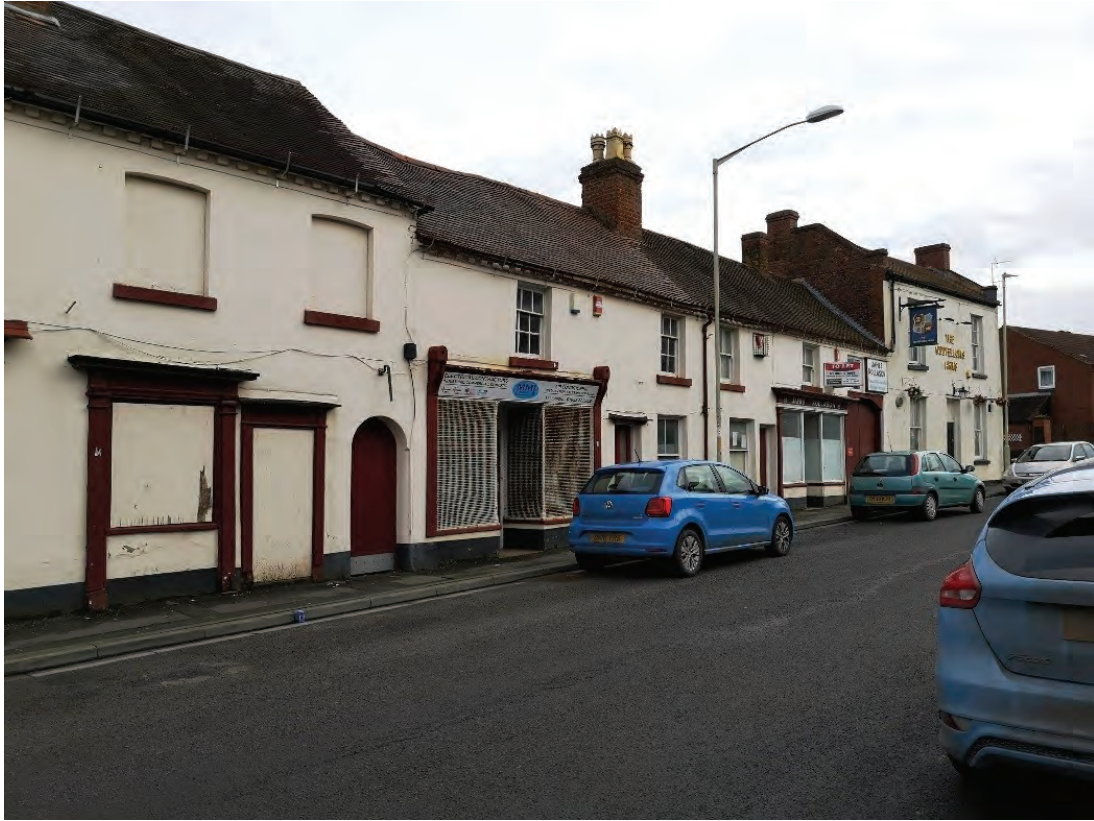
Figure 35: Vacancies such as these at 55-63 High Street are challenging to fill

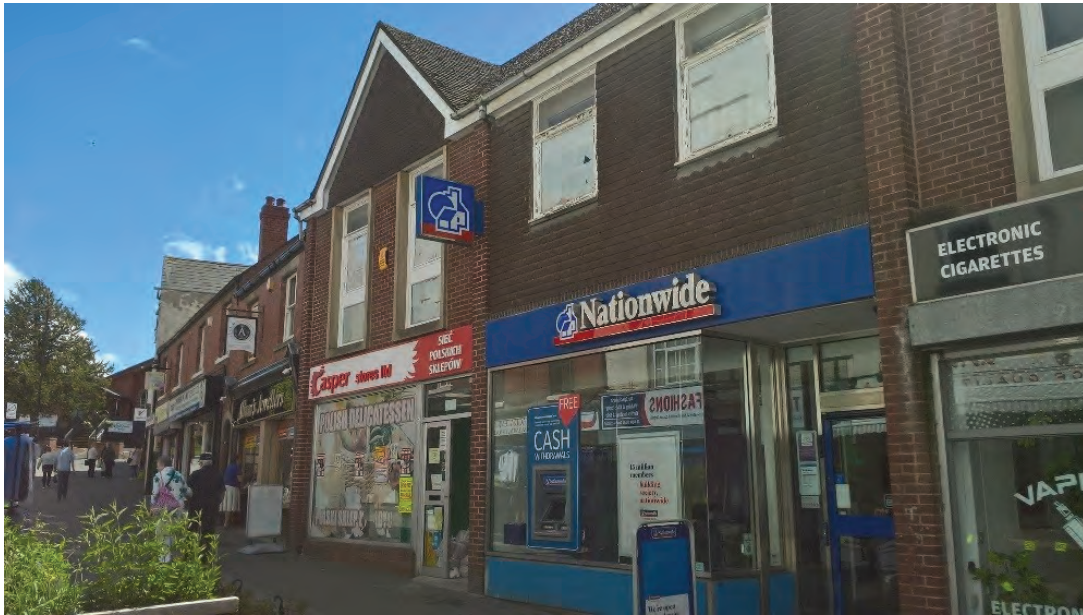
Figure 37: New Street

5.38 New Street retains a good continuity of built development to either side of the street, despite the extent of 20th century development which has replaced earlier buildings. The narrowness and intimacy of the street has also been retained, although the block paving, found throughout the pedestrianised area of the town centre, does not do justice to the quality of the buildings around it. There is, generally, a welcome lack of street furniture, signage and clutter.

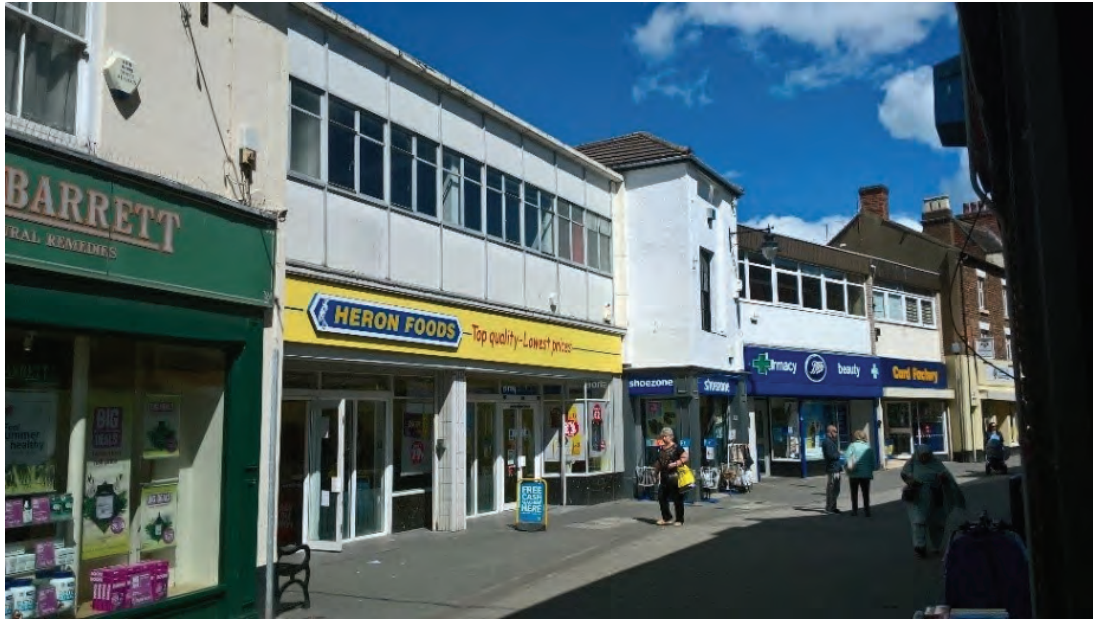
Figure 38: Historic 19 New Street rises above its 1960s neighbours

5.39 Buildings such as 19 New Street which are at the 'elbow' of the subtle bends in the street are particularly prominent in the streetscape. It is therefore all the more unfortunate that the historic 19 New Street is flanked on either side by the poor quality 1960s development at 15-17 New Street and 21-27 New Street. The horizontal bandings of fenestration are at odds with the more vertical rhythm of the traditional buildings in the area and the materials and detailing are not in keeping with the more historic buildings nearby. The narrow widths of the original burgage plots are not reflected in the scale and massing of the building and the uniformity of the roof line is in contrast with the more varied treatment elsewhere in New Street and the surrounding area.

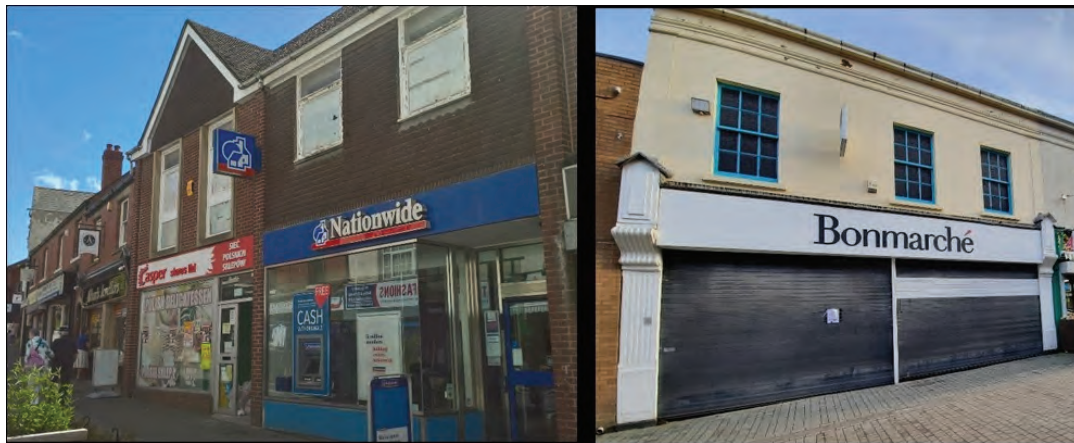
Figure 39: 44 and 46 New Street (left) and 55 New Street (right)

5.40 With regard to modern infill buildings, the simplicity of the fenestration detailing on the Nationwide premises at No. 44 New Street is preferable to the more elaborate treatment of the property to its immediate left at No. 46. Neither of these buildings, however, match the attractive detailing of No. 55 New Street.

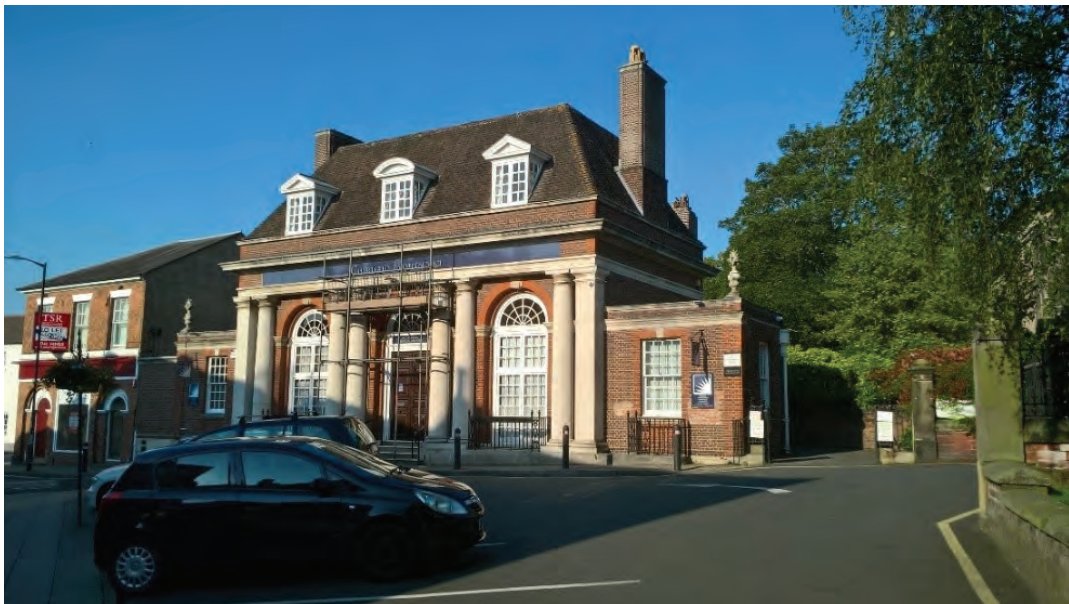
Figure 41: No. 6 Church Street

5.41 The former bank building of 1926 at No. 6 Church Street provides a dominant and distinctive structure adjacent to 'The Green', which is fronted by a car parking area. The angle of the building line helps to define the space and provides an attractive transition into the northern part of Church Street.

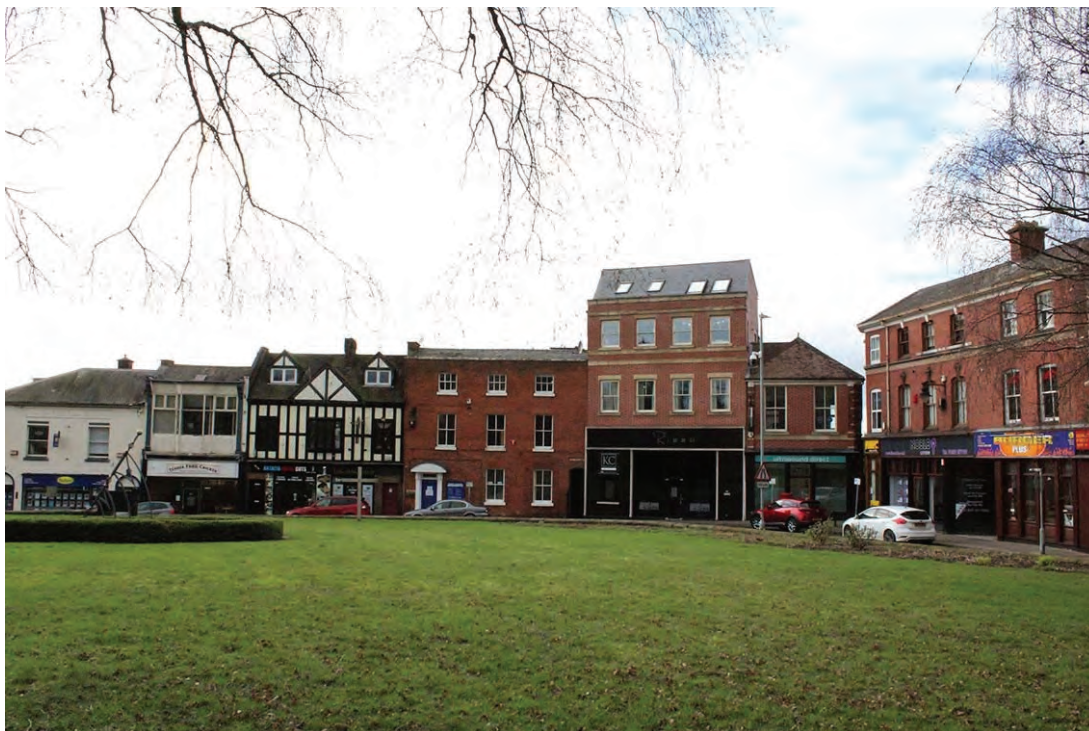
Figure 42: The buildings nearest The Green harmonise in an interesting street scene

5.42 The buildings around the perimeter of the western fringe of the churchyard area along Church Street provide an eclectic range of architectural styles, building materials and architectural detailing. Despite the contrast, the buildings form an interesting composition that tends to work well given the reasonable consistency of the plot widths, fenestration and two-storey and

three-storey buildings heights. The plot widths are, typically, wider than in the Market Square and with a greater uniformity of scale. The gentle slope provides further interest as the buildings step down towards the railway bridge.

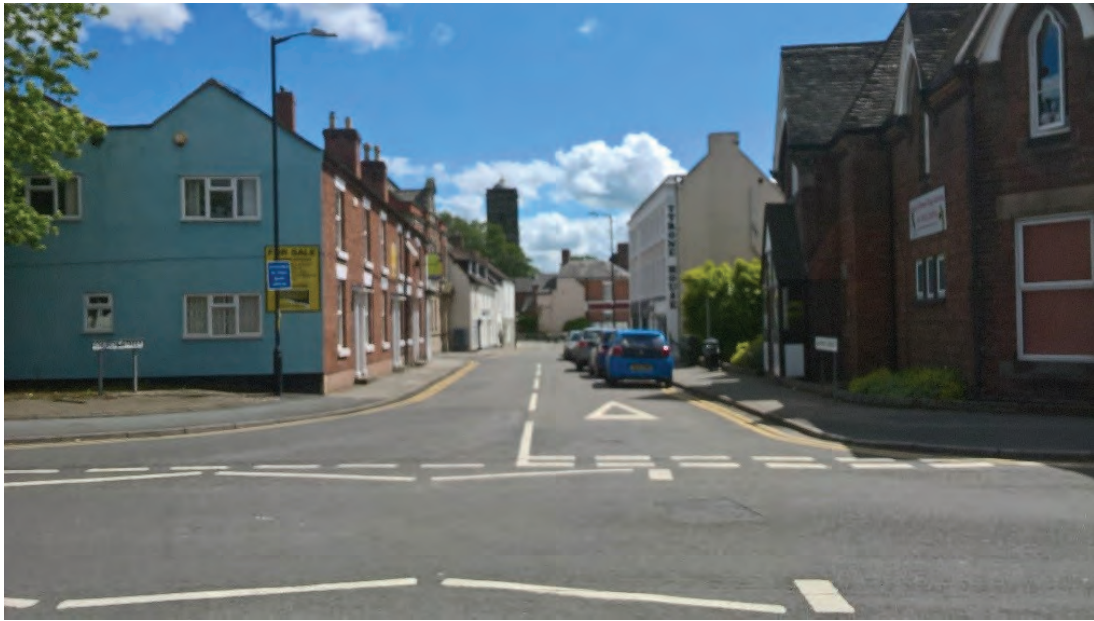
Figure 43: The view south on Church Street from Vineyard Road

5.43 Looking south down Church Street at the junction with Vineyard Road, the bend in the street forms a good visual enclosure, which is enhanced by the tower of All Saints' Church beyond. There is a pleasing mix of architectural styles and building character, with the simple two storey brick cottages on the left, the listed three storey, 18th century Tyrone House and the substantial mass of No. 24 Church Street, dated 1896, with its decorative stonework and entrances.

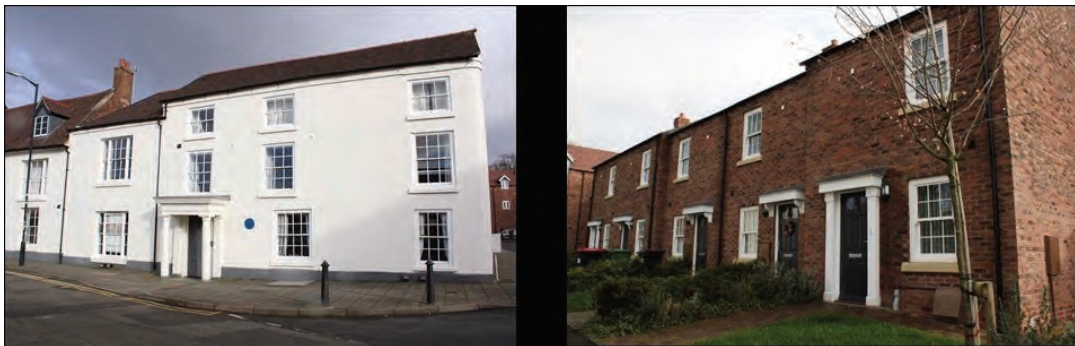
Figure 44: The architectural charm of the former Charlton Arms Hotel is reflected in new dwellings nearby

5.44 The former Charlton Arms Hotel forms a prominent building group at the bend of Church Street and encloses views to the north from the areas adjacent to All Saints' Church. These Grade II listed buildings date from the 18th and 19th centuries and have been converted to residential dwellings.

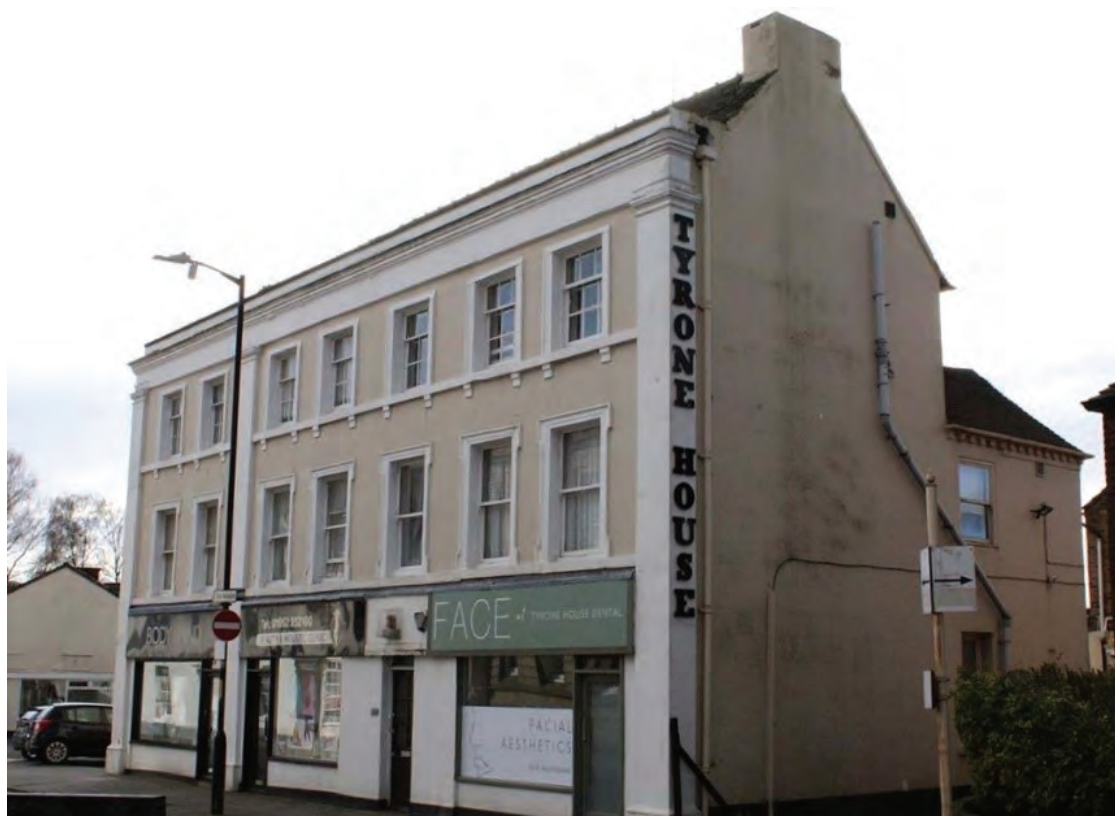
Figure 45: The Tyrone House on Church Street

5.45 The Grade II listed, stuccoed Tyrone House with its slightly quirky giant off-centre pilaster. The modern shop fronts are somewhat crude with overly deep fascias.

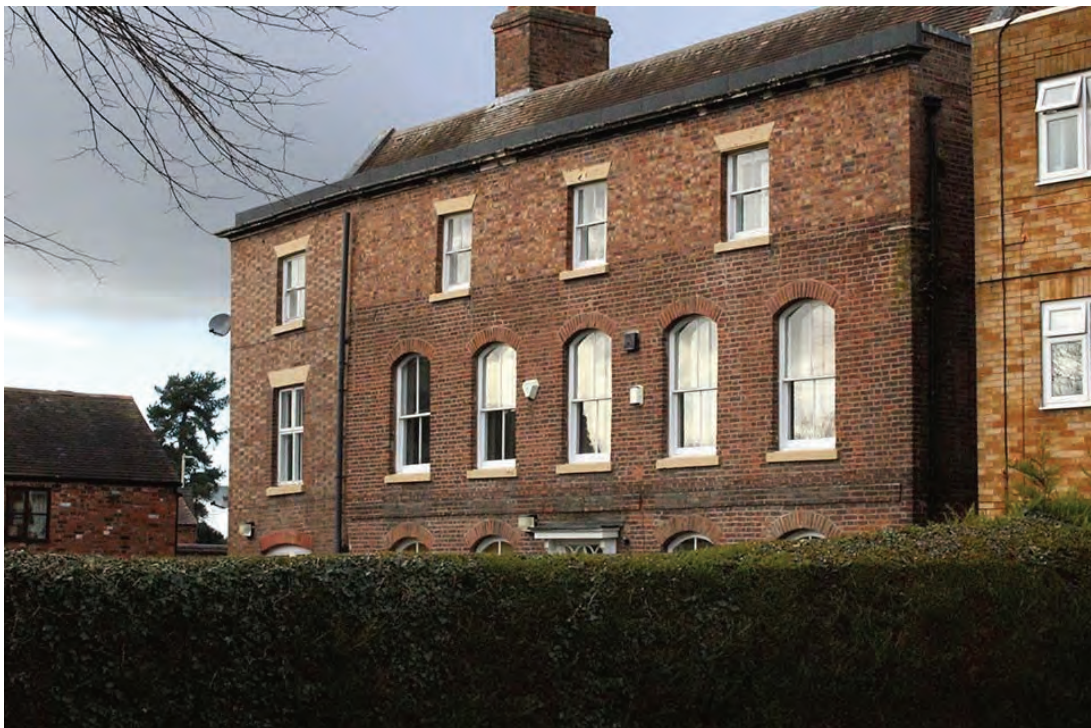
Figure 51: Portway House still retains its sense of grandeur

5.50 On the north side of Plough Road is the stately Grade II listed Portway House. This sprawling 18th century three-storey brick building rises above its humble cottage neighbours to the west and dominates the street scape, despite being considerably set back from the road.
