Telford & Wrekin Council Wellington Conservation Area Appraisal & Management Plan

2022

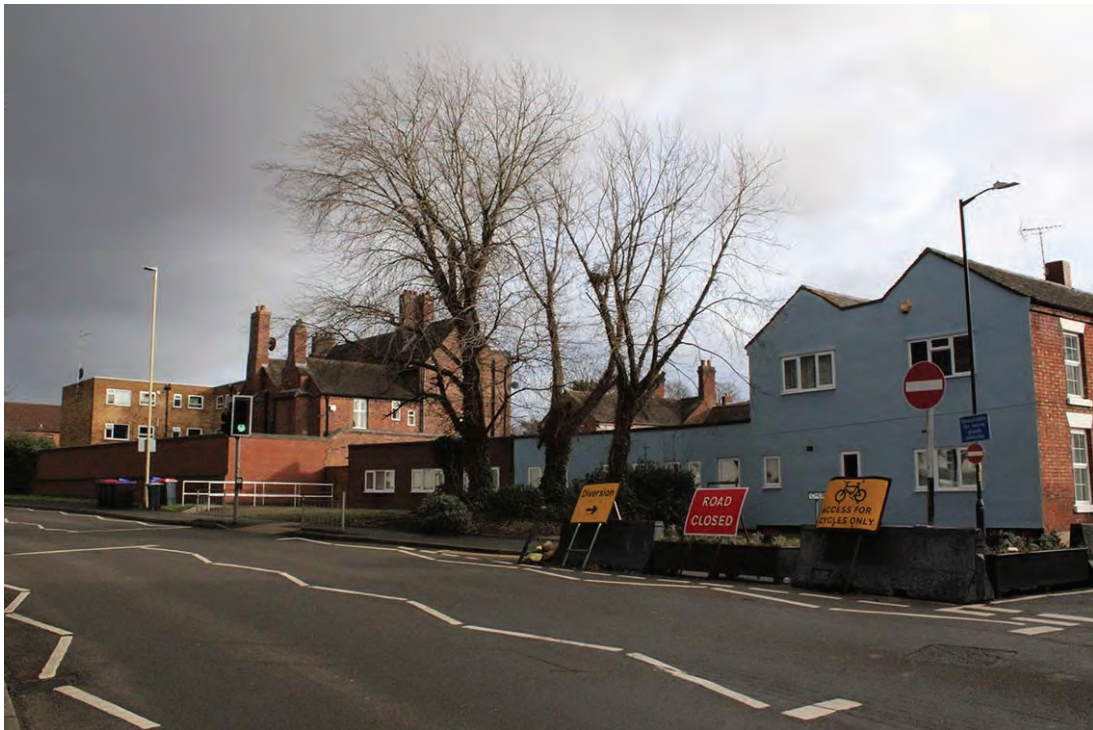
5.52 Vineyard Road, to the east of the junction with Church Road, was only constructed in the 1970s with the formation of the inner ring road network. This has left exposed flanks and backs of properties adjacent to the road and a resultant sterility to the streetscape, as well as divorcing Church Street from Park Street. Park Street is now a cul-de-sac ending with concrete bollards and a pelican crossing with railings, further separating the two streets. There is potential to better integrate the streets, whilst ensuring pedestrian safety.

Figure 53: Exposed flanks and backs of properties on Vineyard Road

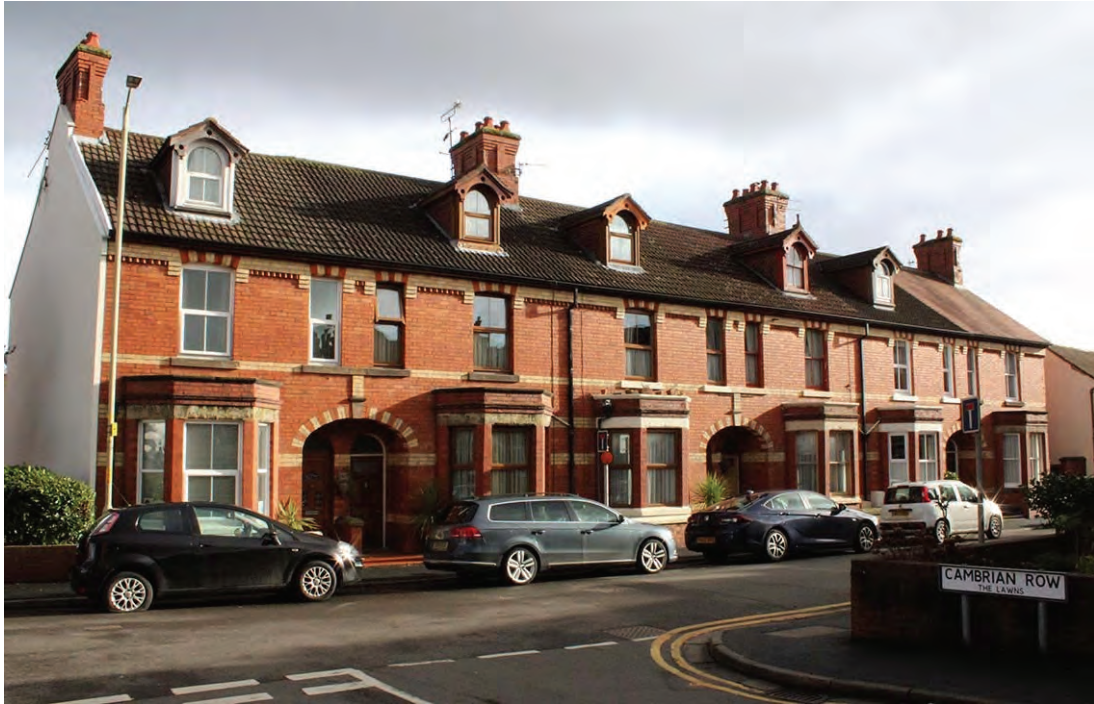
Figure 56: Nos. 6-16 Park Street with their eye-catching brickwork and detailing

5.54 Park Street lies north of Vineyard Road from Church Street and is a quiet, suburban street characterised by a predominance of handsome two and three-storey red brick terraced homes. Of particular note is the terrace comprising Nos. 6-16 Park Street, with its bay windows, decorative bands of buff-coloured brick and recessed doorways behind alternating red and buff brick archways, topped by gabled dormers with carved wooden barge boards and finials.

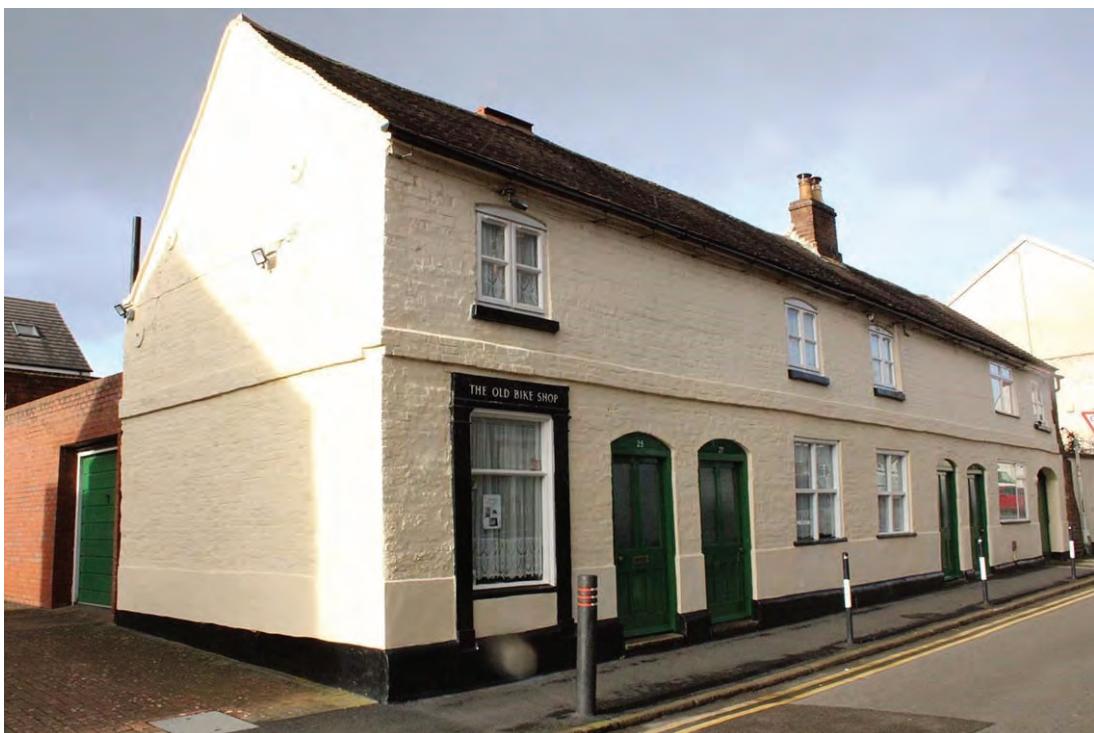
5.57 The humble terraced cottages at Nos. 25-31 are Grade II listed, being comprised of 18th century brick refacing to 17th century timber framing, exposed at the rear with brick infills. Understated in appearance, their form and grace are nonetheless a positive addition to Park Street's character.

Figure 58: Nos. 25-31 Park Street

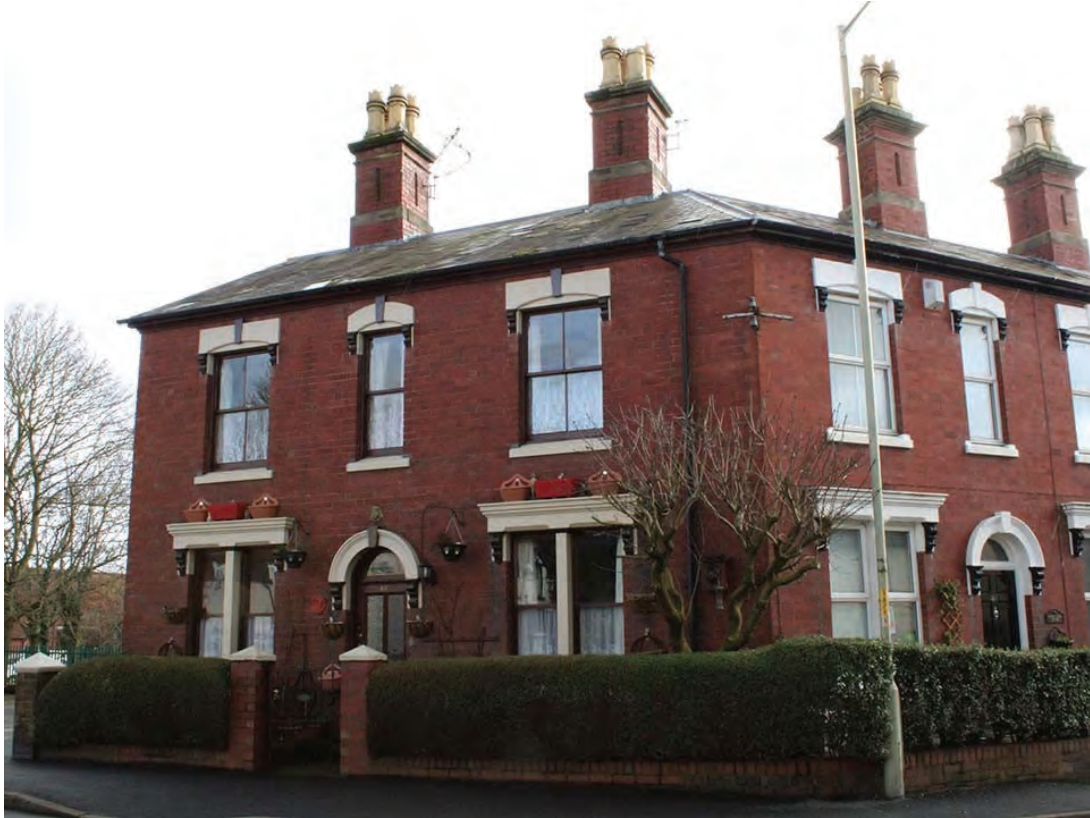
Figure 59: This striking dwelling sits on the corner of Park Street and King Street

5.58 The northeast corner of Park Street at its junction with King Street is crowned by a stately two-storey brick dwelling with hipped slate roof, sash windows and recessed doors with fanlights. Across King Street to the north lies the Grade II listed The Park hotel.

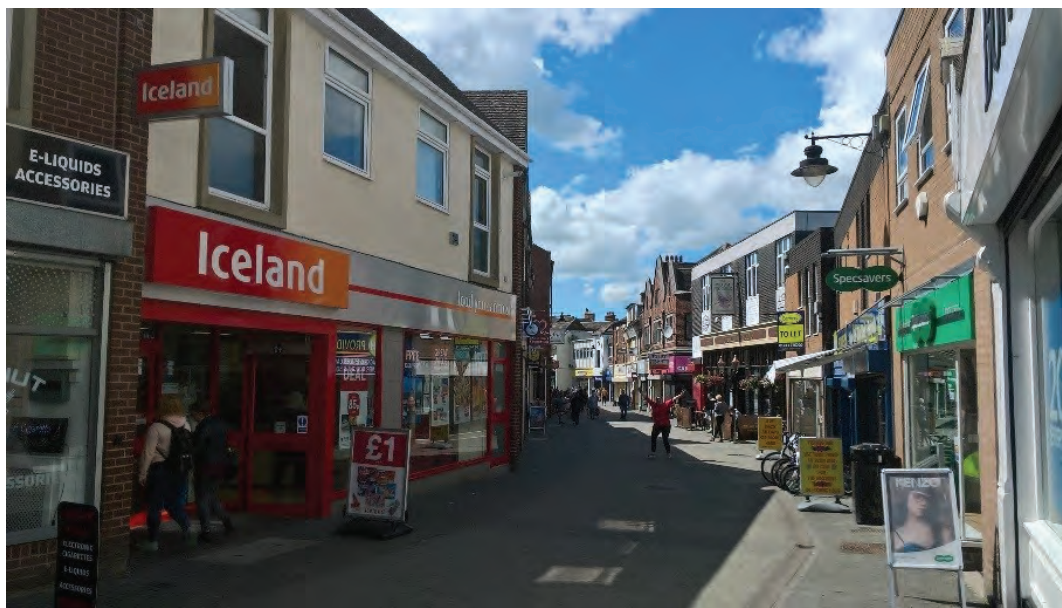
1. The poor standard of building alterations, repairs and lack of regular maintenance, specifically:
 - Loss of heritage details and materials partly due to poor-quality repairs
 - Lack of regular maintenance such as gutter clearing, vegetation removal, roof tile repairs and repainting of timber windows and shopfronts
 - Replacement of wooden sash windows with aluminium and uPVC frames and different window bars
 - Removal of historic architectural details, such as shopfronts and windows

- Removal and capping of chimney stacks and pots
 - Lack of consideration for the heritage character of the area when rebuilding or renovating
2. The impact of inappropriate shop fronts and signage, including Perspex, acrylic and other plastic-based materials.
- A significant proportion of the buildings within the Conservation Area are in retail use and the quality and design of their shop fronts and signs impacts greatly on the appearance of the building and townscape. A poor-quality, or inappropriately designed shop front can dominate the elevation of a building, as well as its neighbours, and disturb the balance and proportion of the streetscape as a whole

Figure 62: Crude shopfront fascias and poor signage with their use of modern materials are generally unsympathetic

7.5 In general, any surviving historic timber shopfronts should be retained, repaired and redecorated in muted and traditional colours. Planning Permission or Advertisement Consent may be required for any proposed shop front alterations.

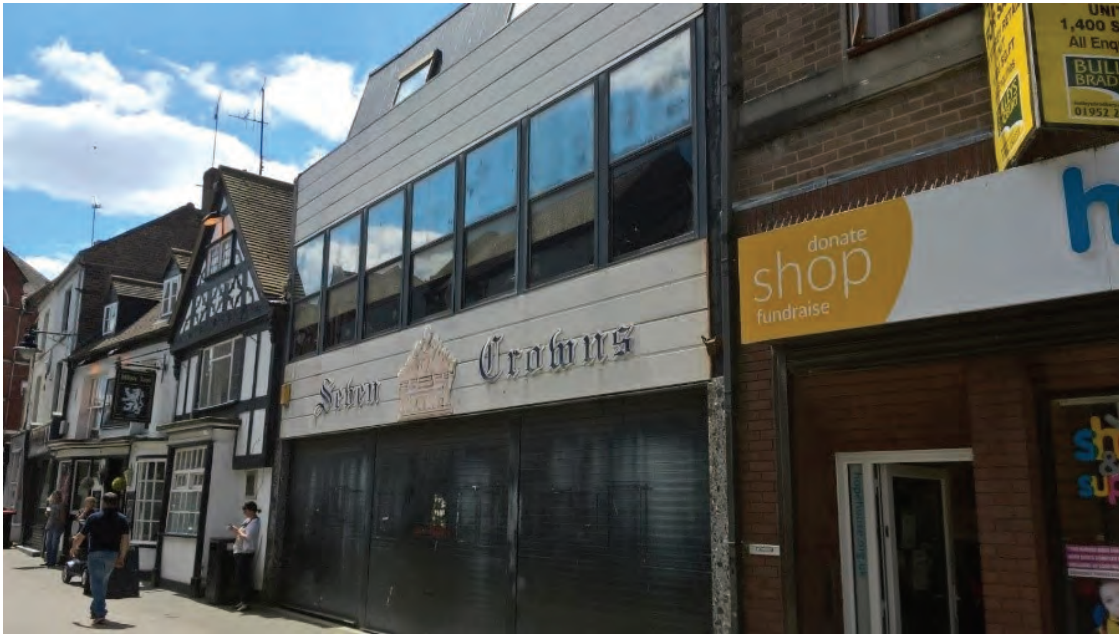
Figure 63: Unsympathetic infill development mars the character of Crown Street

7.1 New buildings that replace older properties should respect the character and design principles of earlier development, such as the narrow burgage plots and the vertical rhythm in scale and massing.

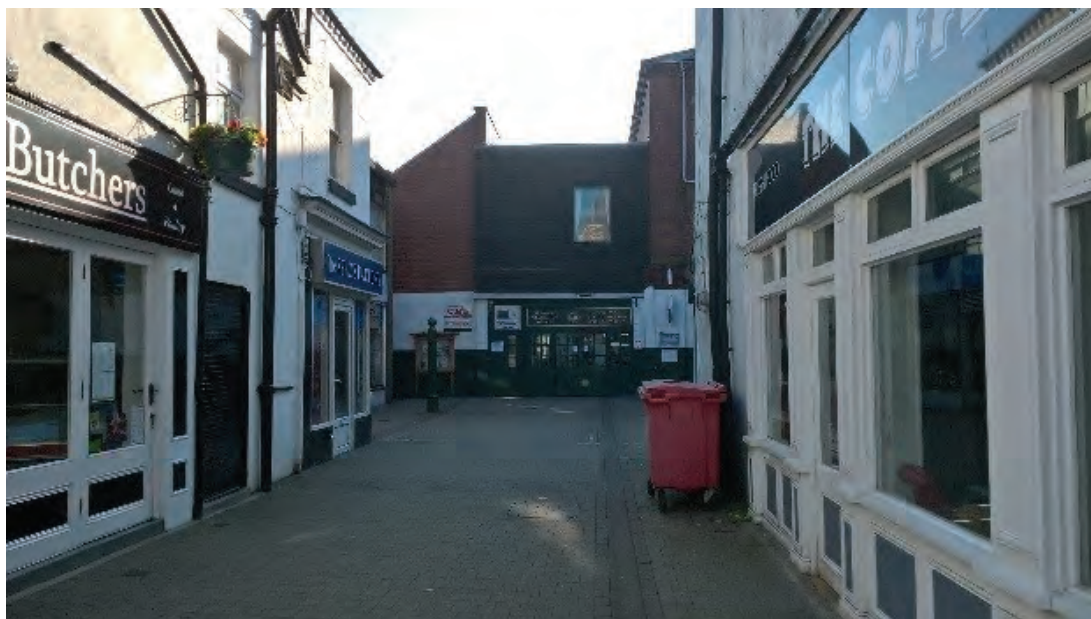
Figure 64: Market Approach is uninviting and could be improved

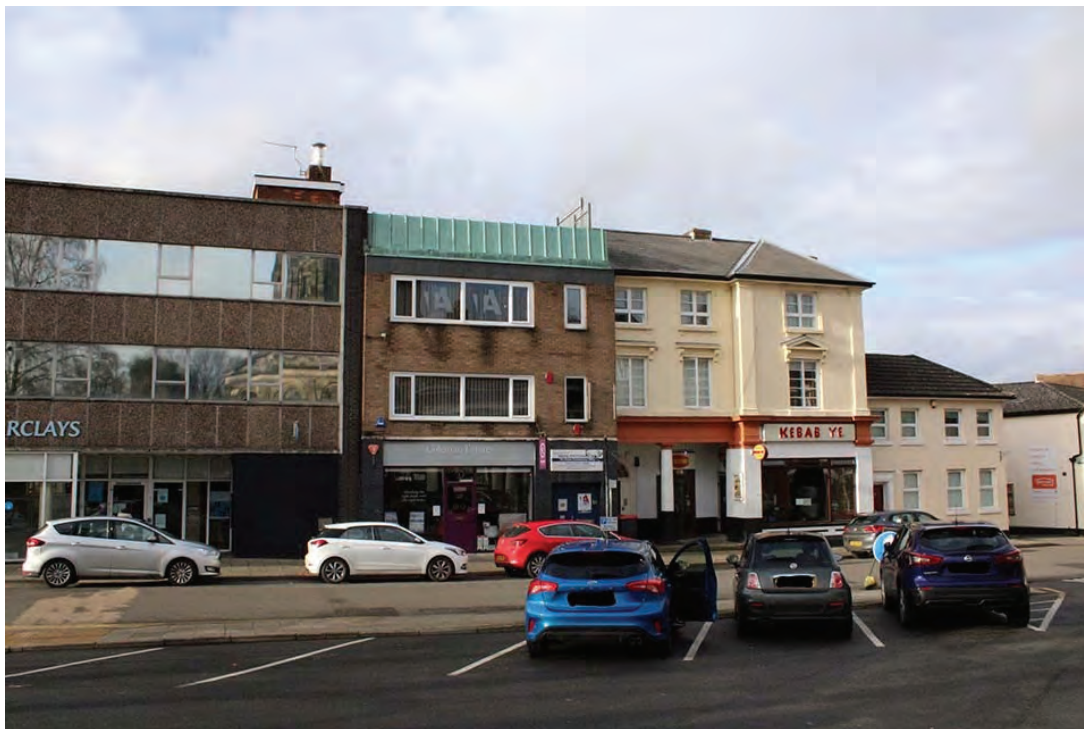
6.10 The building to the right of the photo (right), No. 27 Church Street, is half of what once was a symmetrical block. The replacement building at No. 25, together with its neighbour No. 23 to the left, have a horizontal emphasis of openings on the upper floors, to the detriment of the rhythm, scale and massing of the streetscape.

Figure 65: Nos. 23-27 Church Street

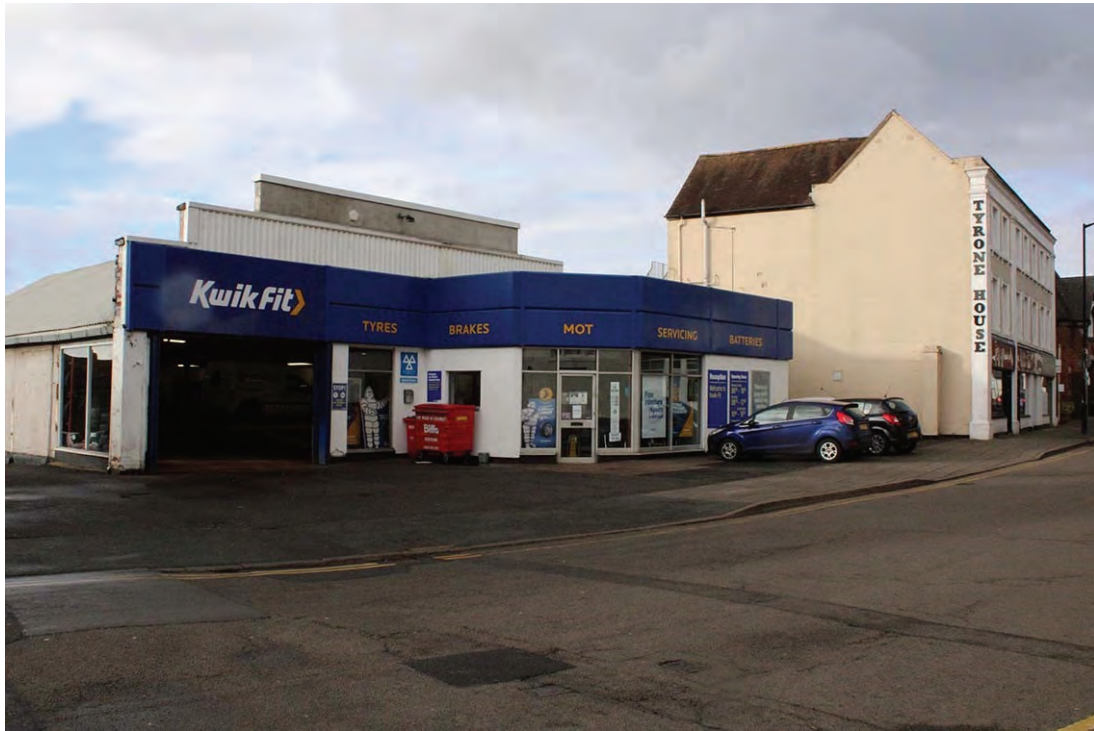
Figure 66: The Kwik Fit garage is a thoroughly unsympathetic addition to Church Street

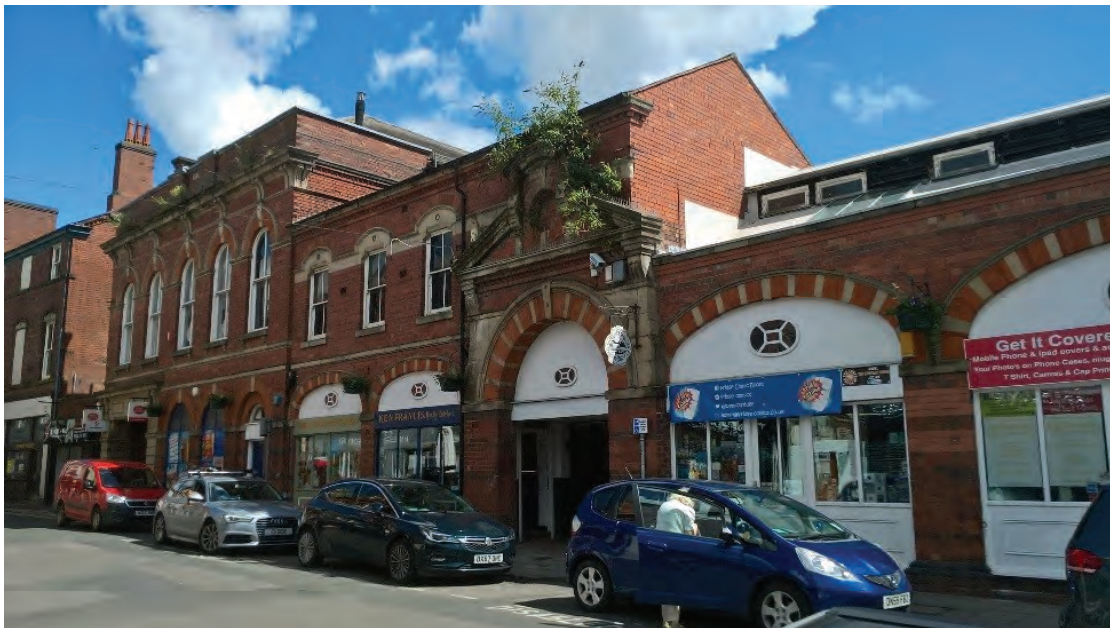
Figure 67: many buildings in town suffer from a lack of maintenance

7.6 Many buildings within the town centre suffer from poor maintenance, with the unused upper floors especially neglected. Blocked gutters and downpipes lead to serious water penetration and damage to buildings which is easily prevented with regular, routine maintenance.

7.8 Regular maintenance should be carried out to mitigate against decay and the need for more significant repairs. Repairs should only be undertaken where strictly necessary to slow down the process of decay without damaging or compromising the character of the building. In the vast majority of cases, a traditional approach to repair should be adopted, one which replaces decayed material on a like-for-like basis. Occasionally, it may be more appropriate to use non-traditional materials and methods if they have been tried and tested over a long period of time and if they allow a greater amount of the existing fabric to remain undisturbed in-situ. In certain circumstances, decay may be so advanced that the fabric is beyond repair and the replacement of features may be necessary. Care should be taken, however, to avoid any unnecessary loss of historic fabric. Some fabric may be capable of adaptation to minimize loss of historic fabric, such as the discrete insertion of modern draft seals which can greatly enhance the heat retention and performance of sash windows.

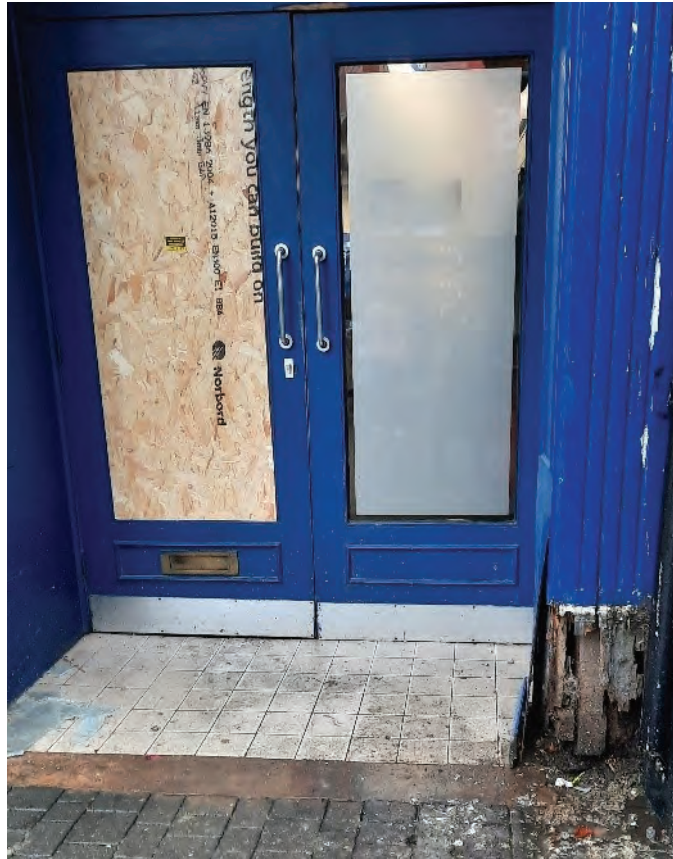
Figure 68: Lack of routine maintenance results in the need for significant repairs

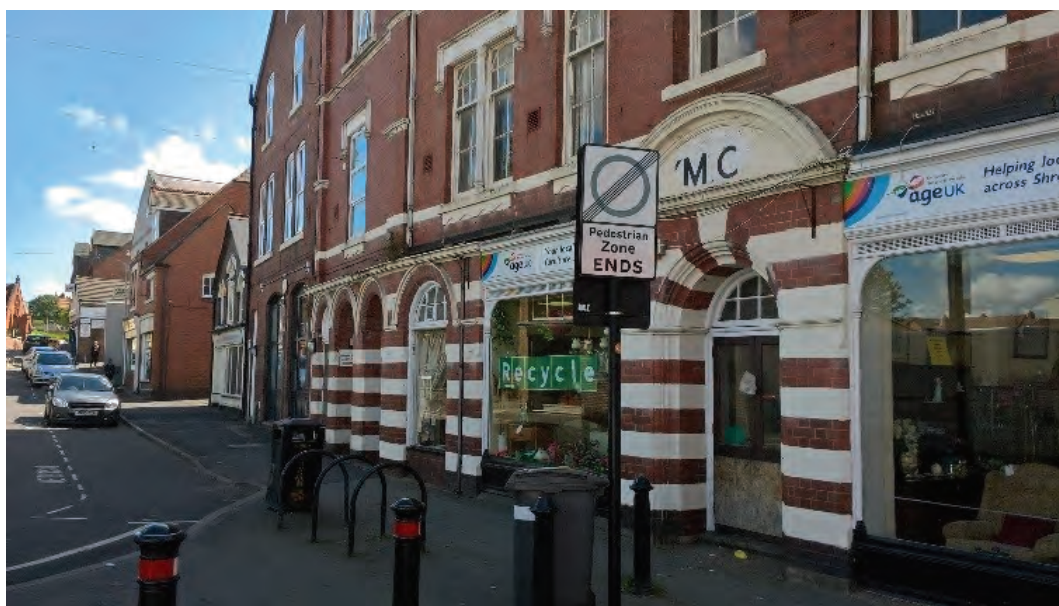
Figure 69: Decorative polychromatic brickwork should never be painted

7.13 Existing decorative brickwork should be retained and carefully restored wherever possible. Where replacement is necessary, an accurate replica should be made, ensuring there is a careful match with the existing brick colour and finish. Natural decorative brickwork should never be painted.
