Project	Telford & Wrekin Level 2 SFRA	Date	4 th March 2008
Note	Site Visit 21/02/2008	Ref	WBTWCS
Author	M Grogan

1.1 On the 21st February 2008 Halcrow visited the Hurley Brook/Ketley Brook and the Crow Brook to facilitate the hydraulic modelling exercises that will follow for the Level 2 SFRA. This Technical Note is a brief summary of the site visit and findings.

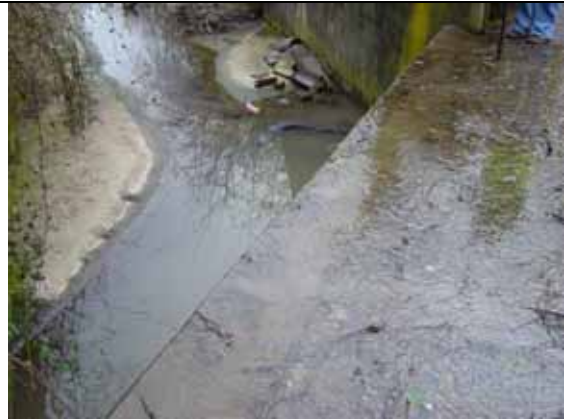
007 Pool On Ketley Brook

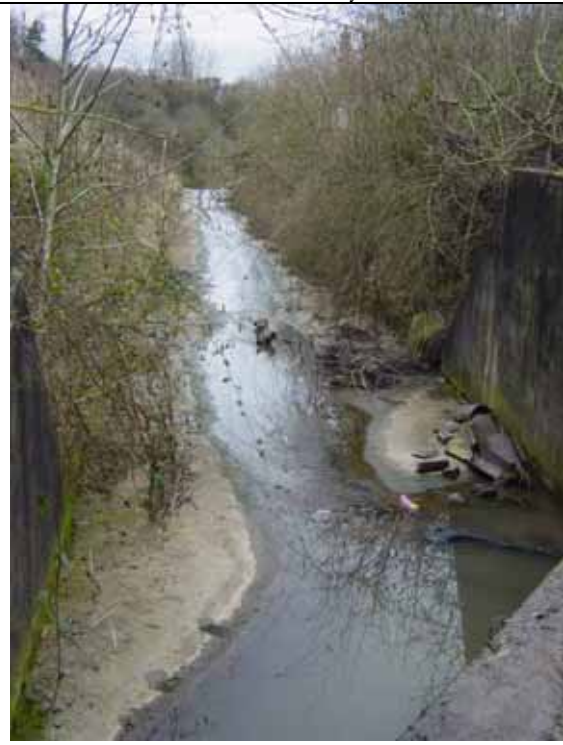
008 Overflow From Pool On Ketley Brook

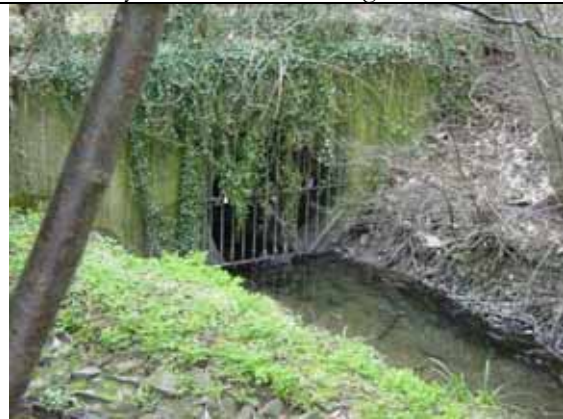
022 Junction of Ketley Book and Hurley Brook

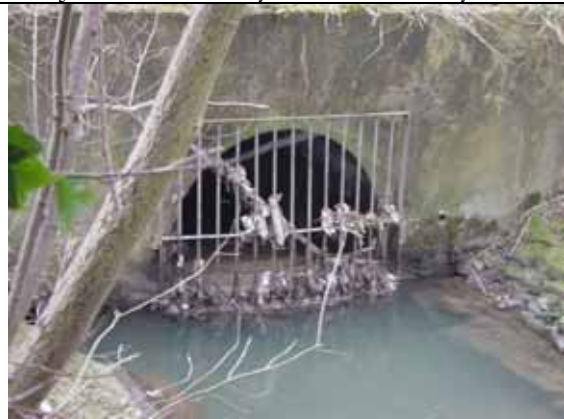
023 Junction of Ketley Book and Hurley Brook
Hurley Brook Culvert DS

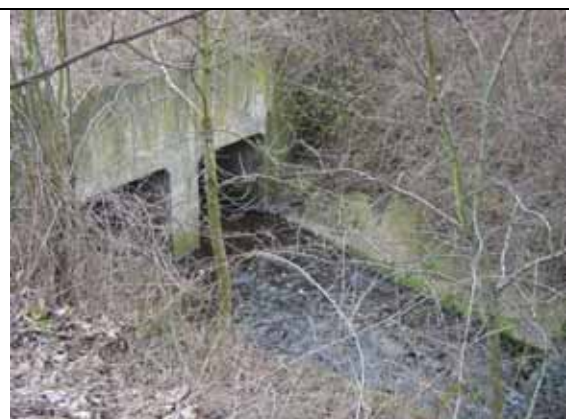
029 Hurley Brook DS A442 Queensway

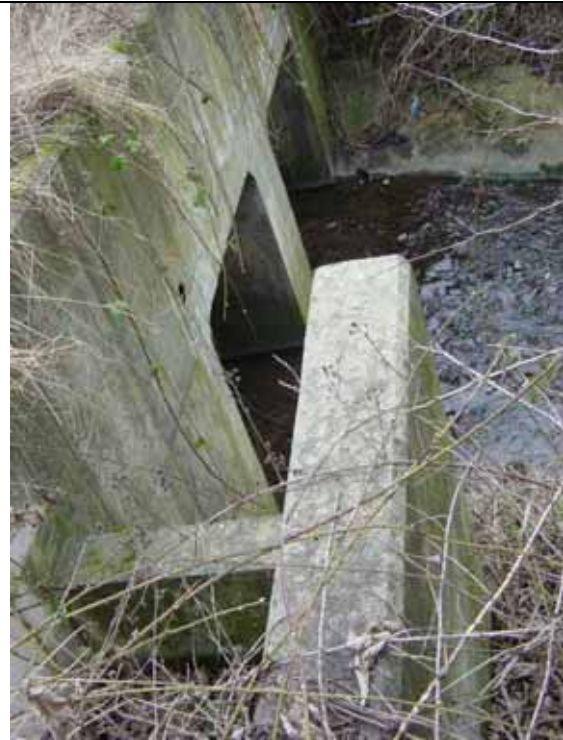
030 Hurley Brook DS Culvert A442 Queensway

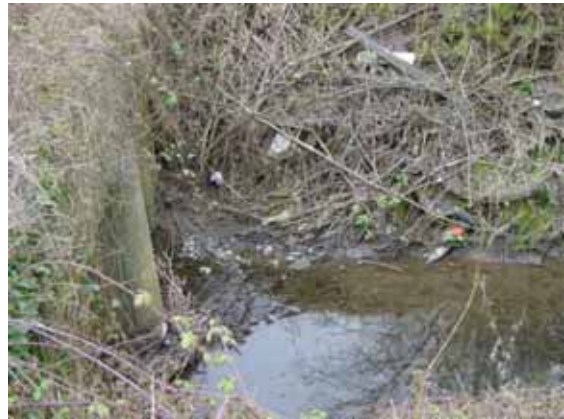
031 Hurley Brook DS Culvert A442 Queensway

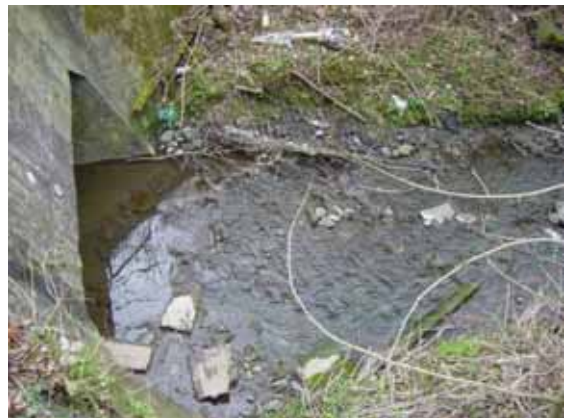
033 Hurley Brook DS Leegate Avenue

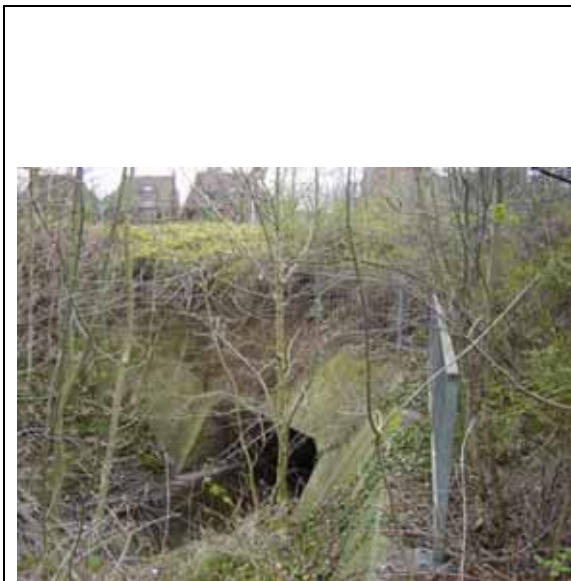
034 Hurley Brook DS Culvert Leegate Avenue

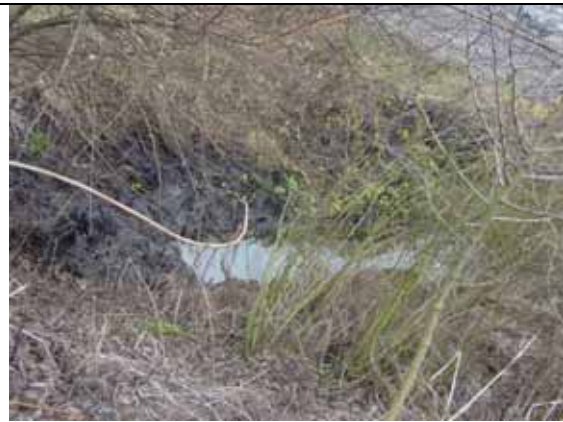
038 Hurley Brook nr Arleston Lane

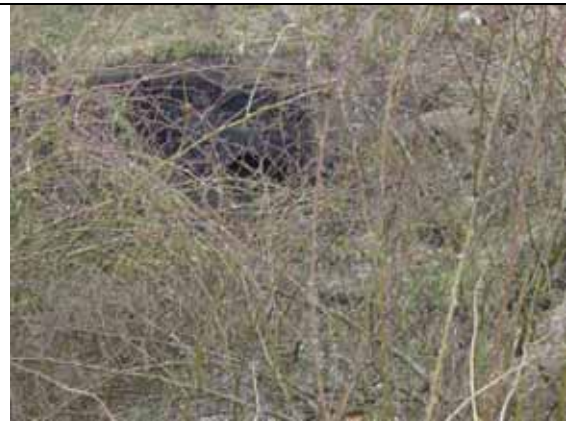
039 Hurley Brook DS US Culvert nr Arleston Lane

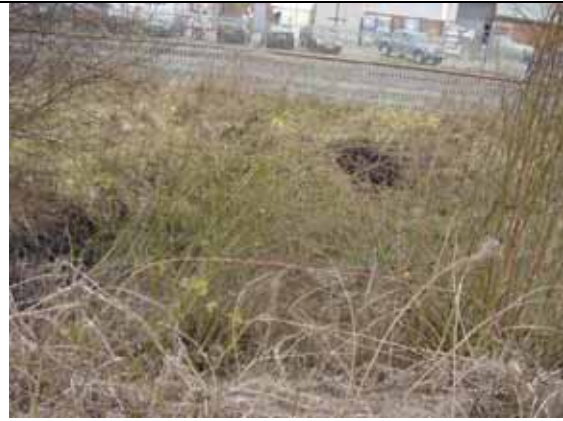
040 Hurley Brook US DS Culvert nr Arleston Lane

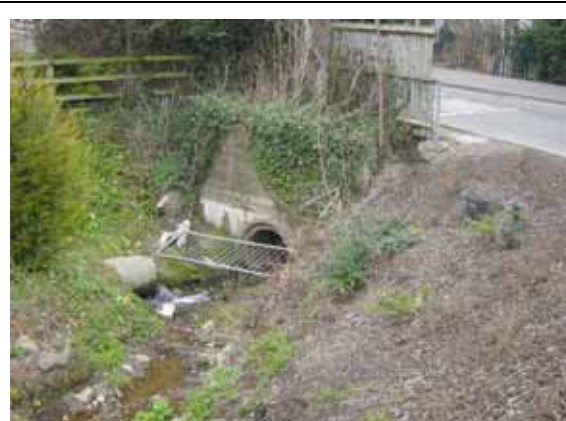
041 Hurley Brook US DS Culvert nr Arleston Lane

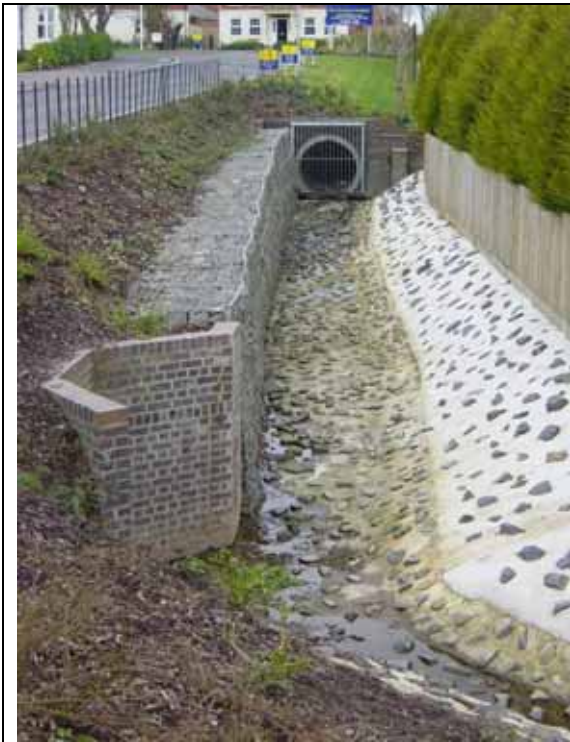
042 Hurley Brook US Culvert Limekiln Lane

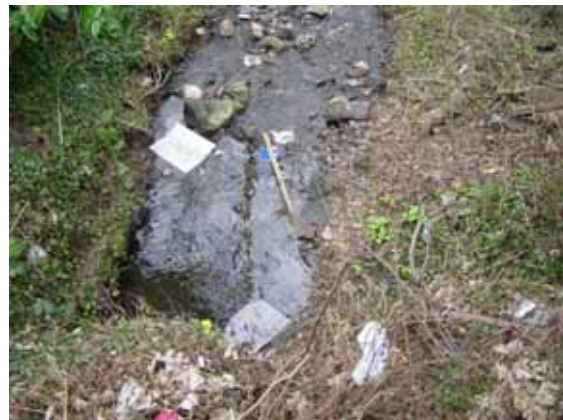
044 Hurley Brook DS Limekiln Lane

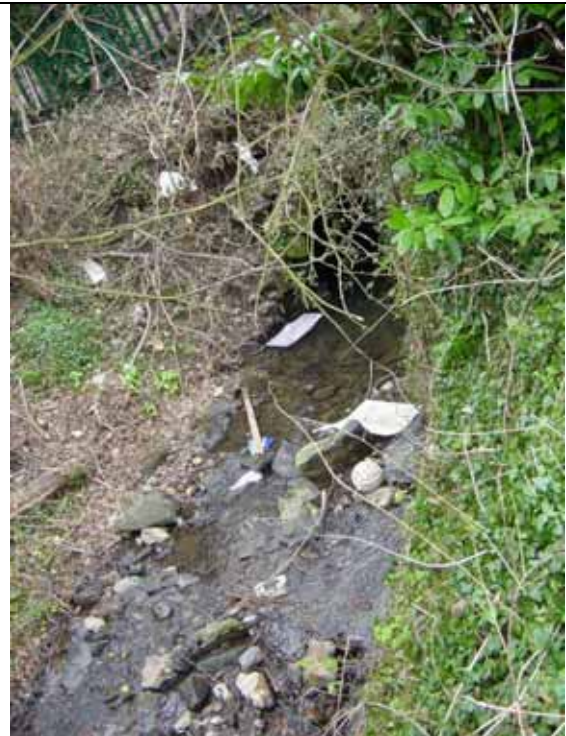
045 Hurley Brook DS Culvert Limekiln Lane

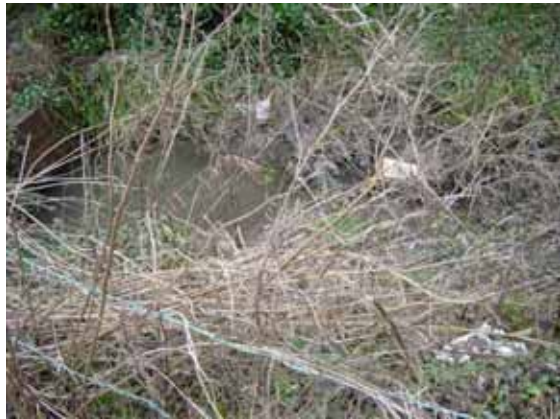
046 Hurley Brook DS Culvert Limekiln Lane

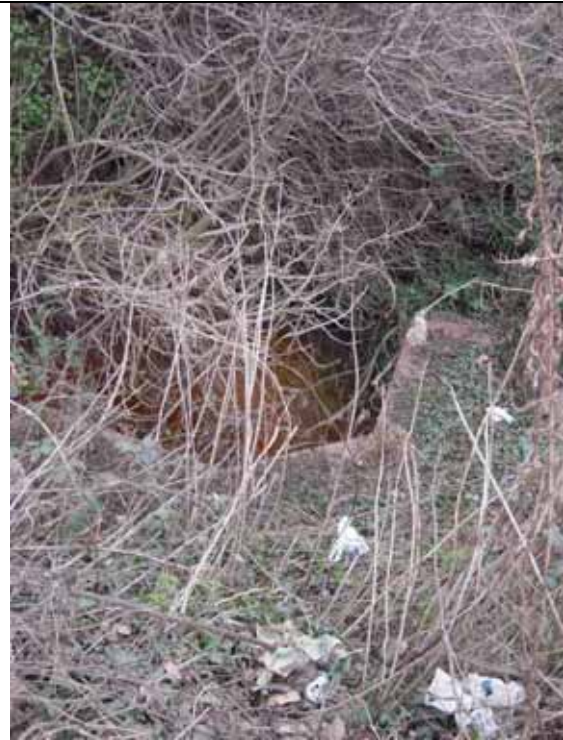
050 Crow Brook DS Sommerfeld Road

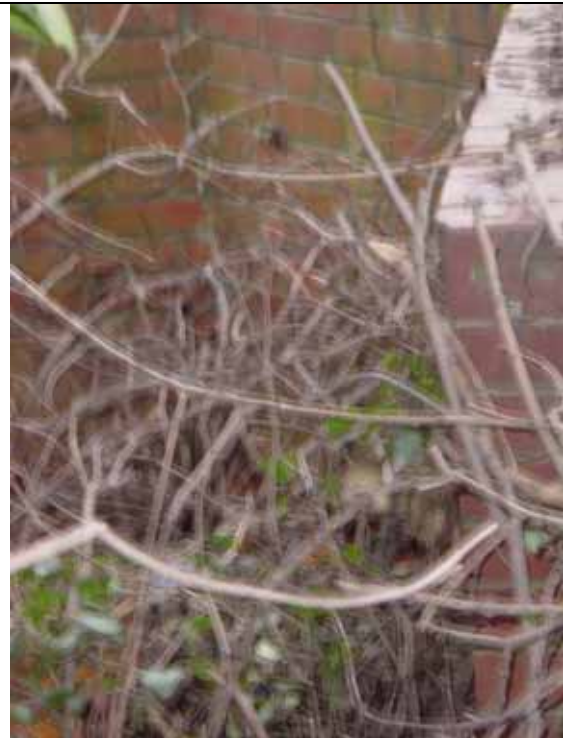
052 Crow Brook DS Sommerfeld Road
Interaction with Area nr Middle Pool

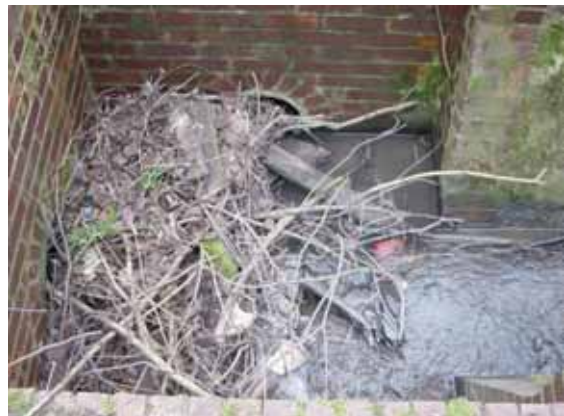
053 Crow Brook DS Culvert Sommerfeld Road

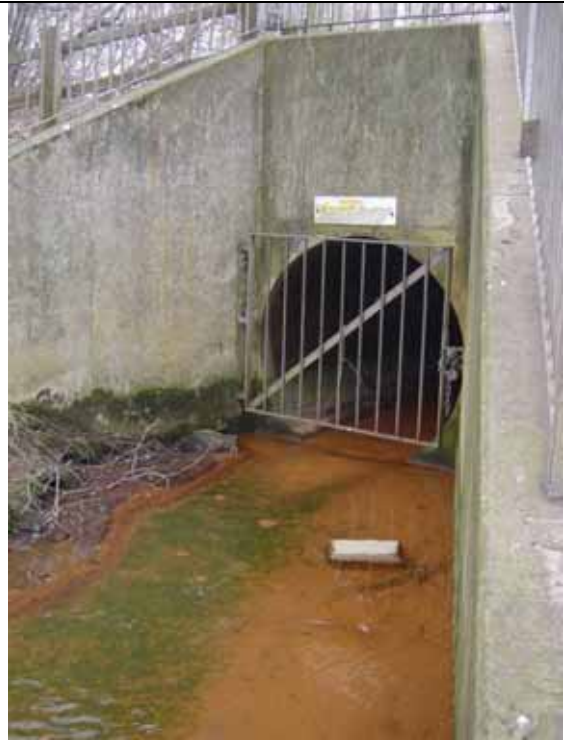
055 Crow Brook US Sommerfeld Road

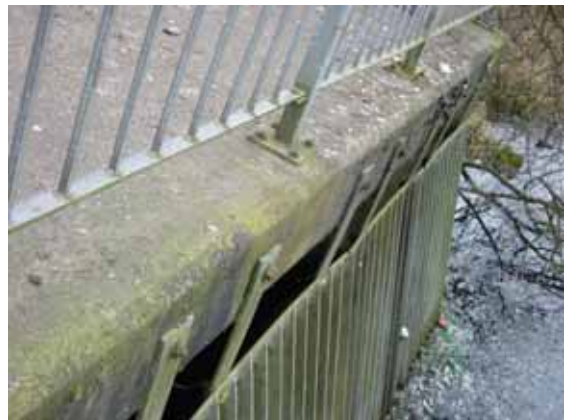
057 Crow Brook DS Capewell Road Trench
Pool Inflow

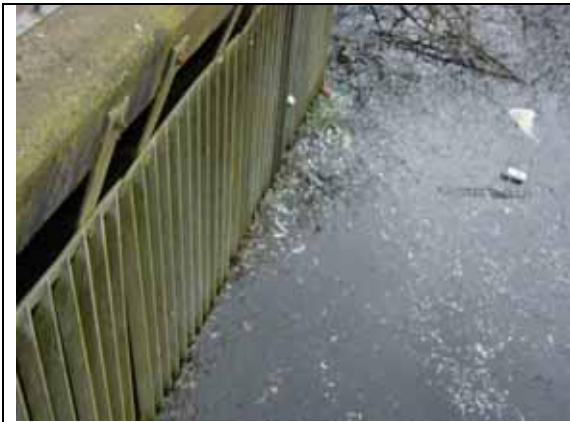
058 Trench Pool DS Overflow

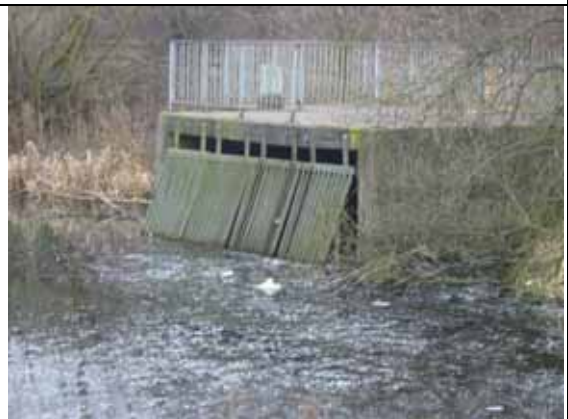
063 Trench Pool

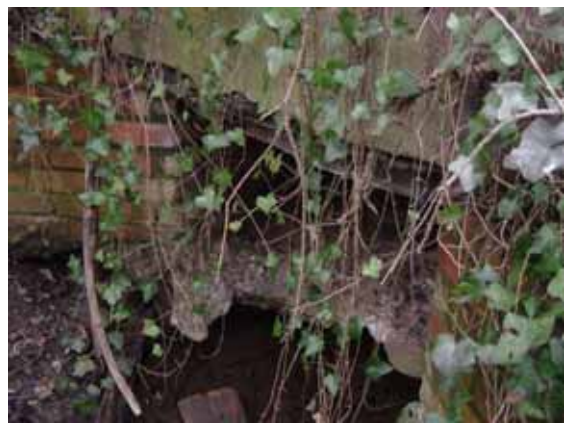
- 4.3 When following the assumed 'old path' and looking for possible places where the Crow Brook may emerge from the culvert, it was observed that site 61900 Land adjacent Oakland House, Hortonwood, was already being developed (picture 65 Appendix A) (SJ 68872 13641). This site also incorporates a reach of watercourse which drains east to west. The interaction of this with either the old or new Crow Brook is not known, and needs to be understood from any existing data on the diversion, to inform how it should be appropriately modelled.

065 Hortonwood Development Site Mound of Earth Over Location of Drain

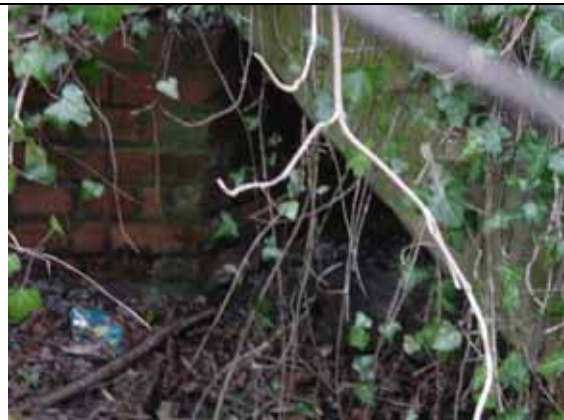
067 Crow Brook nr Horton Lane

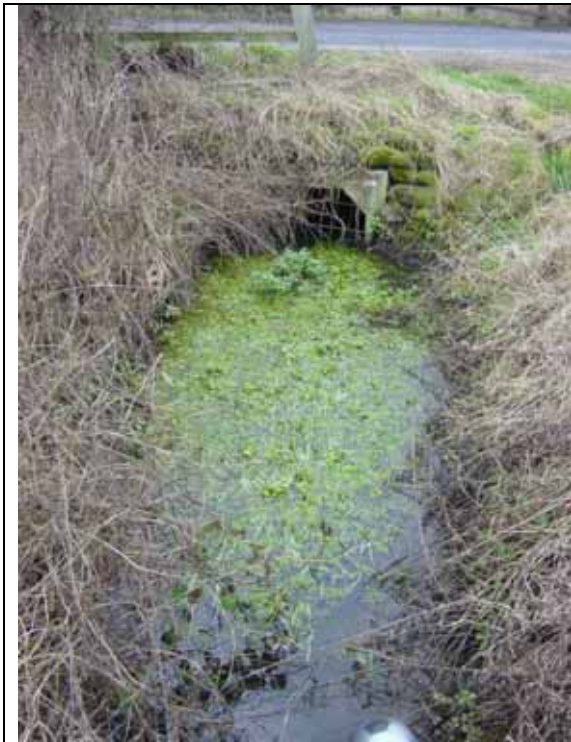
068 Crow Brook US Culvert nr Horton Lane
