Options Study Report

A41 Route Study COMHA1T&W038 / OS-001 / P02 07/07/2025

REPORT TITLE:	Options Study Report		
REPORT NUMBER:	OS-001		
PROJECT NAME:	A41 Route Study		
PROJECT NUMBER:	COMHA1T&W038

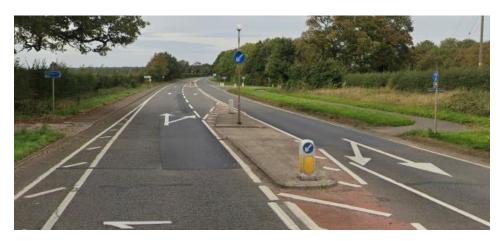
Figure 3 Chetwynd Pedestrian and Cycle Crossing (Source: Google Maps)

- 5.1.8 Marker posts are highly inconsistent along the A41 and appear to only have been installed privately. These can be relatively low-cost solutions to aid in the demarcation of accesses and hazards that are unlikely to require consistent replacement. Good examples of where they could be applied on the A41 in a similar manner are the pedestrian and cycle crossings at Chetwynd in Figure 3 pictured below as well as the similar crossing on the northern exit to the A518 roundabout.

- 5.1.9 Both crossings form part of National Cycle Routes and thus are likely to experience a greater degree of use than most others. Marker posts at either site would aid in drawing drivers' attention to the side of the road for waiting cycle traffic where along most of the route they typically aren't expecting such crossings to occur. This advance highlighting should help drivers identify whether they need to slow down and be aware of the hazard further in advance.
- 5.1.10 The locations the A49 has had VAS installed are in villages, whilst the A41 travels along several bypasses. Woodcote village currently has VAS installed on the A41 and this appears to be a similar successful implementation without need for change. VAS suitability is covered within hazard signage in 6.7.

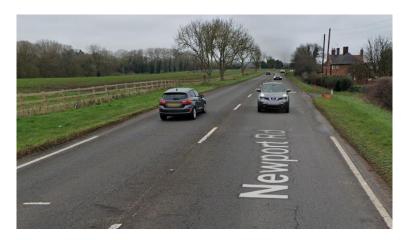
Figure 6: A41 Newport Road Cross-section (Source: Google Maps)

- 6.2.10 Due to the length and variation of the route. It is proposed that any works requiring changes to the carriageway cross section are integrated alongside resurfacing work within the existing maintenance schedule. An example of a location which could be improved with continuation of edge lines and hard strips is shown below in Figure 6.

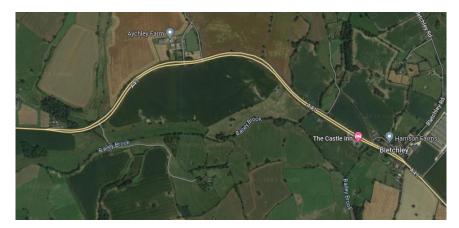
Figure 7 Dual Carriageway Section (Source: Google Maps)

6.2.11 There is a short dual carriageway section shown in Figure 7 along the route for 3km north of Bletchley. This has a 0.5m hard strip, edge lines, a 5m central verge with VRS only present at the bends and has an unrestricted speed limit. One slight and one serious collision have been present here but both are unrelated to each other and the section itself.

6.2.12 Some signs along this section were identified as not being passively safe and the road markings can be quite worn. Although VRS was not identified as an issue in the collision analysis, the current arrangements have been observed to be inconsistent and could benefit from being reviewed¹.

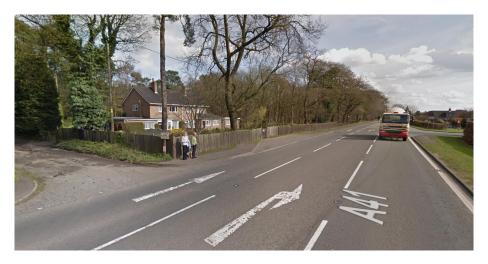
Figure 48 Heathwood Road Lay-by Existing Arrangement (Source: Google Maps)

- 8.4.1 During the site visit layby immediately south opposite the Heathwood Road junction shown in Figure 48 was identified as having a substandard layout. The lay-by is in front of two private dwellings with gates access to the rear of the lay-by. The dwellings also have parking and access to the rear. The A41 through this section is subject to a 50mph speed limit.
- 8.4.2 The lay-by is a type B layby⁴ with shortened length of approx. 27m and narrower width of approx. 2.8m. A slot drain and gullies separates the lay-by from the mainline, consequently there are no road markings or road studs. The lay-by has no footway to the rear and acts as a break in the footway. No signing is provided for the lay-by.

- 8.4.3 Current guidance on lay-bys also states:
 - 'To avoid noise and visual intrusion and to reduce the possibility of trespassing, parking lay-bys... should be sited away from residential and industrial areas.' (DMRB CD169, 2.1.1)
