Note: All cores except core 2 and core 8 show approx. 180-220mm asphalt on sub base. Core 2 is an anomaly, where as core 8 is what is to be expected in an area of narrow widening. Full details of the cores will be included on an updated drawing once the core logs and PAH (if required) results are received.

- Notes
- Plane 110mm (Approx. 2.795m2) and replace with:
50mm HRA 35/14 surf 40/60 des
60mm AC 20 HDM bin 40/60
 - PG100 Rapid Repair asphalt reinforcement system to be laid on planed surface to span old widening joint. Offsets of crack to be recorded on site prior to planing.

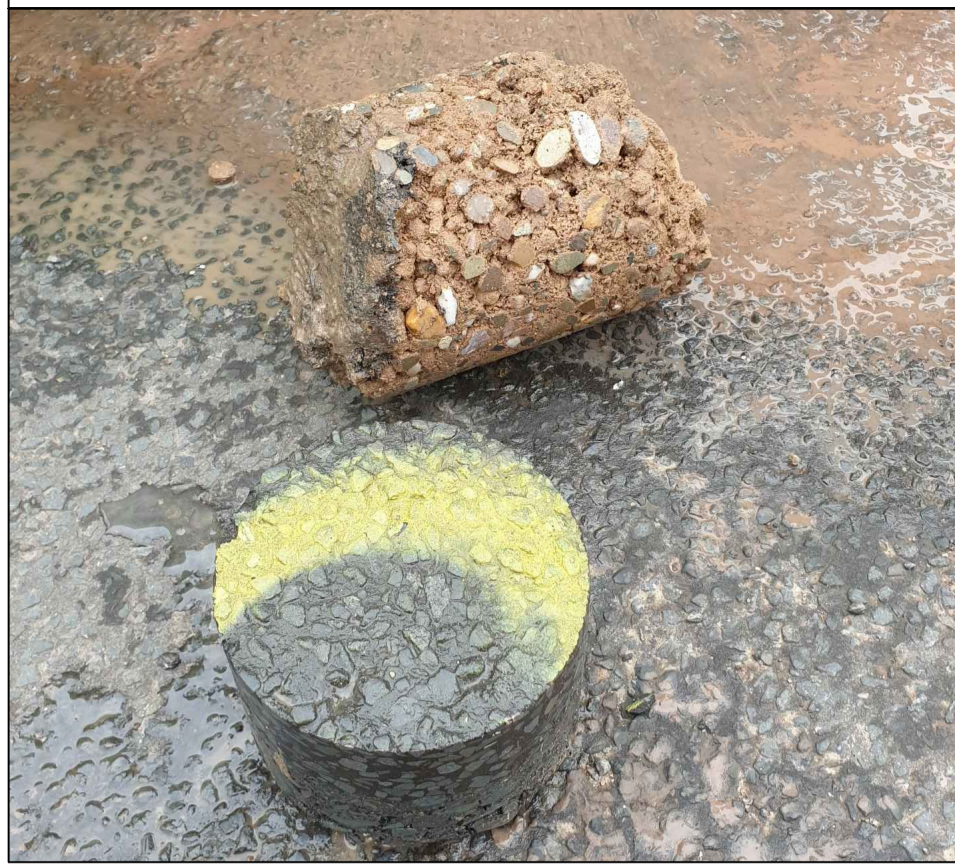
Core 2 @ Chainage 58m: Approx. 100mm Asphalt, 220mm concrete

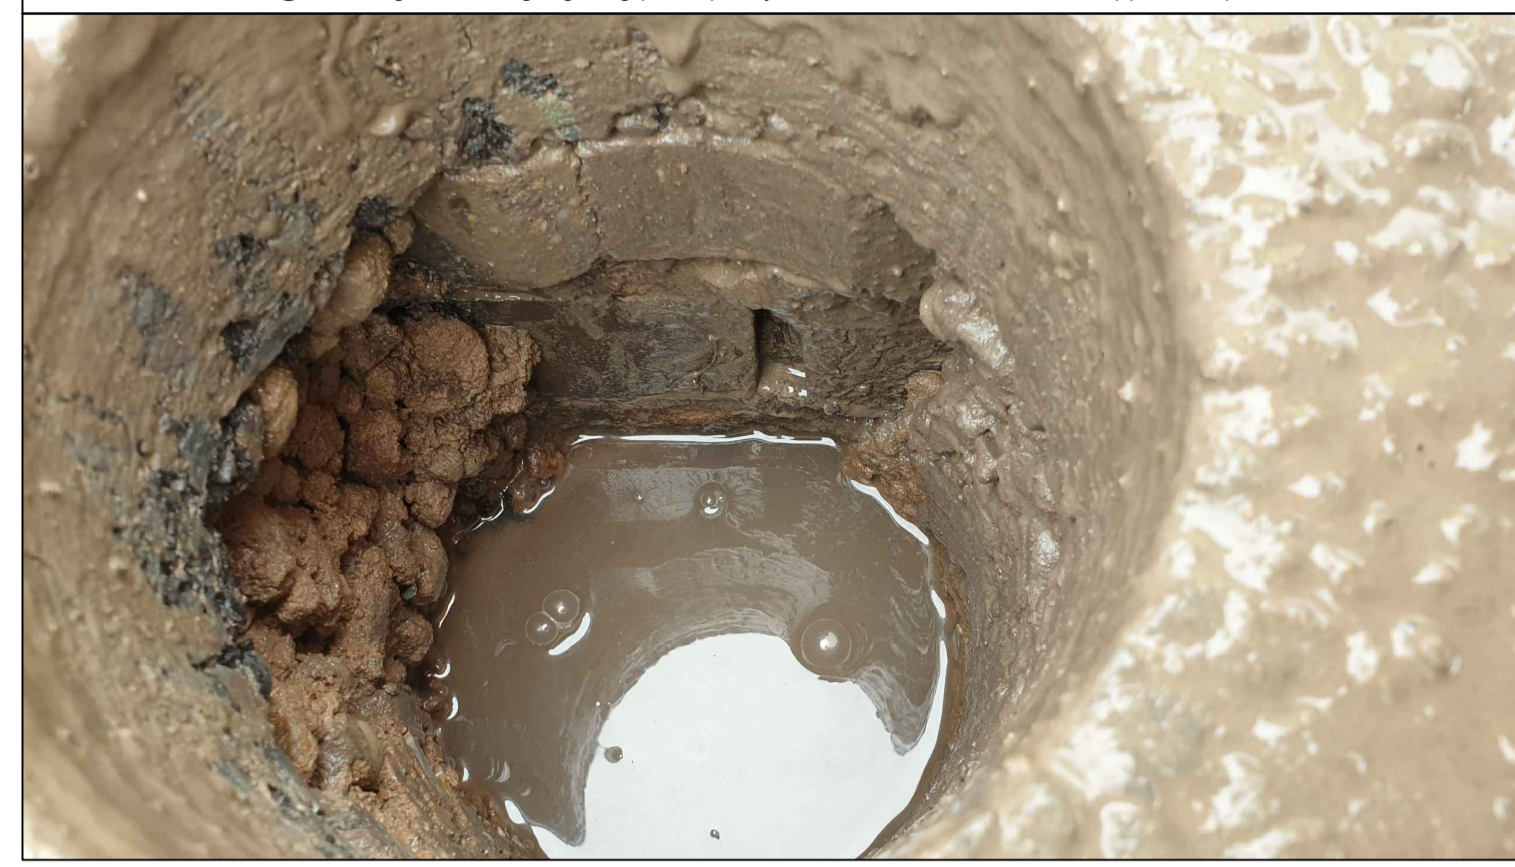
Core 2 @ Chainage 58m: Highlighting poor quality concrete and brickwork, at approx. depth 100mm
