Project  
IRONBRIDGE GORGE  
GEOMORPHOLOGICAL MAPPING

Drawing title  
LINE GEOMORPHOLOGY MAP  
STUDY AREA  
SJ 6503 - 6603

Drawing status  
REPORT

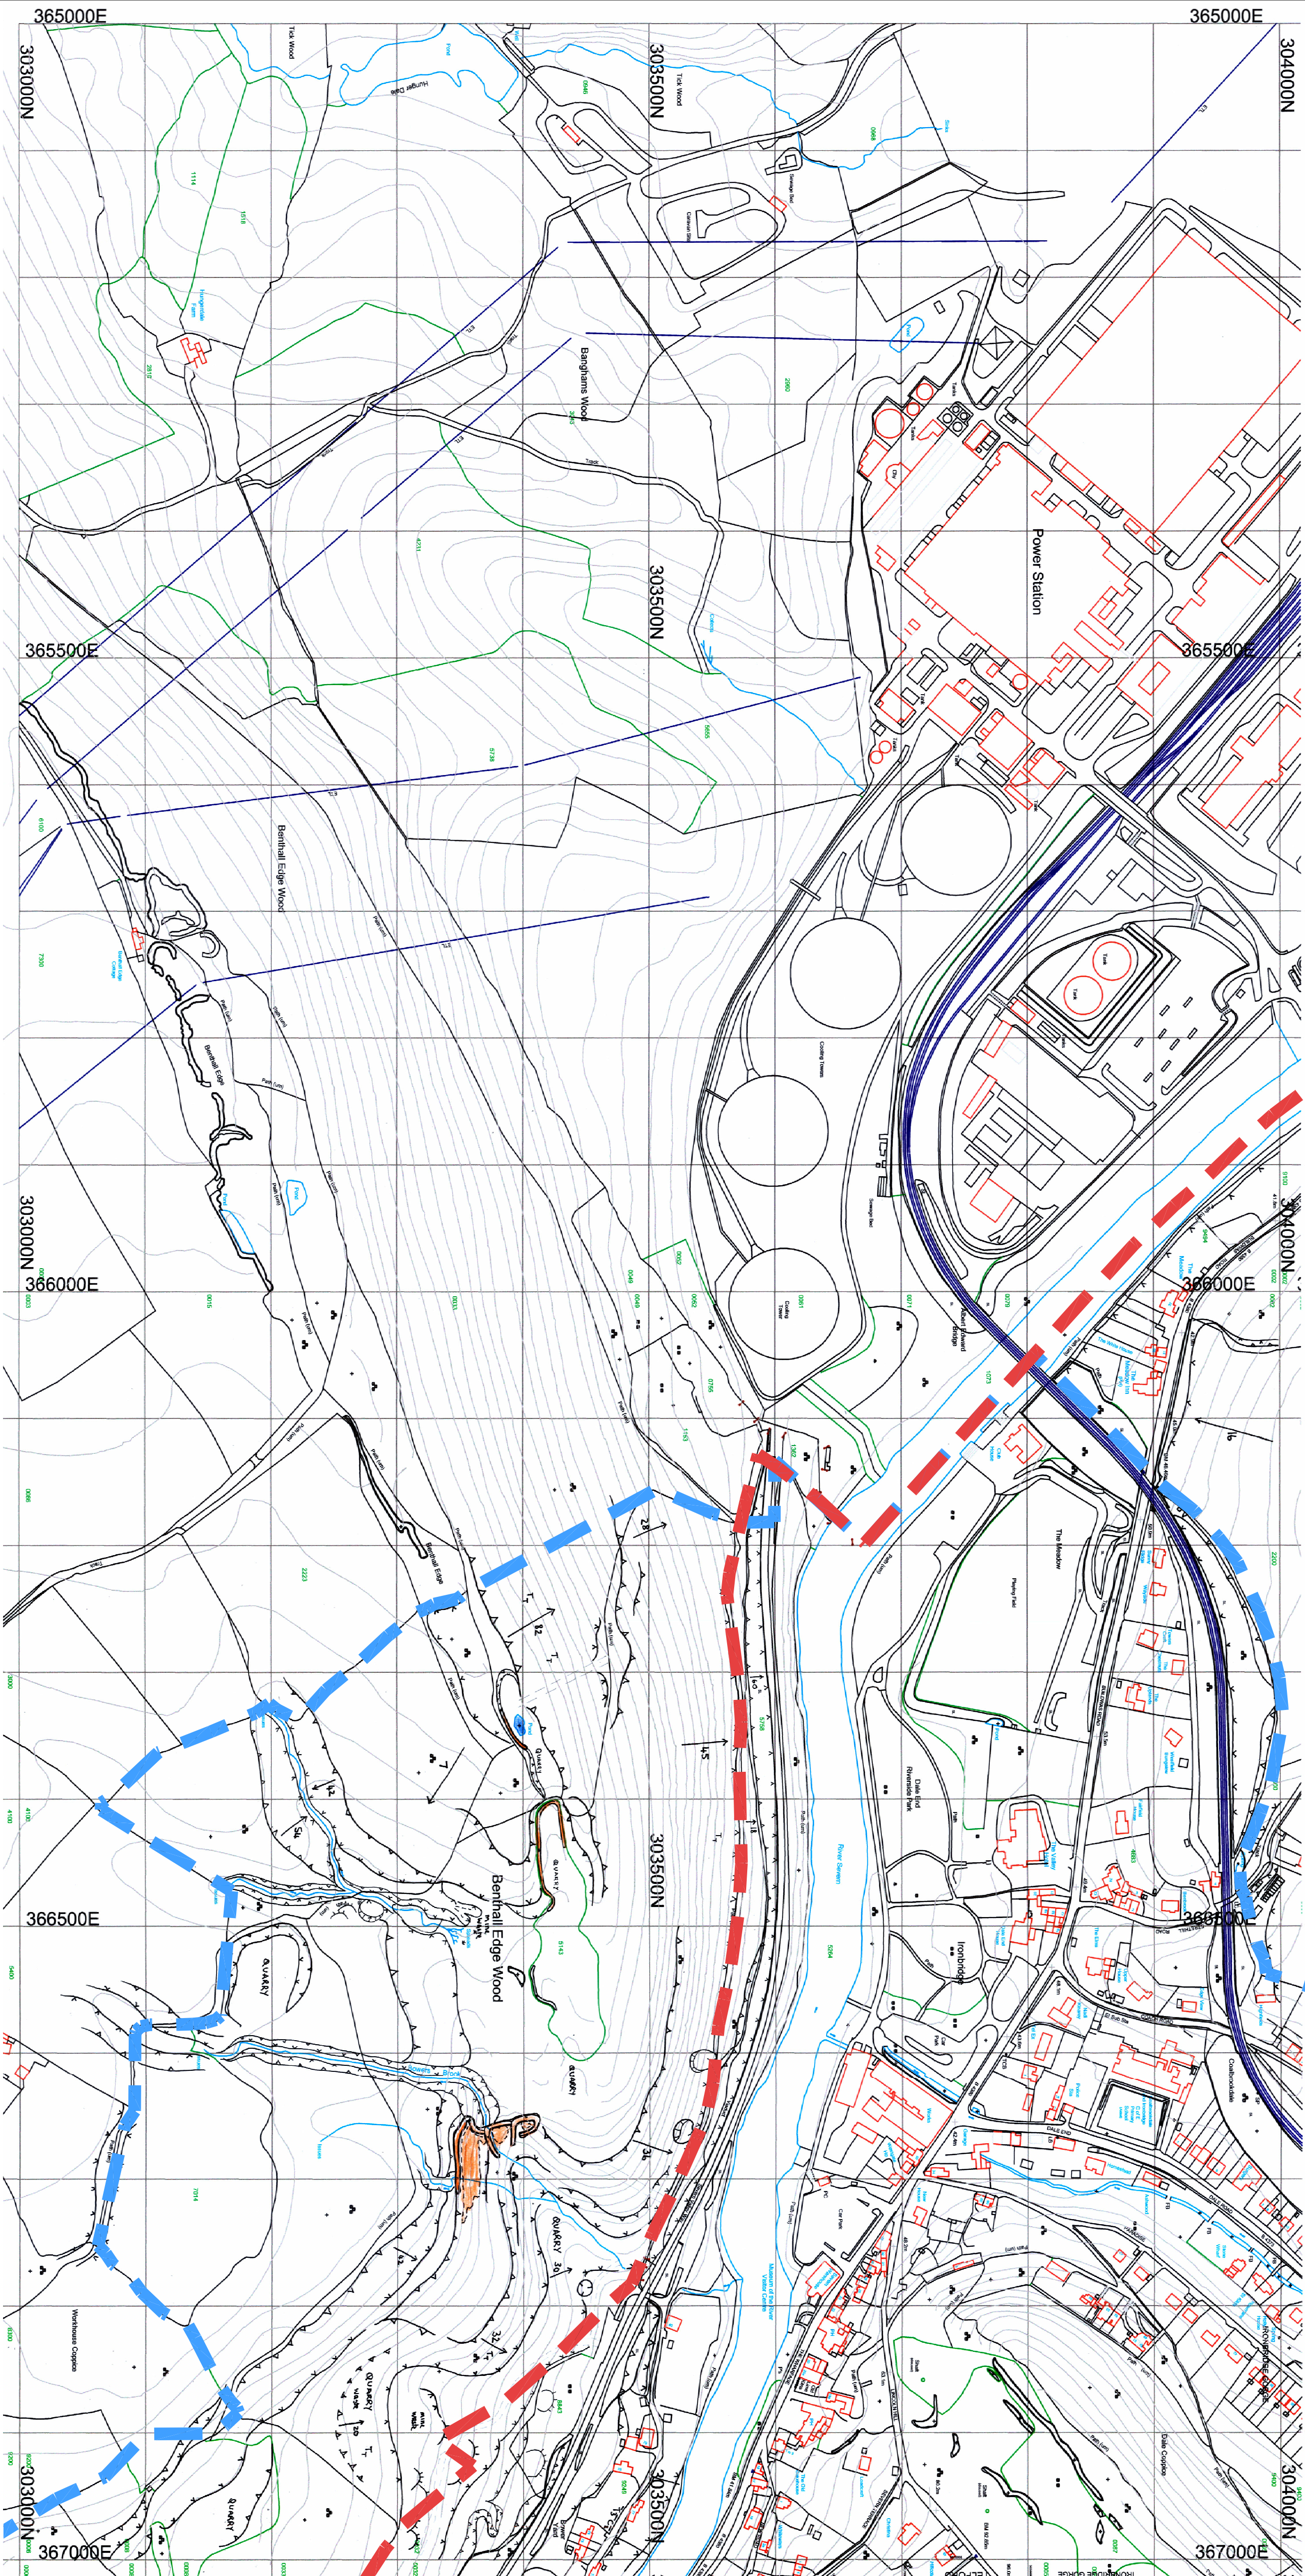
| Drawing number | 1100100/G | Rev | A |

- Convex break in slope (sharp)
- Convex break in slope (smooth)
- Concave break in slope (sharp)
- Concave break in slope (smooth)
- Change in slope, unable to distinguish slope morphology at mapping scale
- Lobate feature
- Tension Crack
- Slope angle and direction (slope angle in degrees)
- Undulating slope angle and direction (slope angle in degrees)
- Exposed Bedrock
- Boulders
- Stream and flow direction
- Wet ground
- Pond
- New Development
