Project	Telford & Wrekin Level 2 SFRA	Date	4 th March 2008
Note	Site Visit 21/02/2008	Ref	WBTWCS
Author	M Grogan

1.1 On the 21st February 2008 Halcrow visited the Hurley Brook/Ketley Brook and the Crow Brook to facilitate the hydraulic modelling exercises that will follow for the Level 2 SFRA. This Technical Note is a brief summary of the site visit and findings.

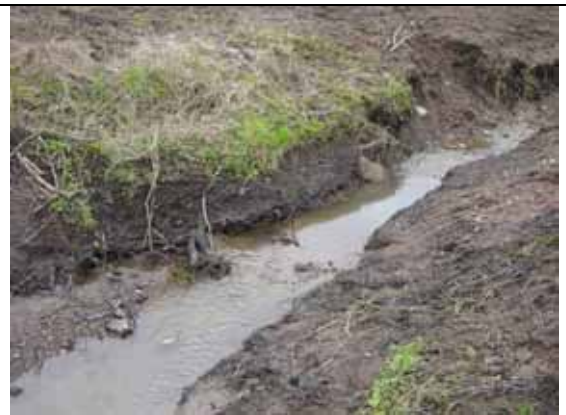
2.2 The first structure on Ketley Brook is the culvert under the M54. This is a 1m diameter circular culvert (picture 001 Appendix A). Downstream of this culvert there is a flow baffle (pictures 003-005 Appendix A) (SJ 67305 10252). The base of this appears to be just above the low flow conditions for the brook. Immediately downstream of this is a balancing pond (pictures 006, 007 Appendix A). Water from the pond flows out over a spill at the eastern side (picture 008) (SJ 67195 10276). The spill incorporates a drop of approximately 1.75m, downstream of which the channel becomes an artificial concrete channel (picture 009). At the downstream end of the artificial channel there is an inflow from the drains on the Ketley Dingle Interchange (M54 junction 6) (SJ 67112 10404). The watercourse then reverts to natural channel and flows towards the Sinclair Ironworks.

001 Ketley Brook Culvert US Under M54

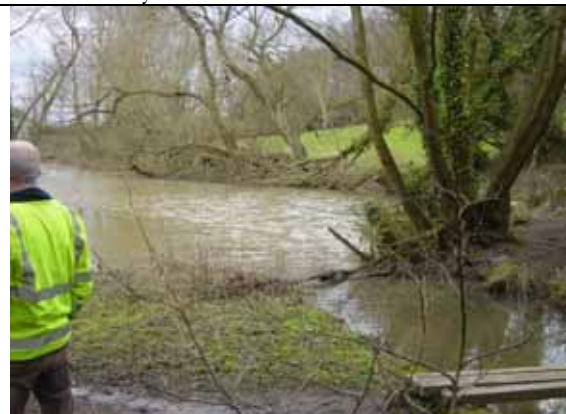
005 Ketley Brook Culvert DS M54 Blind DS

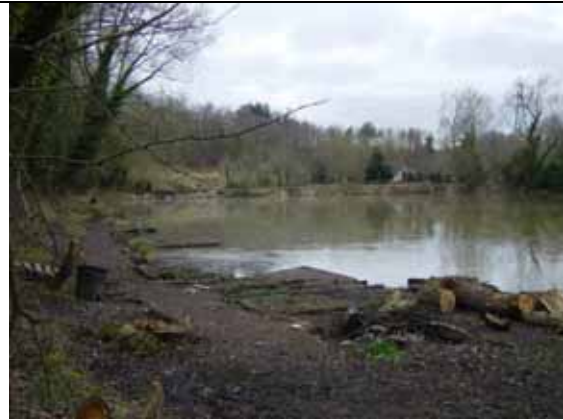
006 Pool On Ketley Brook

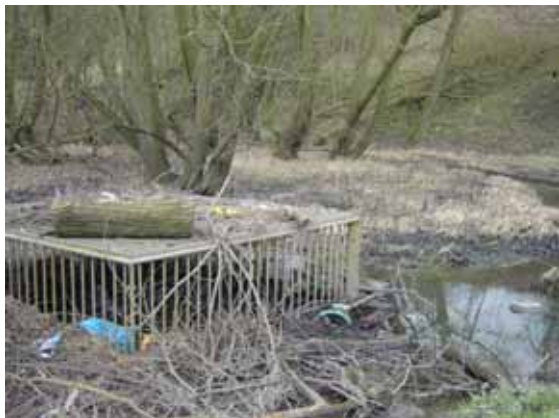
2.3 Information from the EA (based on the submitted consent for modification of the culvert) has indicated that Sinclair Ironworks has diverted a culvert (which originally flowed under the site) and replaced it as it was in poor condition. The culvert is now a 1950mm diameter pipe with an invert of 102.180m and is located at SJ 67100 10500. It was not possible to examine the inlet as it lies within the Sinclair Ironworks site and permission to enter the site had not been obtained. The culvert emerges north of Holyhead Road (A518) (pictures 10-12 Appendix A) (SJ 66950 11063). The watercourse emerges from two

012 Ketley Brook DS A518 Holyhead Road

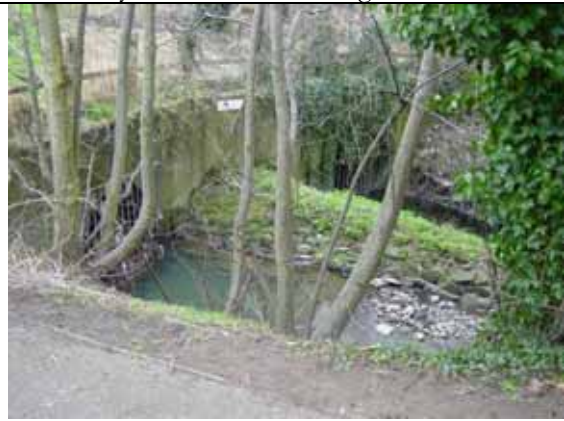
021 Ketley Brook Sink nr Wedgewood Crescent

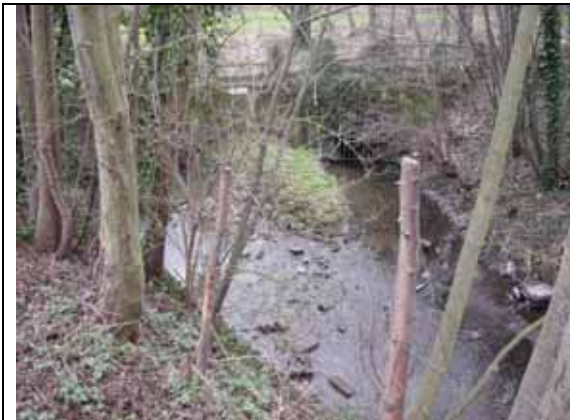
024 Junction of Ketley Book and Hurley Brook
Ketley Brook Culvert DS

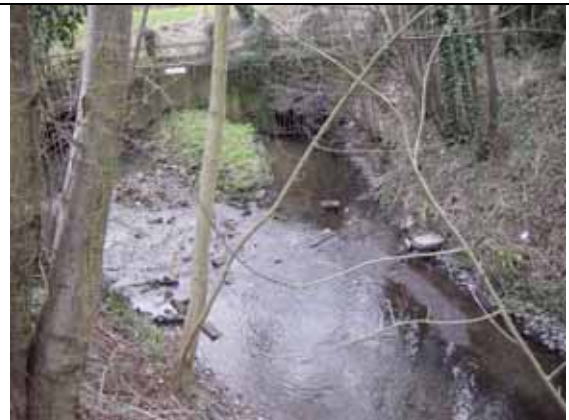
025 Junction of Ketley Book and Hurley Brook

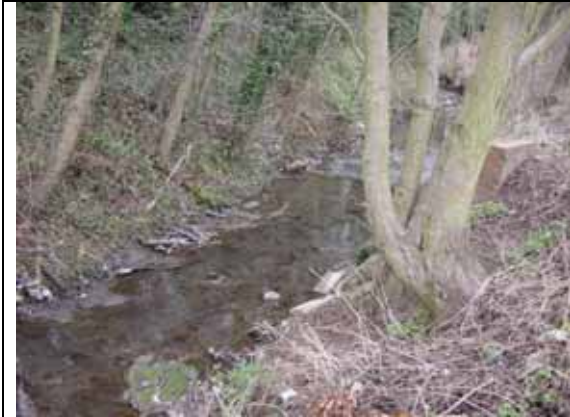
026 Junction of Ketley Book and Hurley Brook

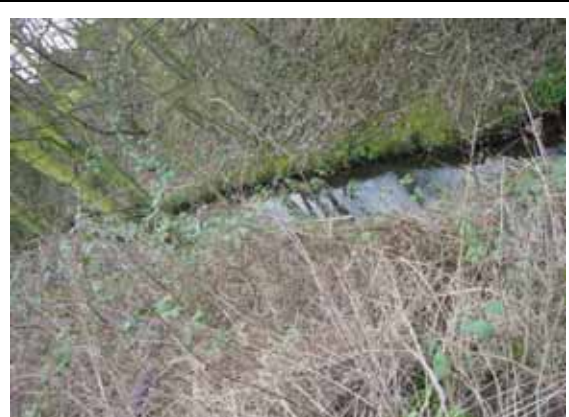
027 DS Junction of Ketley Book and Hurley Brook

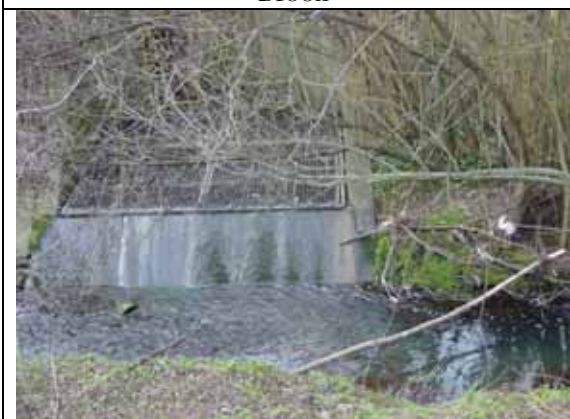
028 Hurley Brook DS Extent

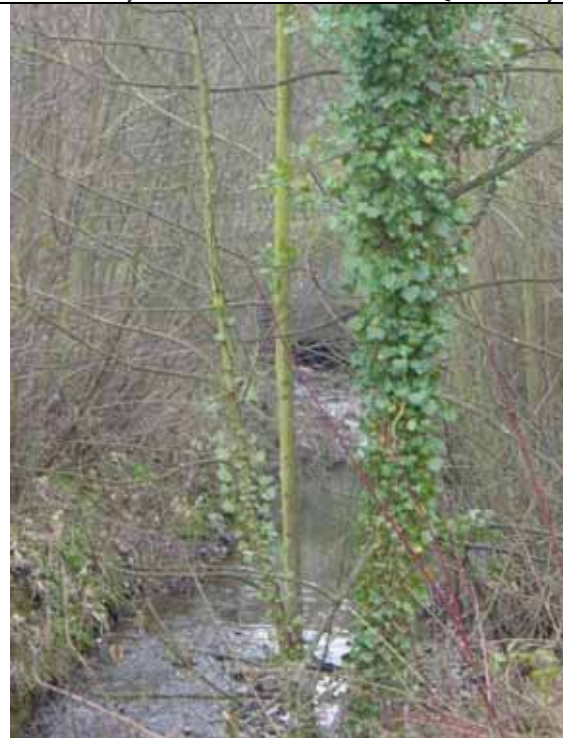
032 Hurley Brook US Culvert A442 Queensway

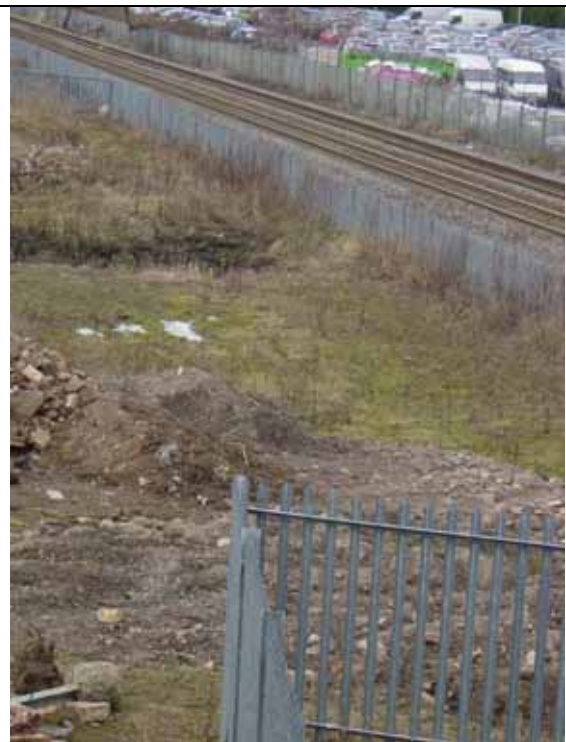
035 Hurley Brook US Culvert Leegate Avenue

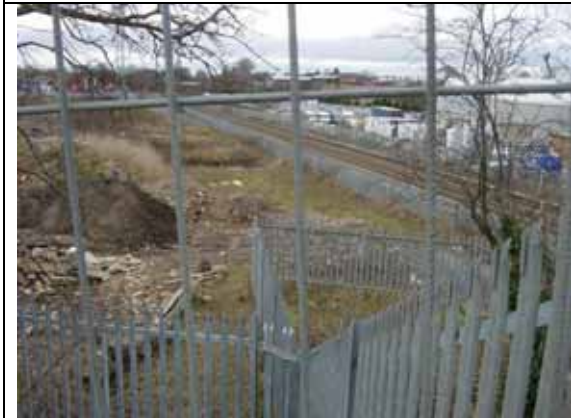
036 Hurley Brook nr Arleston Lane

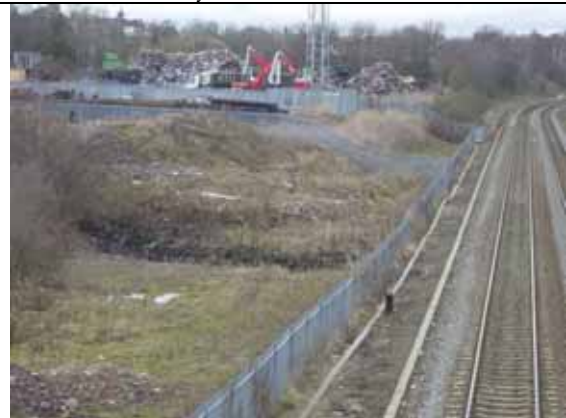
037 Hurley Brook nr Arleston Lane

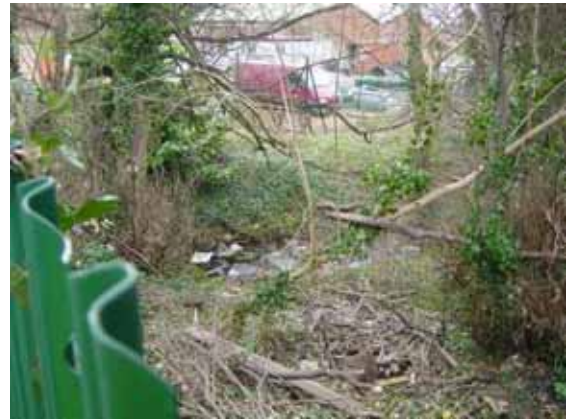
043 Hurley Brook US Limekiln Lane

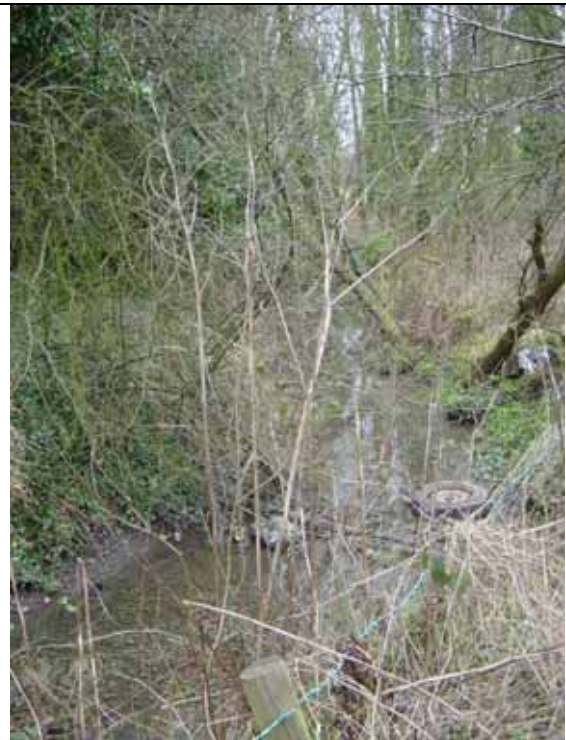
047 Crow Brook DS Culvert Hadley Road

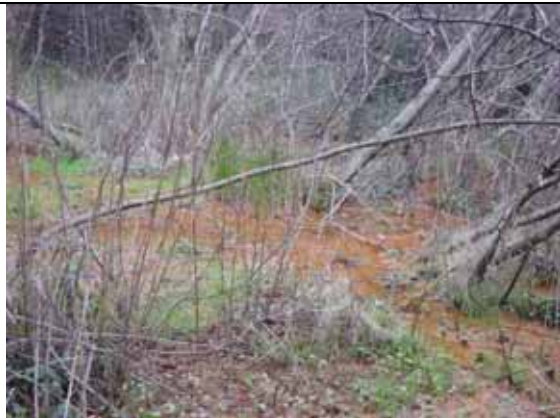
048 Crow Brook DS Hadley Road

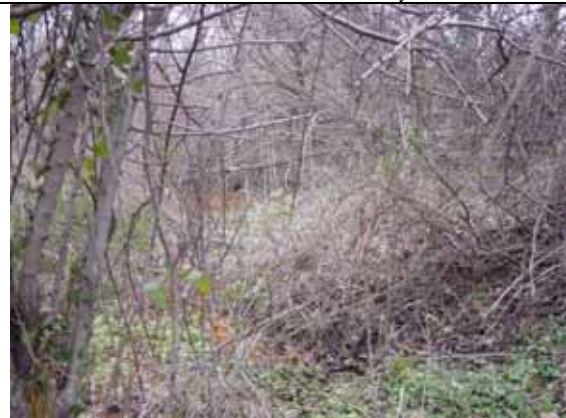
049 Crow Brook DS Sommerfeld Road

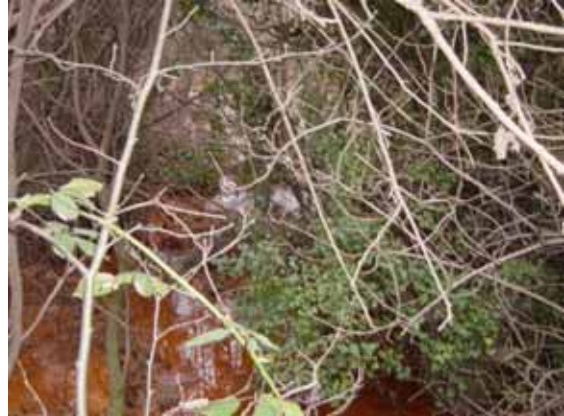
051 Crow Brook DS Culvert Sommerfeld Road

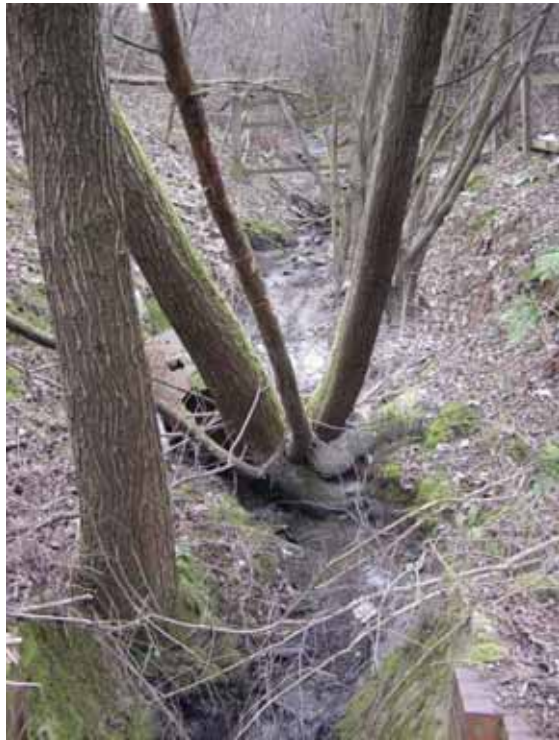
054 Crow Brook US Culvert Sommerfeld Road

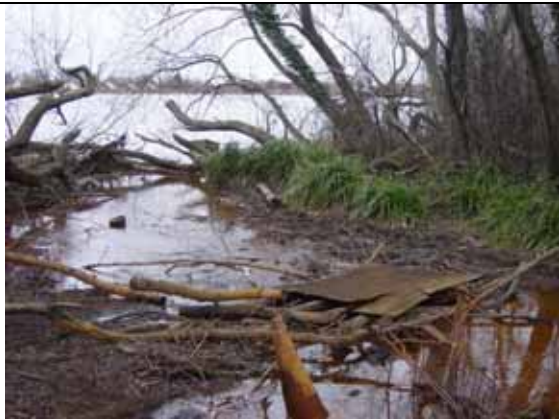
056 Crow Brook DS Culvert Capewell Road
Trench Pool Inflow

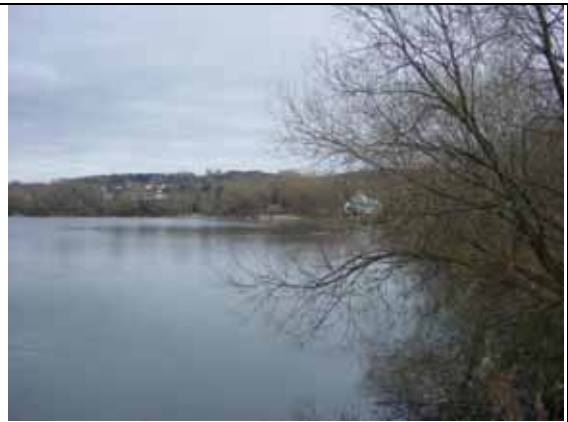
059 Trench Pool DS Overflow

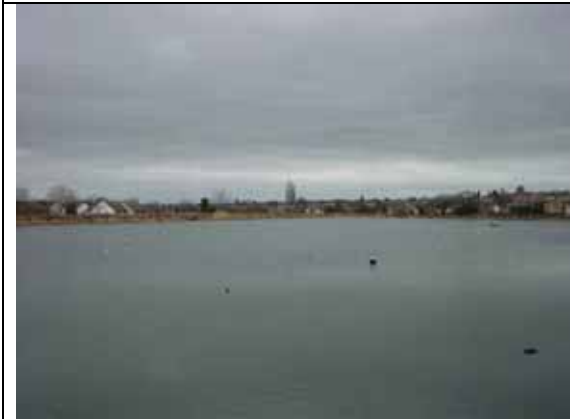
060 Trench Pool

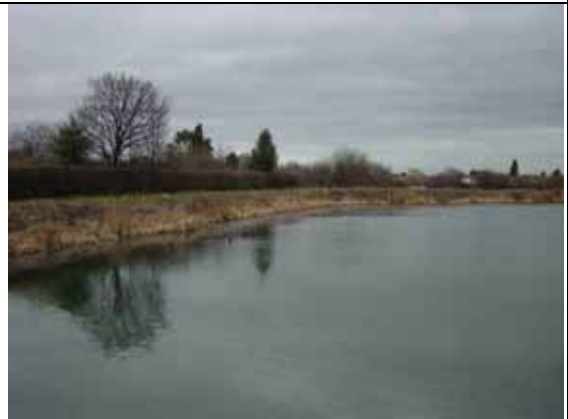
061 Trench Pool

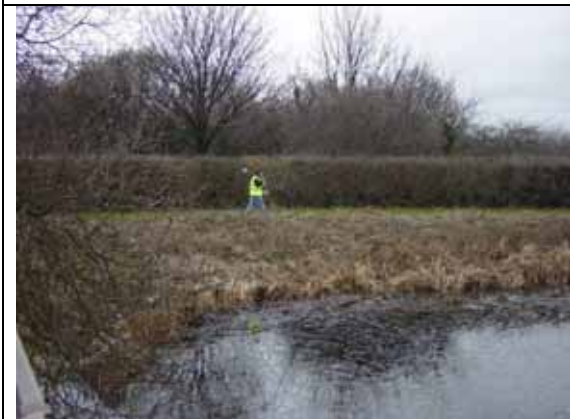
062 Trench Pool

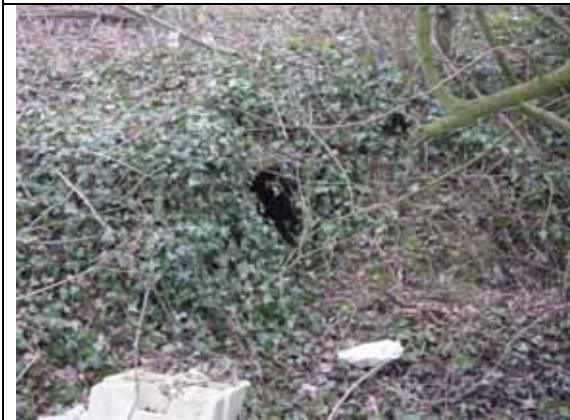
066 Crow Brook DS Culvert nr Horton Lane

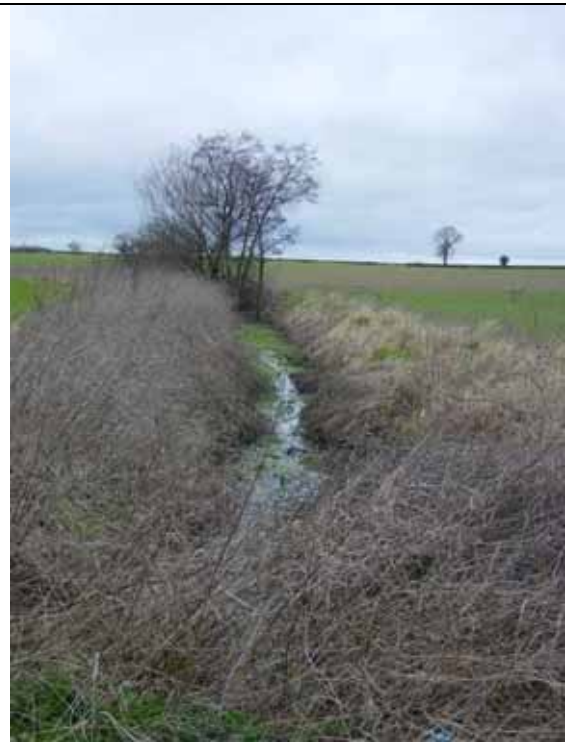
069 Crow Brook DS Culvert Humber Lane
